## Further note on the printing chronograph

Sitter, W. de. (1925). Further note on the printing chronograph. *Bulletin Of The Astronomical Institutes Of The Netherlands*, 3, 72. Retrieved from <https://hdl.handle.net/1887/6213>

### Further note on the printing chronograph, by *W. de Sitter*.

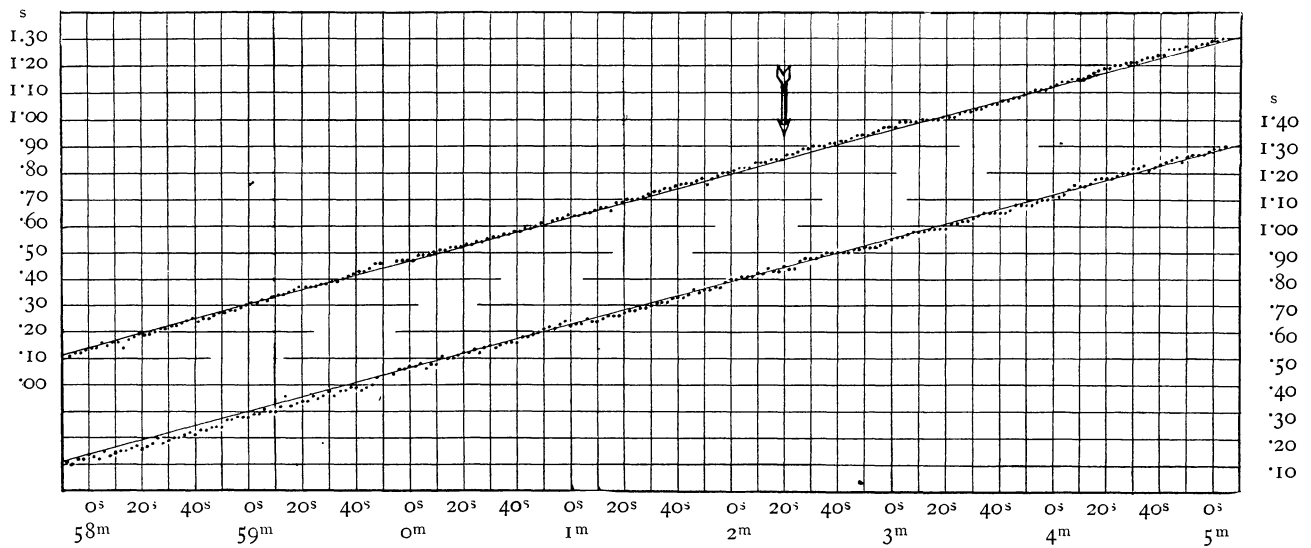
For this reason we caused the mean time clock to register its seconds on the chronograph while the

latter was being synchronised by the sidereal clock. Any irregularities in the running of the motor must produce a deviation of the plot of these printings from a straight line. Several of such series of printings were taken. Those of one of them, taken on Oct. 25, 1925, are represented in the annexed diagram, the abscissae being the whole seconds and the ordinates the hundredths read off from the strips. The even (upper line) and odd (lower line) seconds were plotted separately, the ordinates being shifted 0.40, since there may be a systematic difference in the contacts made at the two ends of the swing of the pendulum of the mean time clock. The straight lines were drawn through the centre of gravity of the middle minute (1<sup>m</sup>0<sup>s</sup> to 1<sup>m</sup>59<sup>s</sup>) with the computed slope, taking account of the known daily rates of the two clocks, and disregarding the systematic difference between the odd and the even seconds. In judging these plots it should be kept in mind that the strips are read to the nearest hundredth of a second, no attempt being made to estimate thousandths. Some of the small fluctuations would undoubtedly have disappeared if thousandths of seconds had been read off, but it was thought better to use the readings as they are made in actual work on stars. The deviations from a straight line are due to three causes. Firstly to irregularities in the contacts of the mean time clock and in the time of reaction of the several relays and of the electromagnet *H*, secondly to irregularities in the contacts of the sidereal clock and the time of reaction of the relays of the synchronising circuit and the electromagnet *S*, and thirdly to irregularities in the synchronising and in the running of the motor and the clockwork. It will be seen that the sum of these three errors never amounts to more than  $\pm 0.03$ , and is generally smaller than  $\pm 0.01$ . Especially at the point (about 5.85) where the disc *s* is brought back to its original position by the spring 9 acting on the pin 8, which is marked by an arrow in the diagram, there is not the slightest discontinuity in the curves.

If we take means of a number of successive residuals, the effect of the accidental errors, and of the estimation of whole hundredths, is eliminated. From the remaining residuals we can determine 1: a constant correction to the zero point of each series, 2: a systematic difference between the even and odd seconds, which is assumed to be the same for all series taken on the same date, and 3: a correction to the adopted relative rate of the two clocks, also constant for all series taken within a short time of each other. For the series represented in the diagram this correction

was + 3<sup>s</sup>.24 in the relative daily rate, a large quantity, but not at all impossible, since especially the mean time clock is not an instrument of precision, and its rate may very well vary considerably during the day. \*) All the series were treated in this way. The residuals remaining after this treatment still contain a considerable percentage of accidental error, different for the different series. If, however, we take the mean of several series, we may hope to eliminate the accidental error, and these means may thus be considered to represent the effect of periodic errors in the clockwork and in the motor, and systematic errors of the synchronisation.

The following table gives in the first column the time *t* elapsed since the last synchronisation. The next two columns give, for the series represented in the diagram, the residuals of the means of from 15 to 20 consecutive printings remaining after the treatment explained above. It will be seen that these are very small indeed. The fourth column contains the mean deviations derived from four different series, including the one taken as an example. The formula
