## **Challenges of the Jordanian museums : the role of environment in preventive conservation**

Alghazawi, R.

# **CHALLENGES OF THE JORDANIAN MUSEUMS**

**THE ROLE OF THE ENVIRONMENT IN PREVENTIVE  
CONSERVATION**

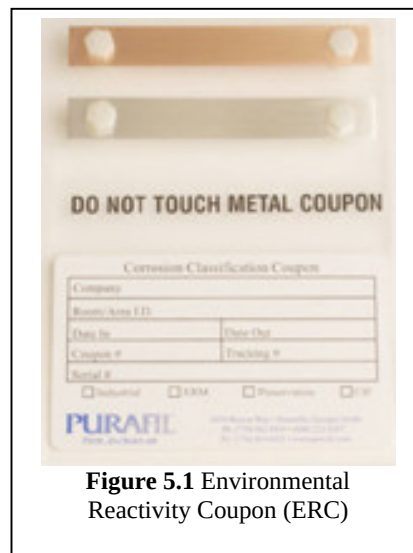
**Figure 5.1** Environmental Reactivity Coupon (ERC)

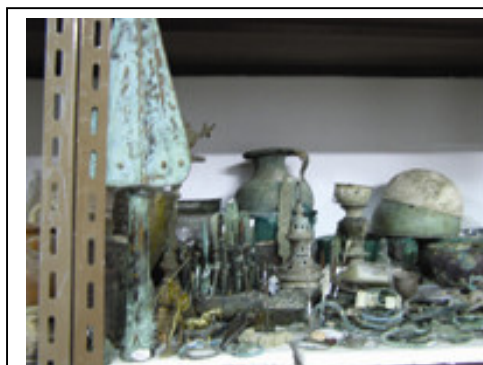
**Figure 6.11** The mass corrosion.  
Metal shelf infection  
Photo by: R. Alghazawi
