# **CHALLENGES OF THE JORDANIAN MUSEUMS**

**THE ROLE OF THE ENVIRONMENT IN PREVENTIVE  
CONSERVATION**

**RAED ALGHAZAWI**

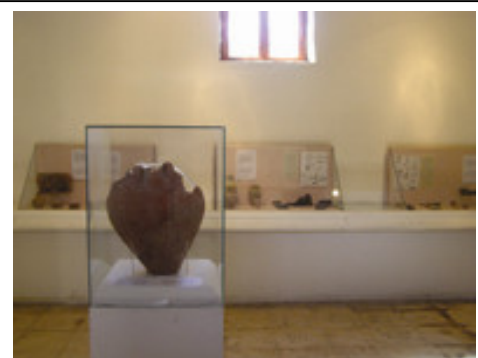
**Figure 3.4** Shows different types of showcases used at museum.  
Photo by R. AlGhazawi

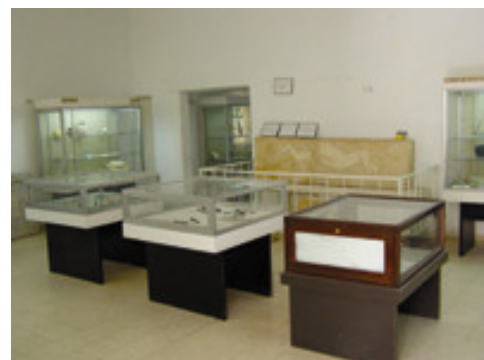
**Figure 3.28** Showcases in the Madaba Archaeology Museum.  
Photo by R. AlGhazawi

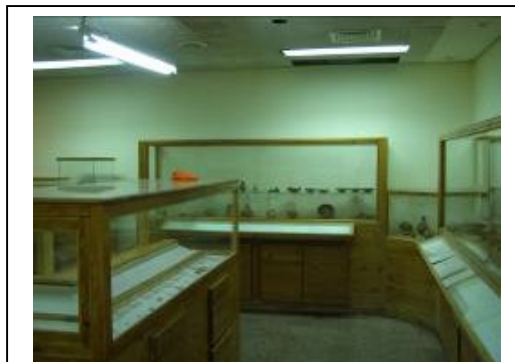
**Figure 3.33** The wooden showcases.

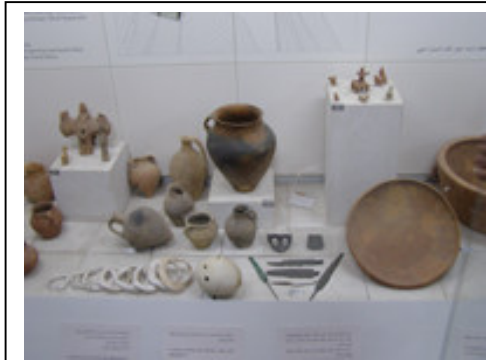
**Figure 3.51** Flooring within showcases.  
Photo by: R. AlGhazawi

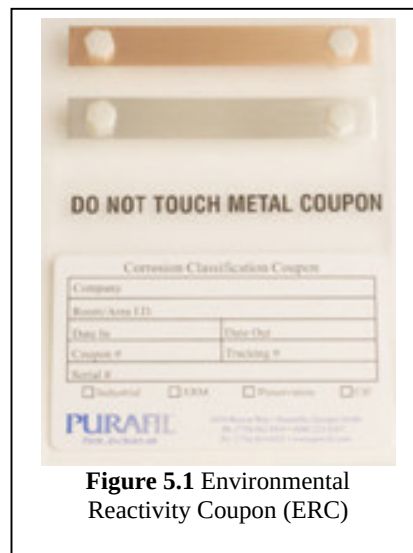
**Figure 5.1** Environmental Reactivity Coupon (ERC)

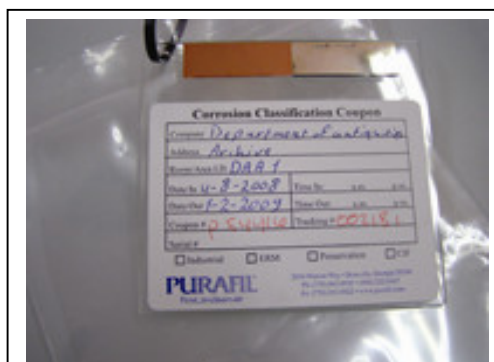
**Figure 5.2** One of the used coupons.  
Photo by: R. Alghazawi

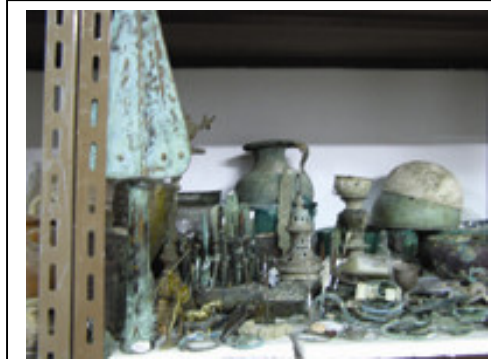
**Figure 6.11** The mass corrosion.  
Metal shelf infection  
Photo by: R. Alghazawi
