## **Changes in the cultural landscape and their impacts on heritage management : a study of Dutch Fort at Galle, Sri Lanka**

Jinadasa, U.N.

## 5. Changes to the Physical Urban Landscape

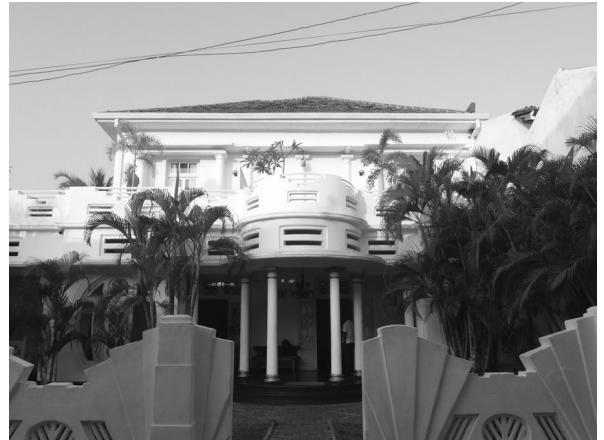
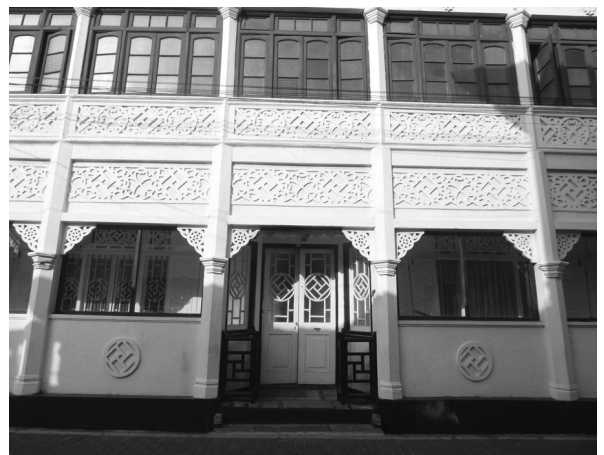
**Figs. 44–45** Buildings exhibiting popular architectural styles of different periods, Light House Street.

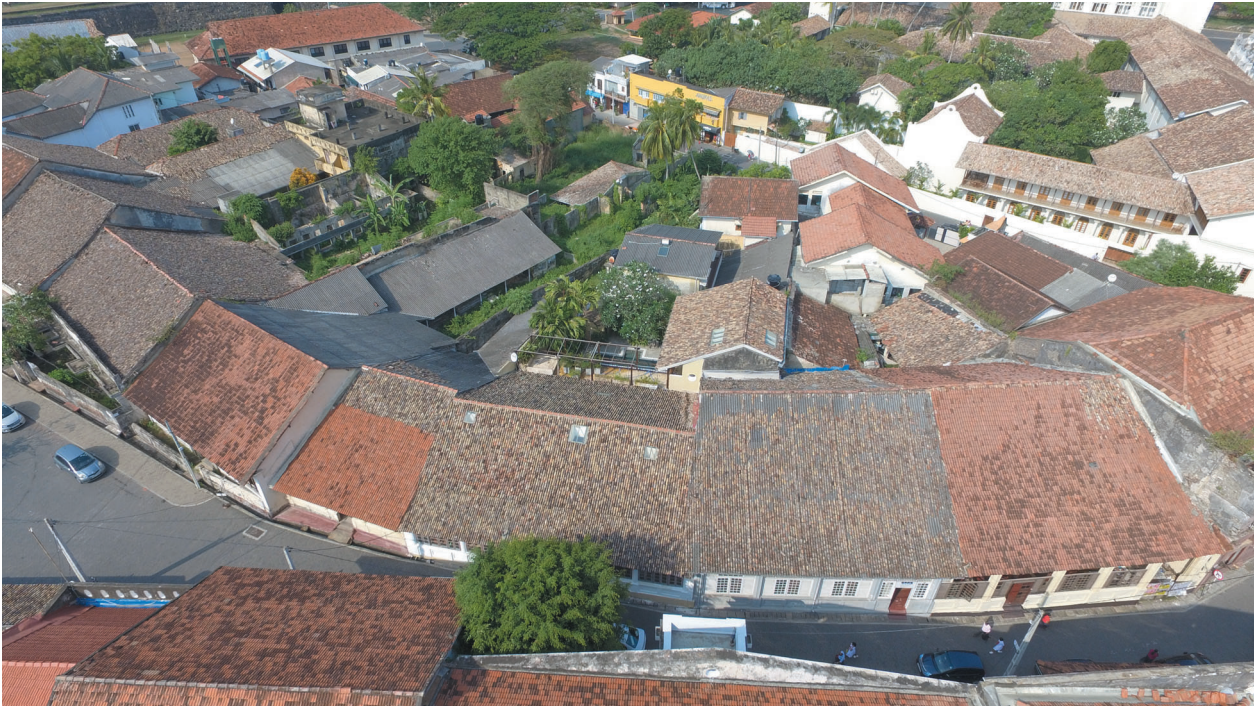
**Fig. 47** Aerial view of the streetscape of Middle Street, showing the narrow street frontages and deep interiors of houses.

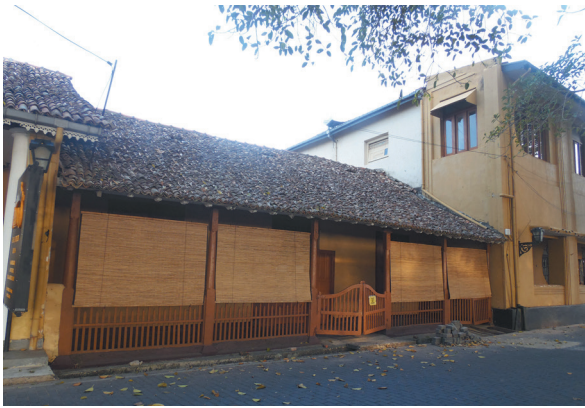
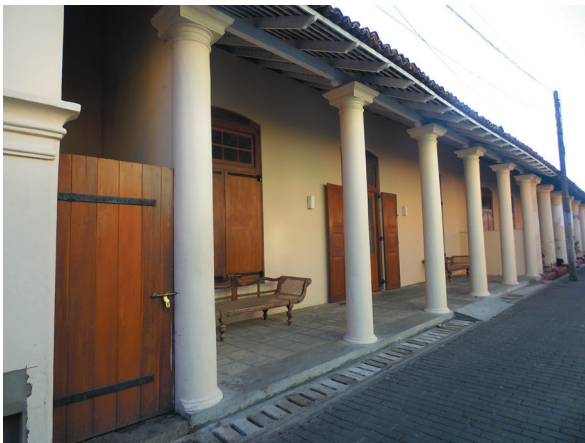
**Figs. 53–54** A timber-pillared verandah (above) and a renovated Doric-pillared verandah (below).

The verandah, which is the chief visible architectural feature of the colonial houses in Galle Fort, may consist of wooden pillars, masonry pillars or arches (Figs. 53–56). While the original type of support was square wooden pillars, Doric masonry pillars appear in the late Dutch and early British periods, followed by arches, which evolved in the late British period (Boxem and Führen 2010, 44). According to Boxem and Furhen (2010), the verandah was a later addition to the houses of the Dutch era, probably from around the late 18<sup>th</sup> century, and replaced the earlier, higher *stoep* in front of the buildings.

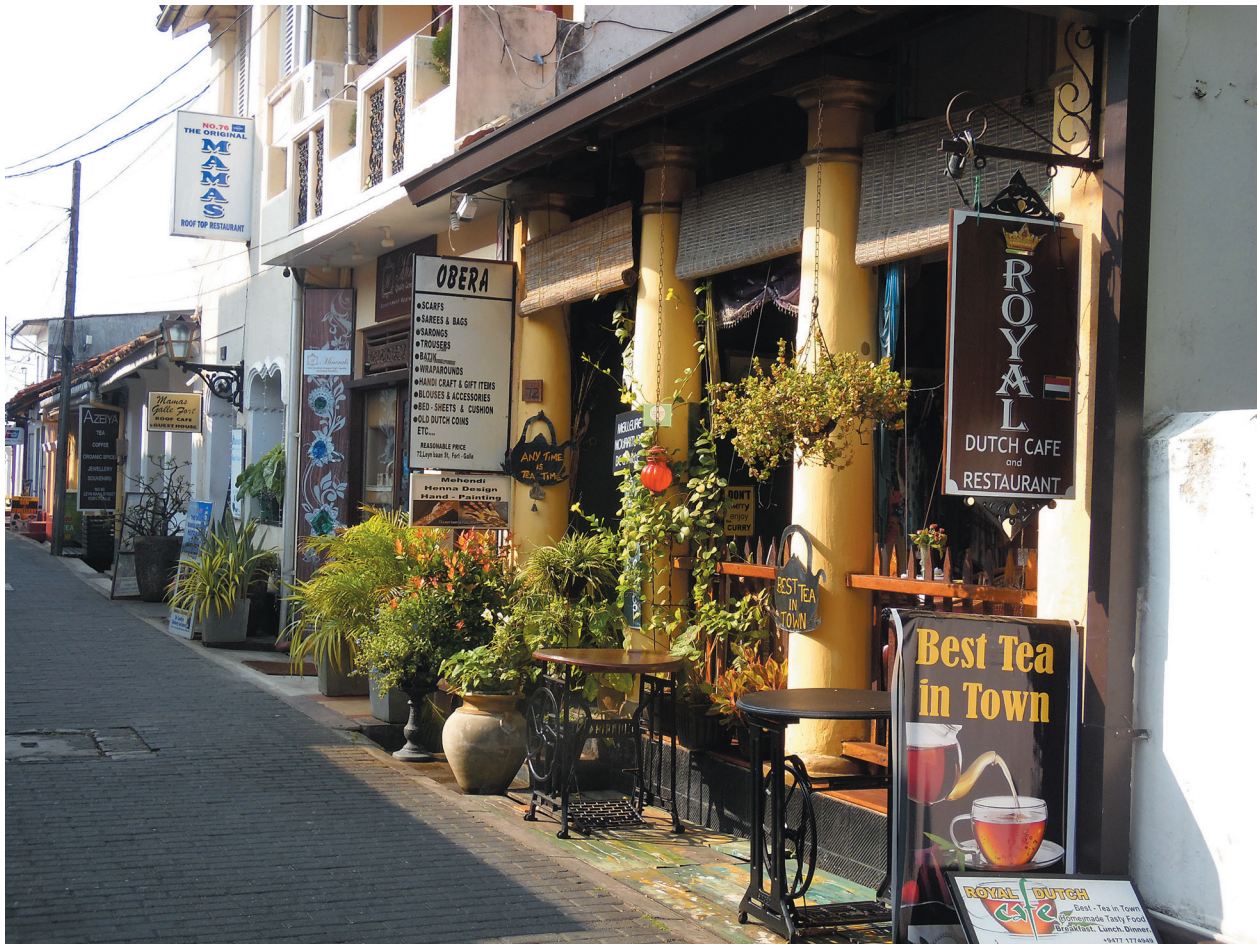
**Fig. 71** The same houses as shophouses and tourist accommodations in 2018: (right to left) no. 72 (a house with a café), no. 74 (a house with a jewellery shop and B&B), no. 76 (a restaurant and accommodation), no. 78 (boutique villa) and no. 80 (a house with a packed tea shop).

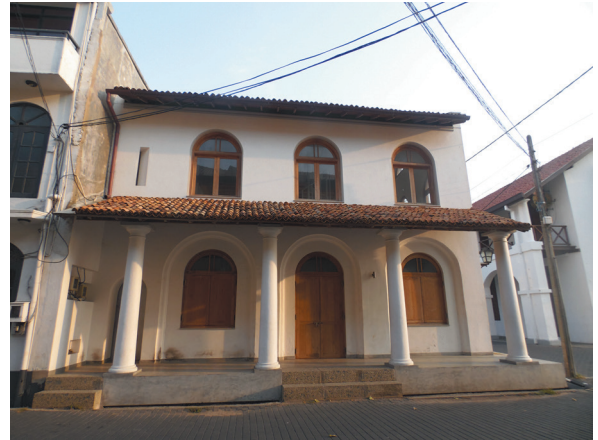
**Figs. 82–83** A “disturbing” façade (at left; Kuruppu and Wijesuriya 1992, 145) that changed into a “contributing” façade after an approved development (at right, 2016).<sup>373</sup>

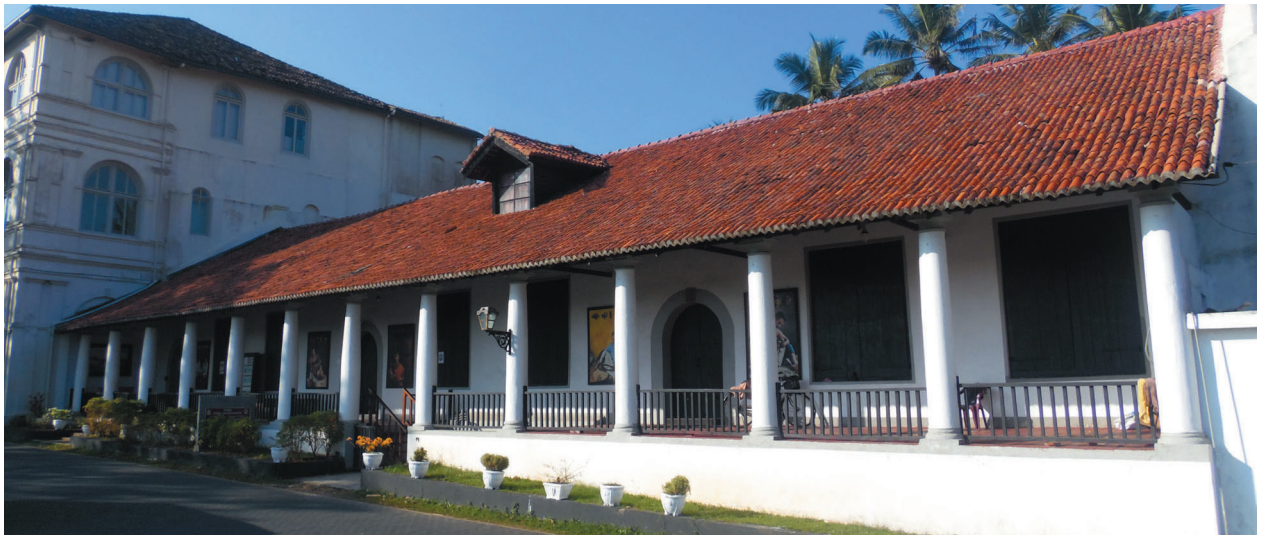
**Fig. 97** The same building in 2016, with a full verandah added in the early '90s.

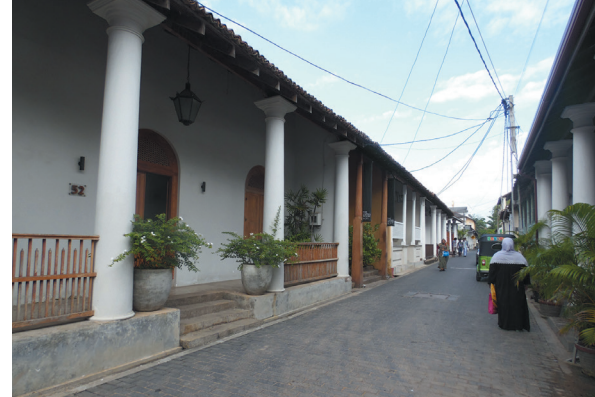
**Fig. 121** Reconstructed colonial streetscape (Light House Street, with new developments).

in a reconstructed colonial streetscape (Figs. 120–121). Although the statistics show the willingness of a considerable number of property owners to have a verandah, there are exceptions for the occupants of comparatively small houses, as will be elaborated in sub-chapter 7.2.3.

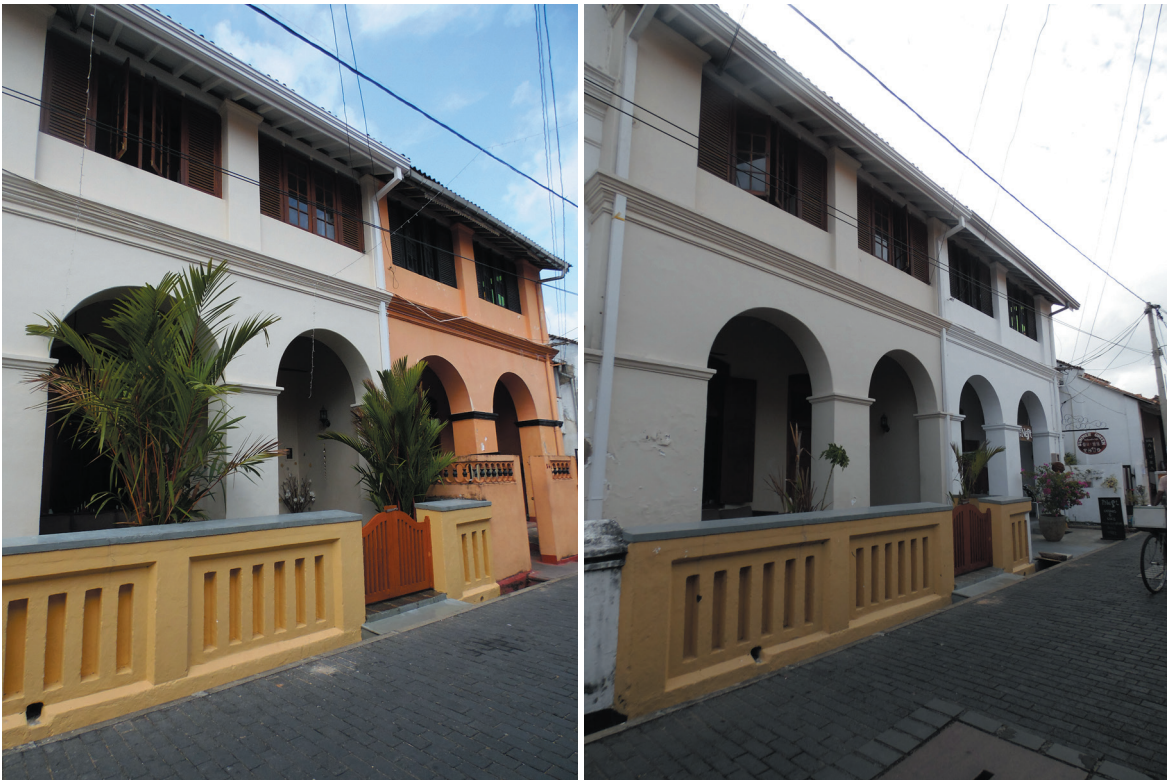
**Figs. 127–128** The unacceptable orange colour found on a house in 2016 (left) was changed into an approved colour by 2018 (right).

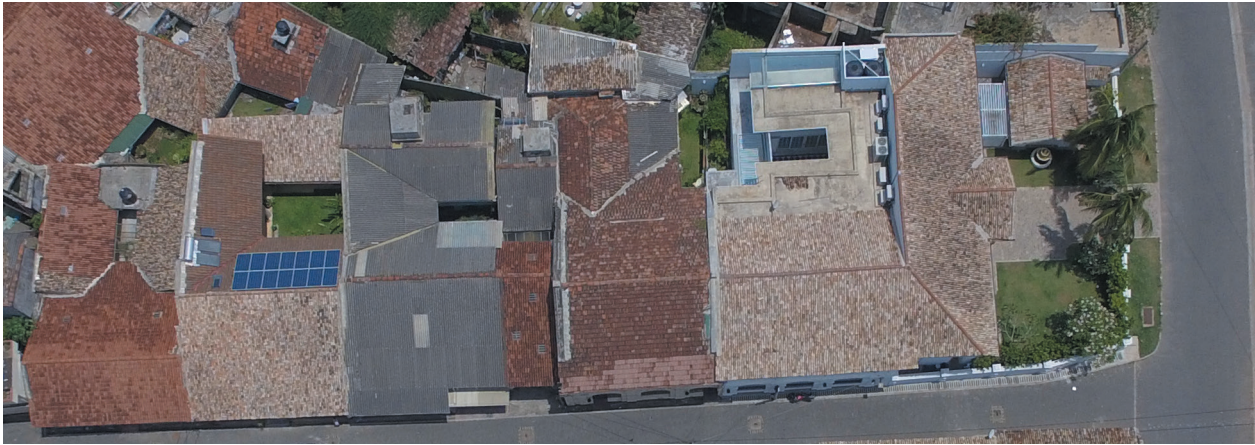
**Fig. 133** Roofscapes of the same buildings in 2016: four of them are covered in clay tiles, while only one (in the middle) has the prohibited asbestos. Furthermore, approved developments have positively increased the use of half-round tiles over asbestos (extreme right and the second from the left, also with solar panels).

It was observed by drone images that a number of buildings have half-round tiles only on the visible areas of the roof, while the rest is covered with asbestos. In addition, nearly 10% of the buildings have solar panels, a positive trend of using clean energy, especially popular with providers of tourist accommodation, both local and foreign.

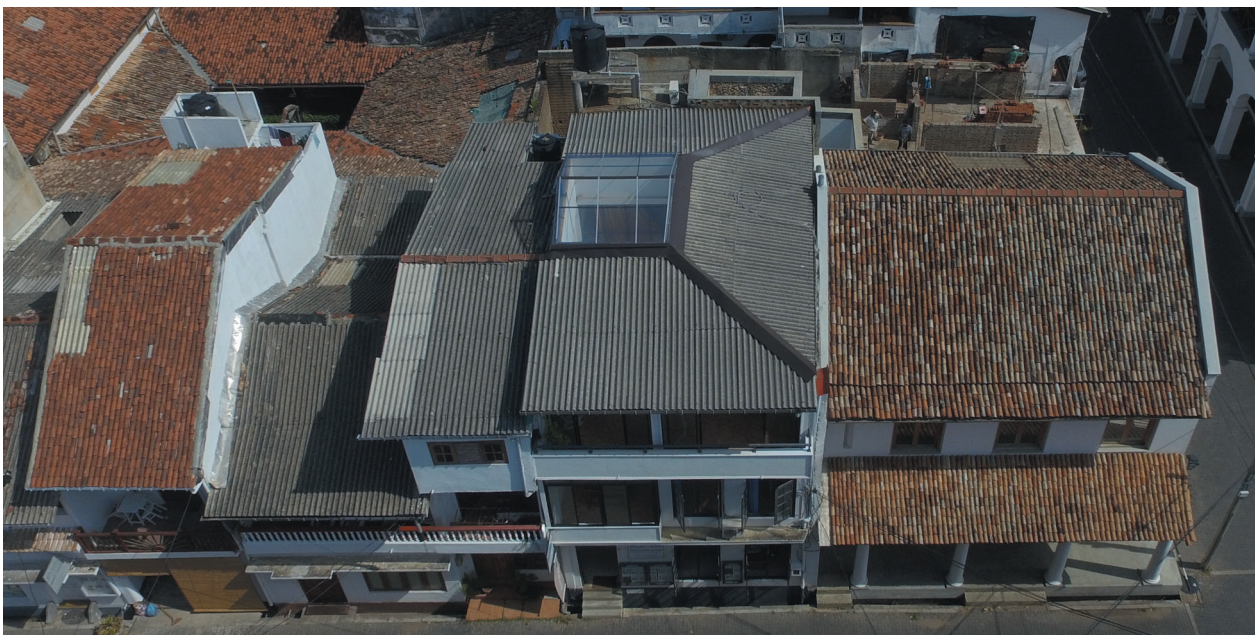
**Fig. 134** Difference in the usage of roof materials between approved and "illegal" developments: while half-round tiles over asbestos are used in approved developments (extreme left and right), the rest, in the middle, are covered with the prohibited asbestos.

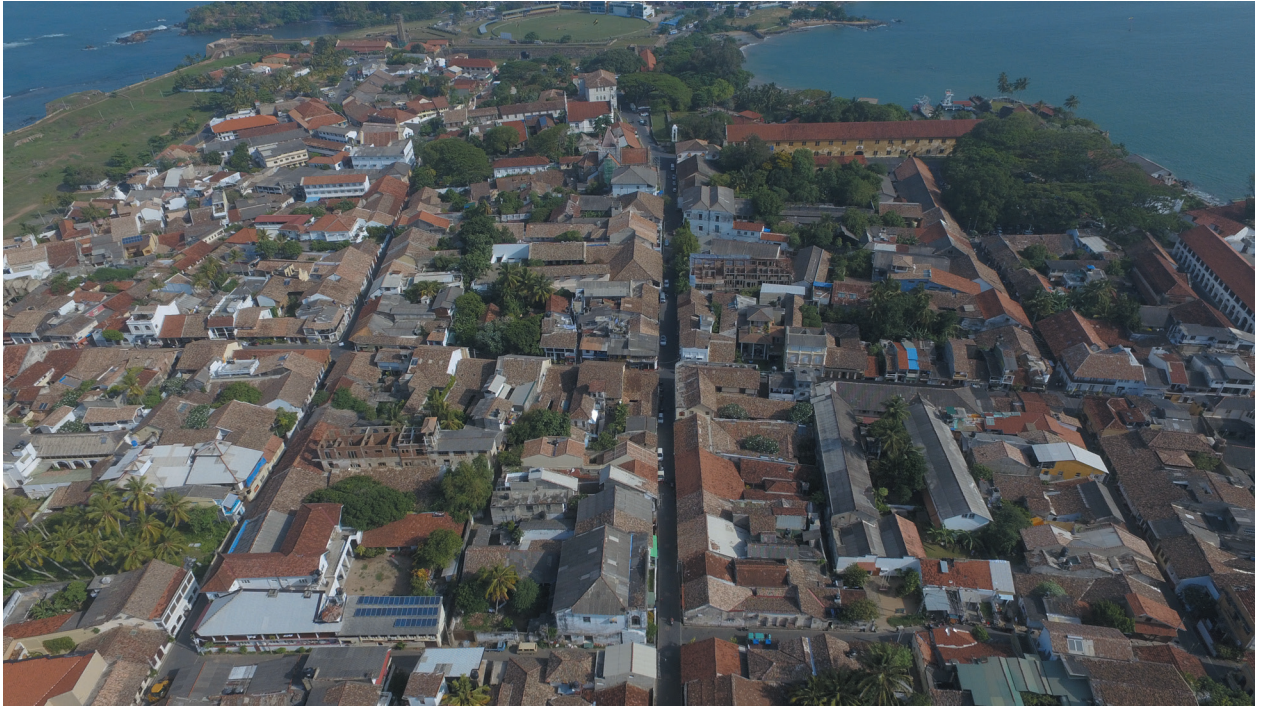
**Fig. 135** The roofscapes in 2016, showing more tiled roofs and a substantial amount of prohibited asbestos.

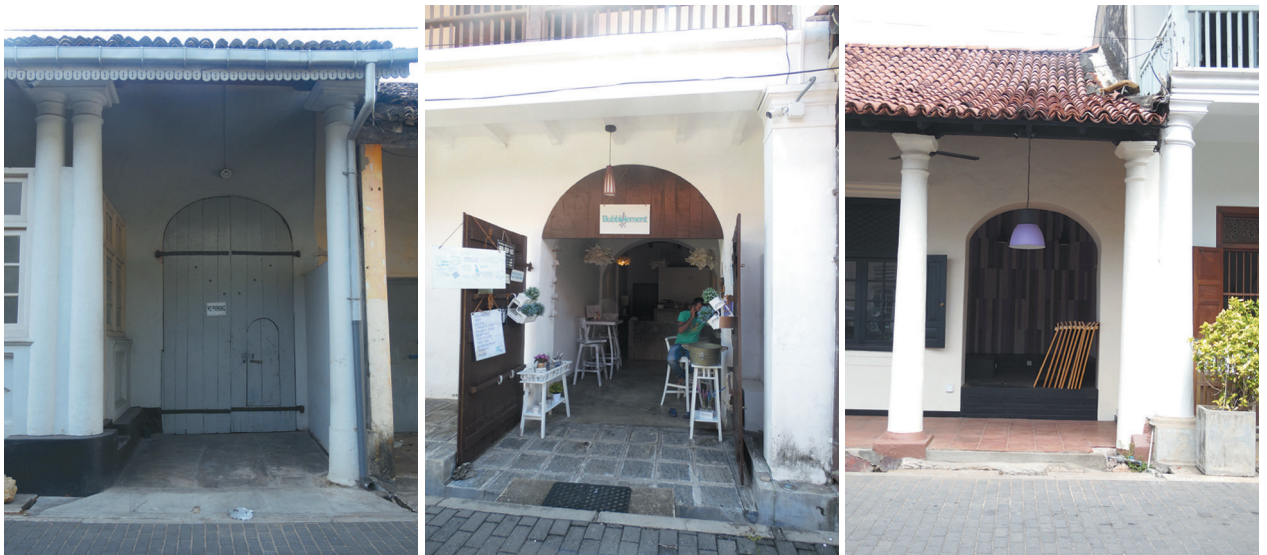
**Figs. 136–138** Three stables in different conditions: unchanged (the first one, on Church Cross Street); renovated with positive changes (the second, on Parawa Street); and an ongoing “unpermitted” change, in December 2017 (the third, on Pedlar Street).

Colonial stables can be identified as a disappearing element due to their increasing commercial value as shop spaces. Nine out of 12 stables/old garages are used for commercial tourism purposes, which coincides with mostly discarding their colonial characteristics. While one stable on Parawa Street has been positively converted without much architectural change, alterations in another on Pedlar Street have destroyed the authentic stable, according to the Project Planning Officer of Galle Heritage Foundation (Figs. 136–138).<sup>383</sup>

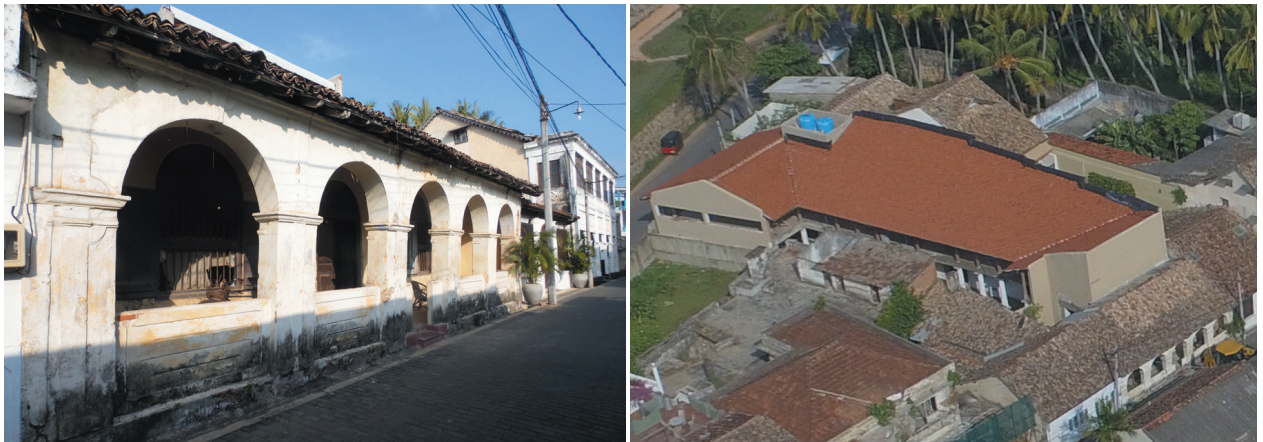
**Figs. 143–144** The British façade kept as it is (left) and the aerial view of the development of the same building behind the façade (right), an ongoing approved development of a boutique hotel (2016).

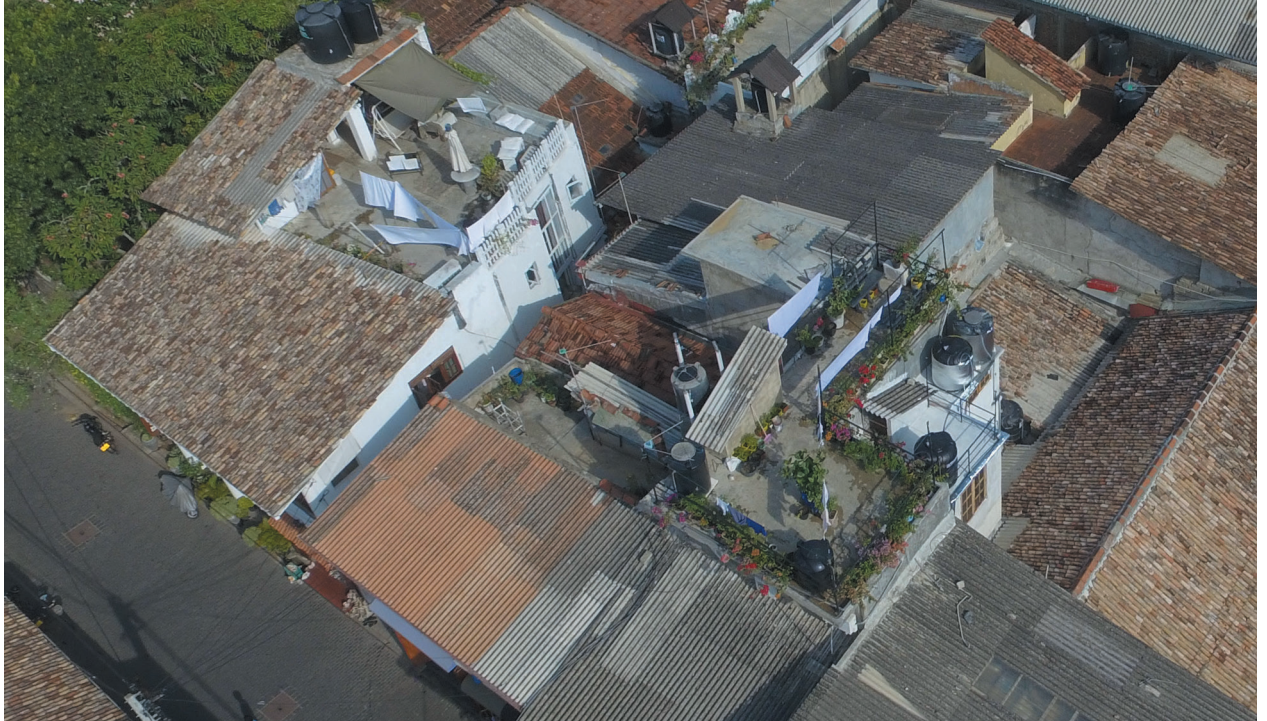
**Fig. 168** Rooftops of B&Bs, examples of further vertical constructions halted by the heritage authorities.

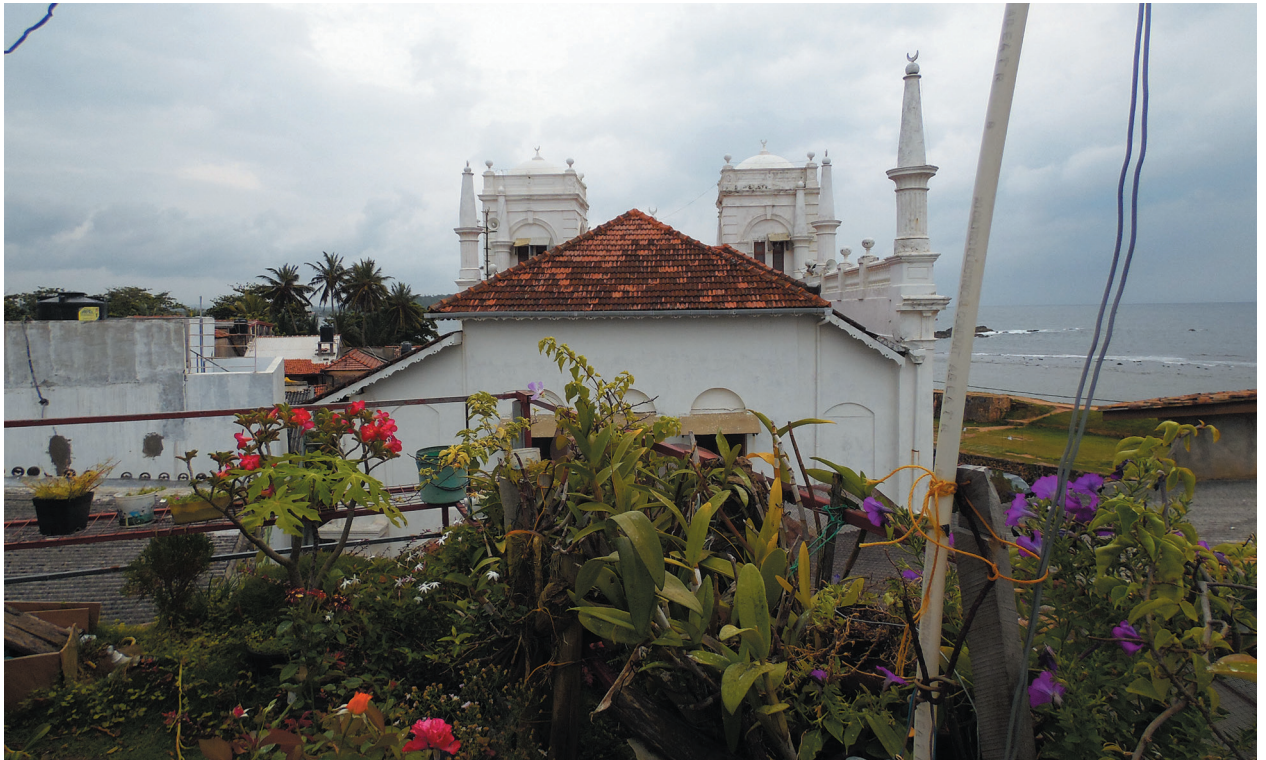
**Fig. 169** The rooftop as an alternative to a courtyard: rooftop gardening in a B&B run by a retired resident couple who do not have a courtyard.

It was observed that rooftops are used as an alternative space, for buildings that do not have a courtyard or those that have lost their courtyards due to development, for practical functions, such as gathering spaces, gardening, drying clothes, etc. (Fig. 169). Thus, this is an element that is practically useful for both residential and commercial purposes.

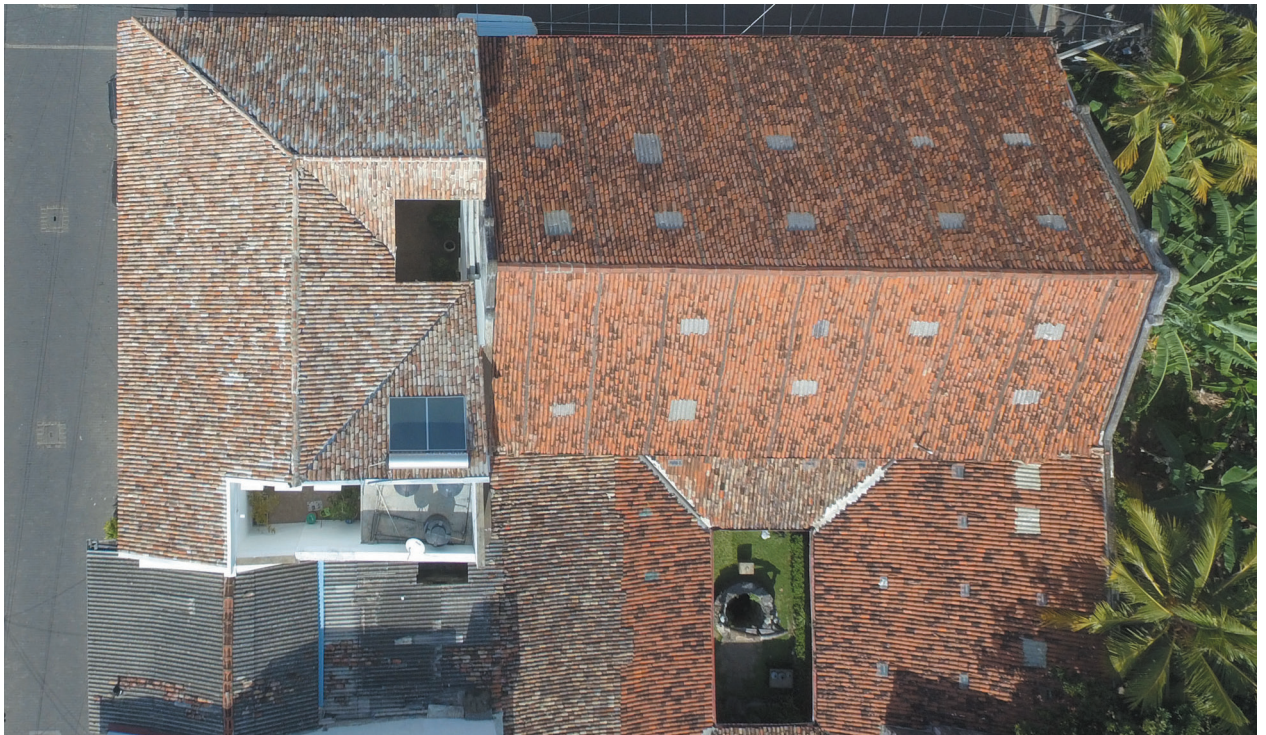
**Fig. 176** Small courtyard in an approved development at left vs. a (renovated) colonial central courtyard with a well at right, showing the change in the utilitarian function of courtyards.<sup>391</sup>

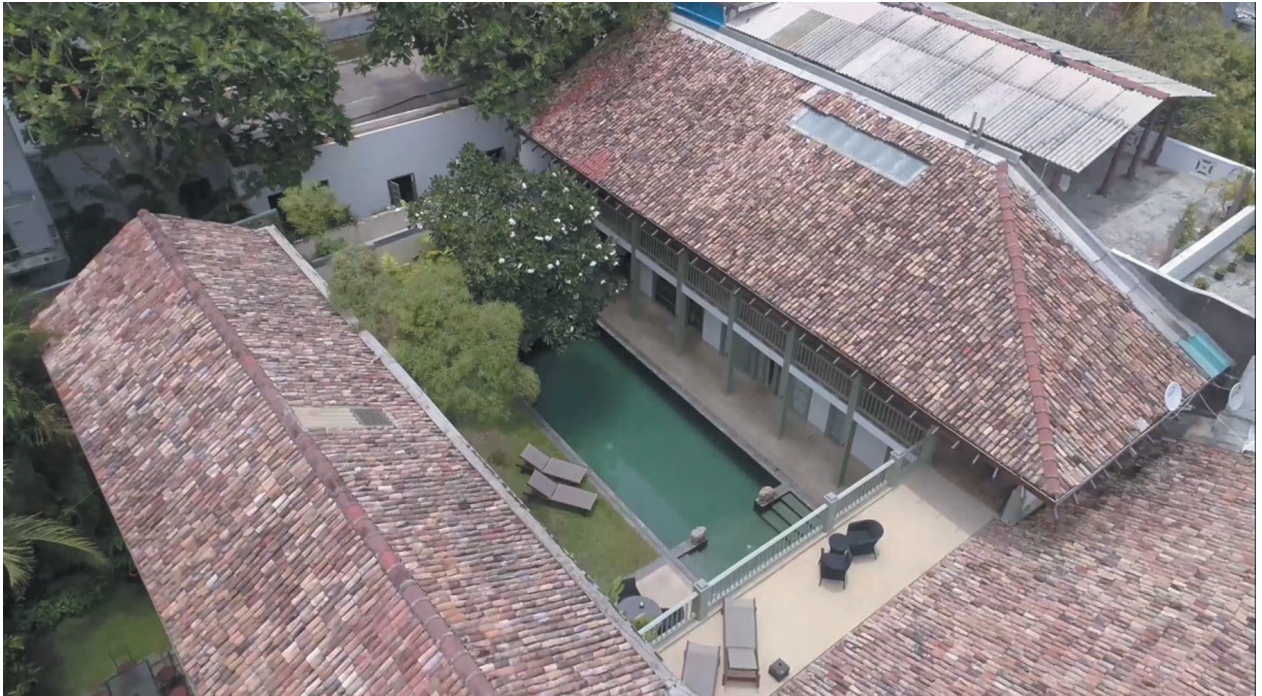
**Fig. 178** A swimming pool in a newly developed villa; the pool replaced the former central courtyard.<sup>394</sup>

Fourteen and 15 swimming pools, respectively, were recorded by the UDA survey (2016)<sup>396</sup> and GHF survey (Liyana Arachchi 2009, 43). Nineteen swimming pools were identified in this study, including one plunge pool, by the joint use of drone images and websites of tourist accommodations that list their facilities. Sixteen of these pools have fully or partially replaced the courtyards (Figs. 178–181).

<sup>394</sup> Kuruppu and Wijesuriya record a central courtyard in this building in 1992, which was replaced by the current swimming pool.

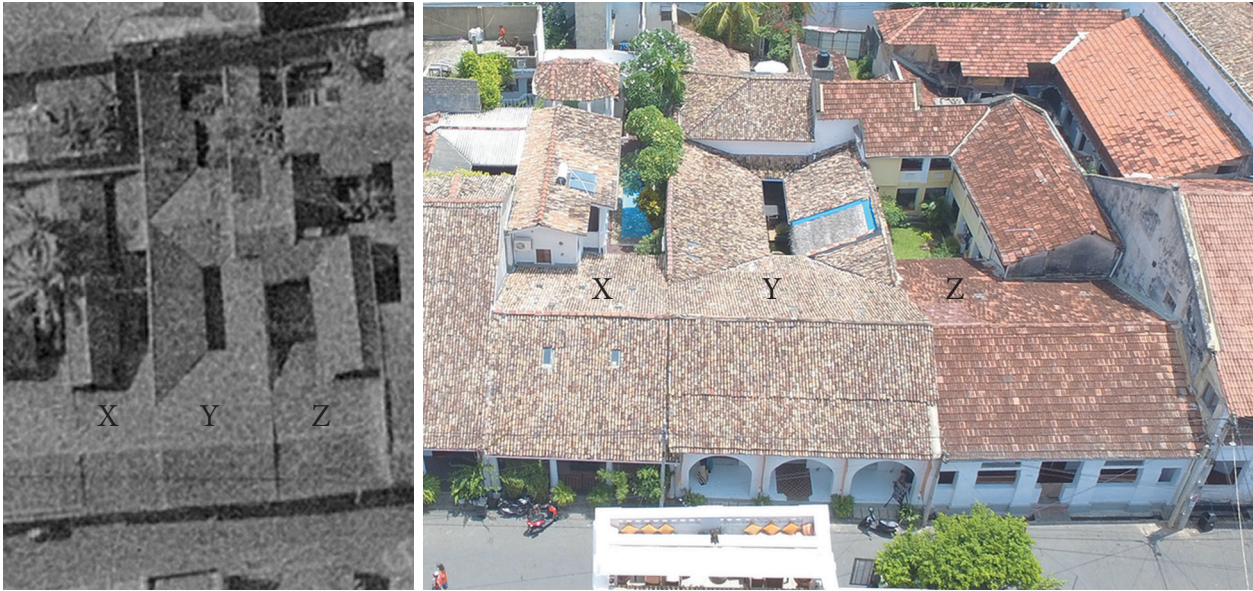
**Figs. 179–180** Areal views of the same location in 1965 (left)<sup>397</sup> and 2016 (right): the side courtyard was turned into swimming pool (X) and the central courtyard into a pond (Y), while the side courtyard remained unchanged (Z).

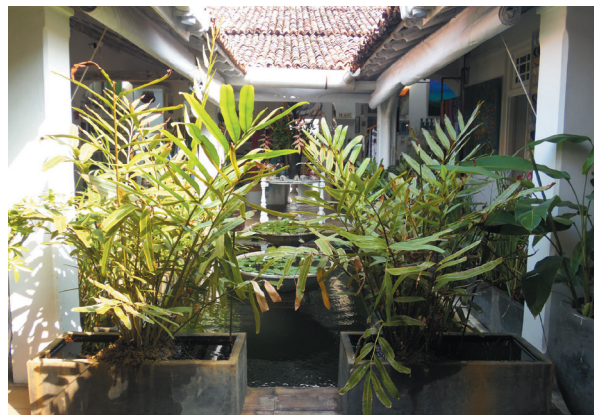
**Fig. 181** A pond that replaced a central courtyard.

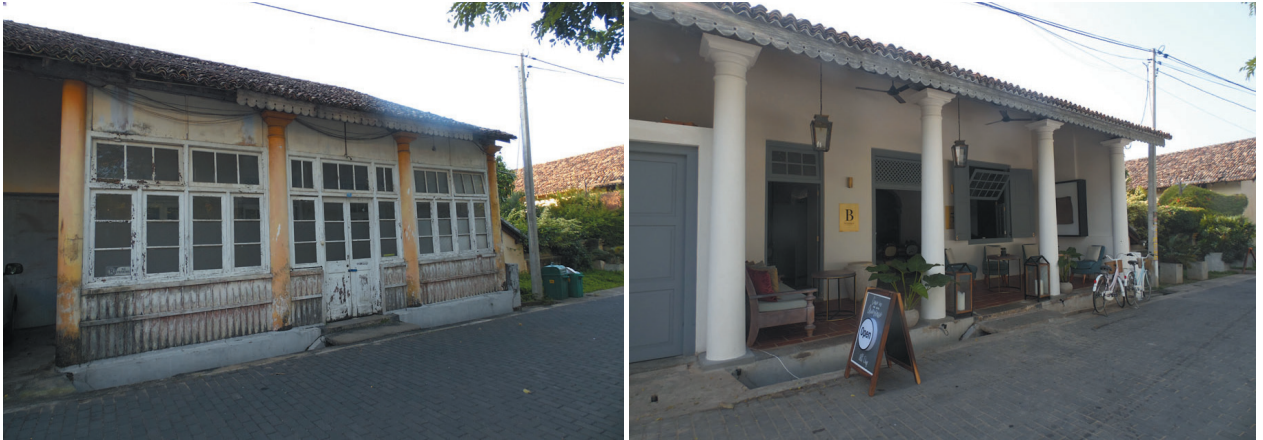
**Figs. 182–183** A dilapidated building in 2016 (left) and same as a restaurant in January 2019, after its development (right).

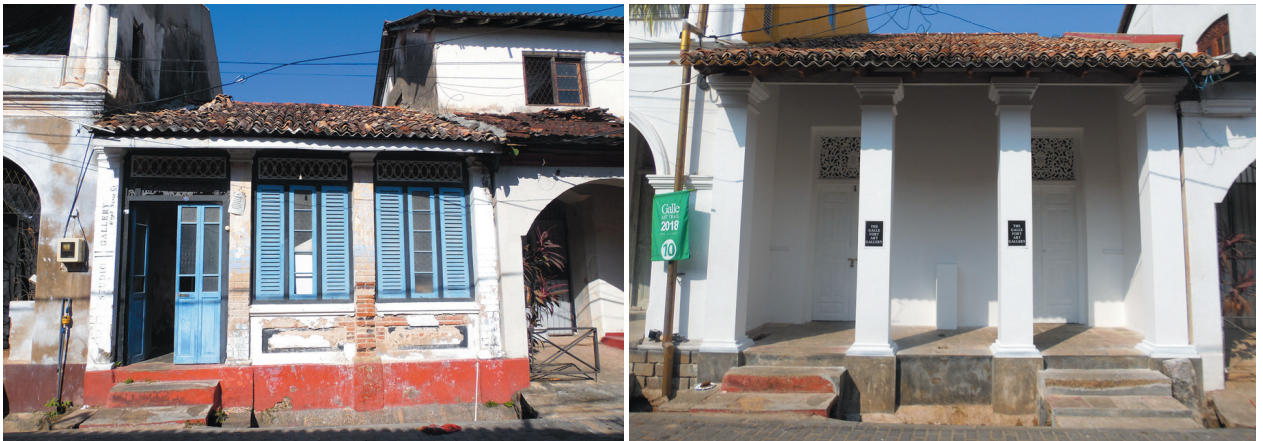
**Figs. 184–185** A building in 2016 (left) and same one, in January 2018, as a gallery, after its development (right).

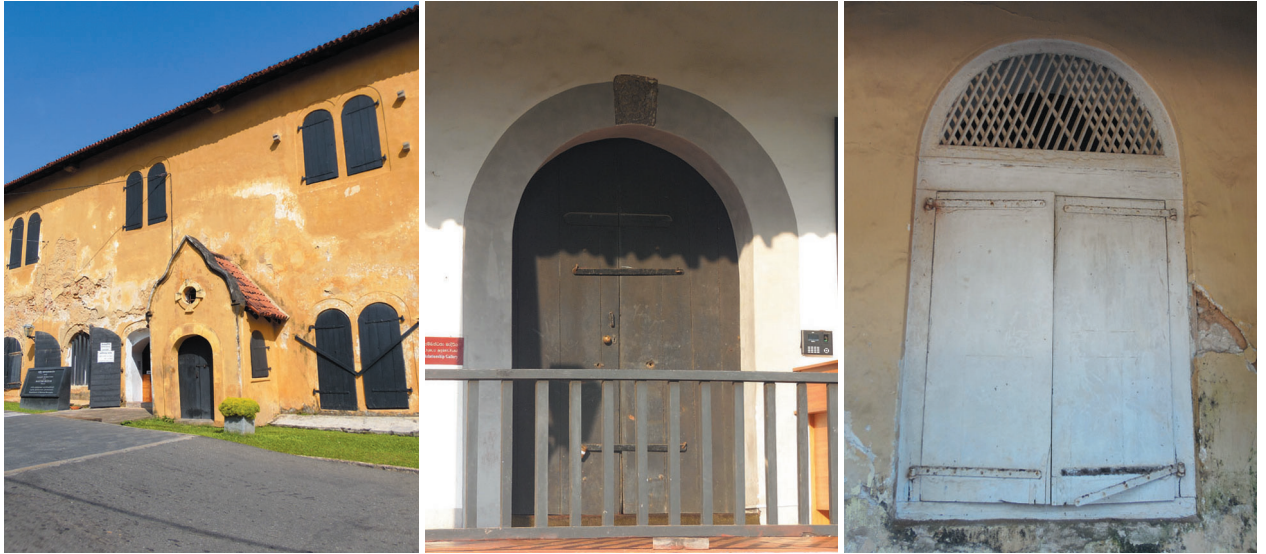
**Figs. 192–194** Colonial arch-shaped doors and windows: the Dutch warehouse (left), the Dutch-period Galle National Museum (middle) as well as a British-period window in a house on Pedlar Street.

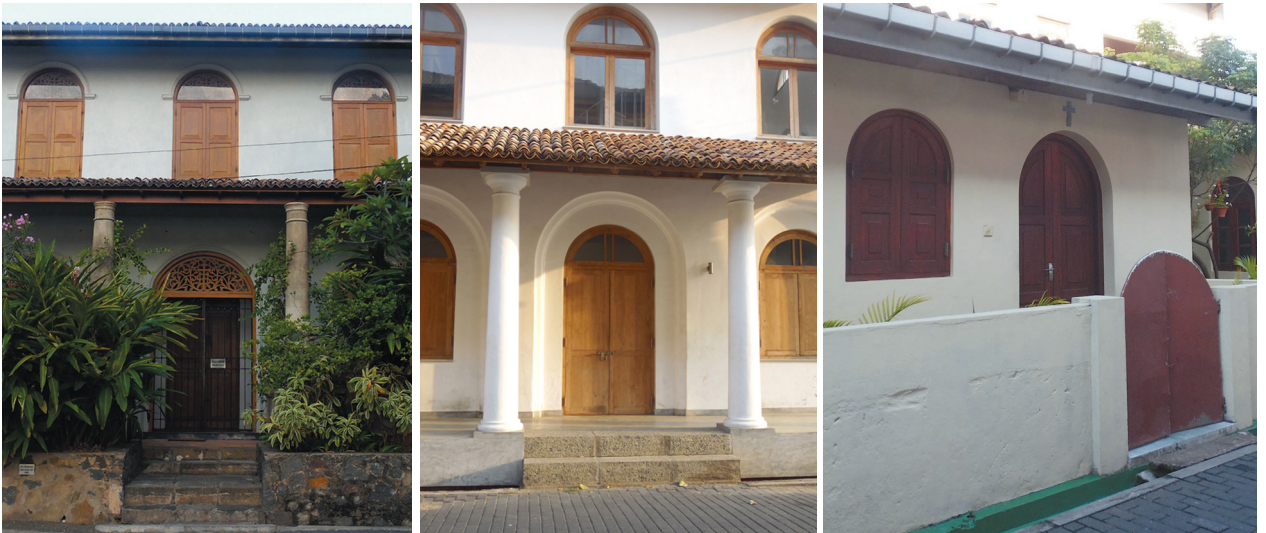
**Figs. 195–197** Developments adopting similar shapes and styles: a villa (first) and two houses (middle and right).

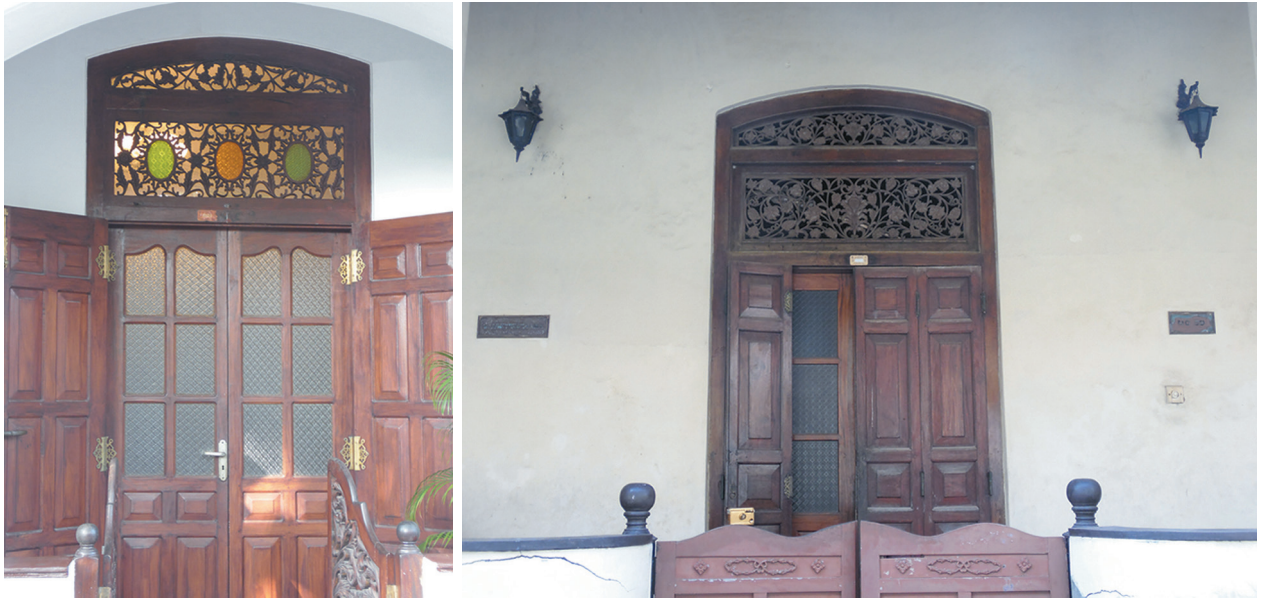
**Figs. 202–203** Original doors with detailed carvings.

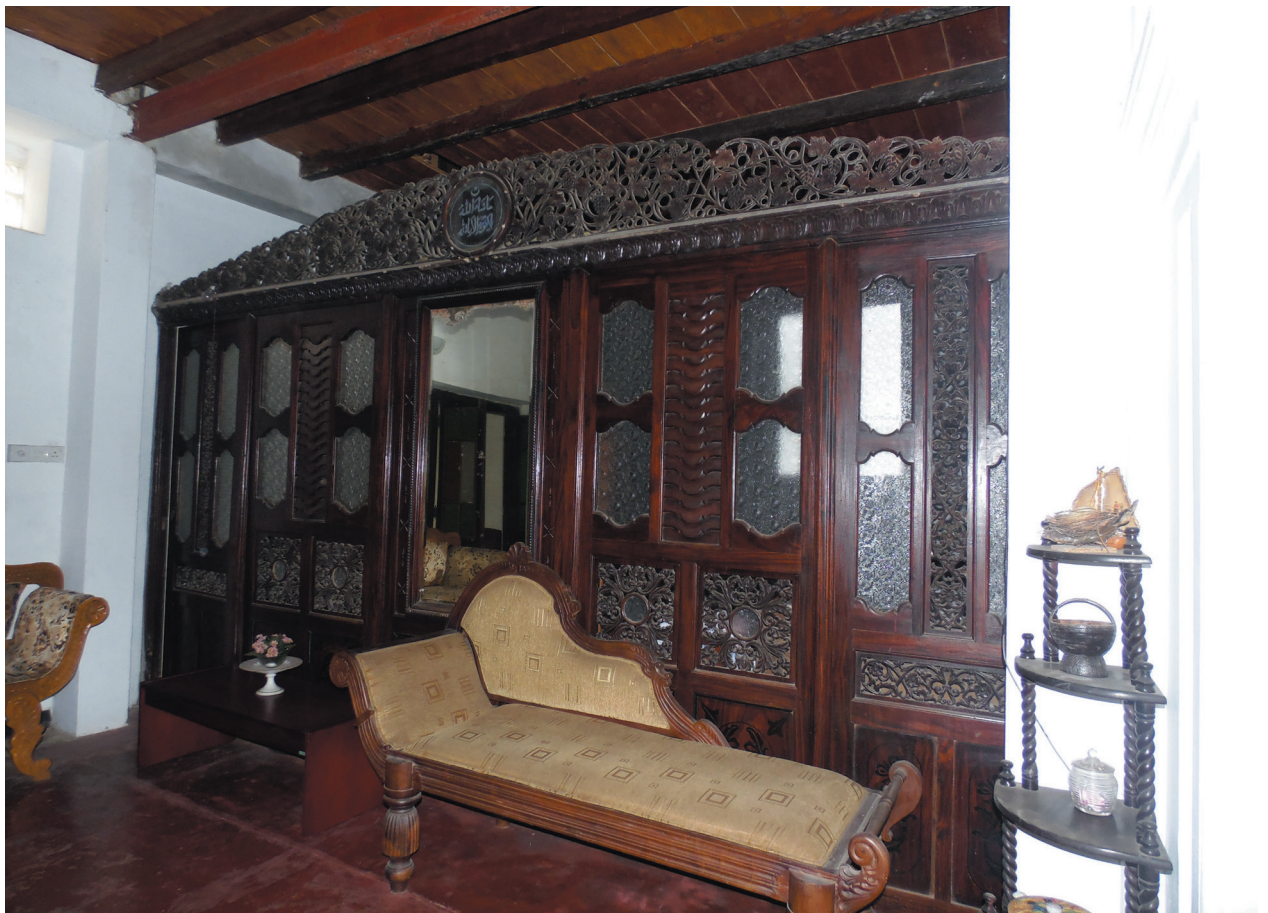
**Fig. 204** Intricately carved wooden separator (of rooms) in a house.
