Changes in the cultural landscape and their impacts on heritage management: a study of Dutch Fort at Galle, Sri Lanka Jinadasa, U.N.

### 5. Changes to the Physical Urban Landscape

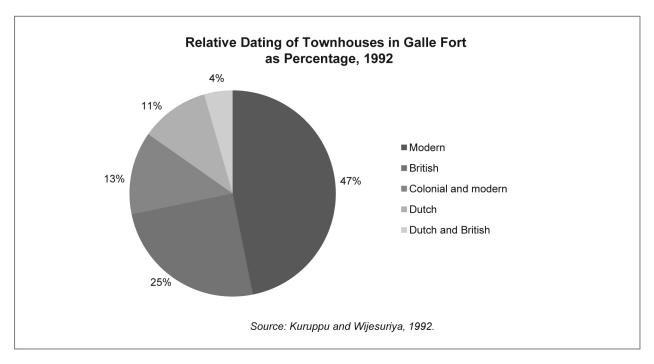
Fig. 42 Relative dating of the townhouses of Galle Fort (as percentage), 1992.

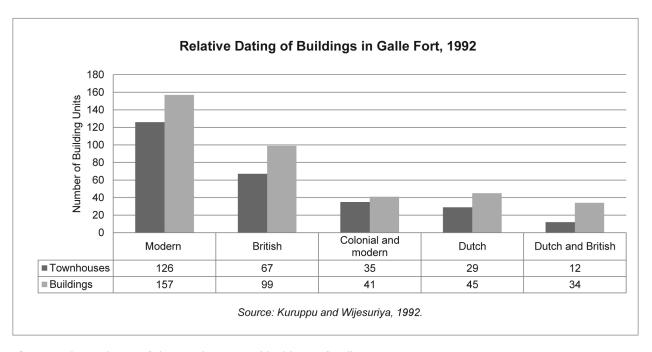
Fig. 43 Relative dating of the townhouses and buildings of Galle Fort, 1992.

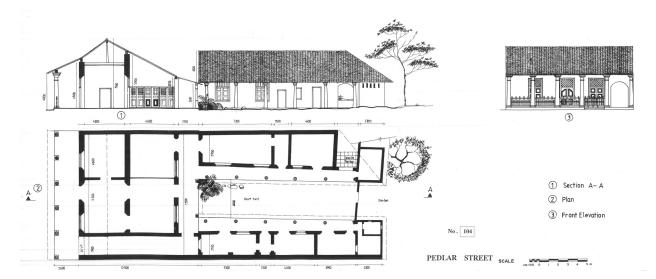
**Fig. 50** Ground plan of no. 104, Pedlar Street (Kuruppu and Wijesuriya 1992, 335).

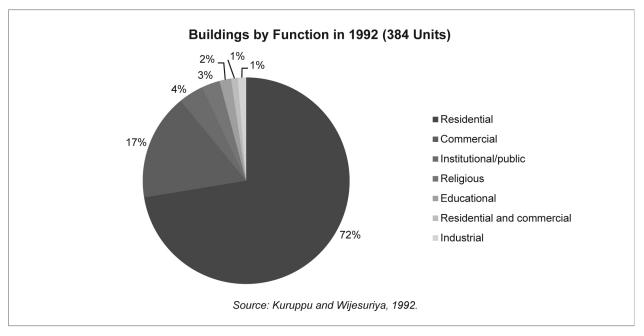
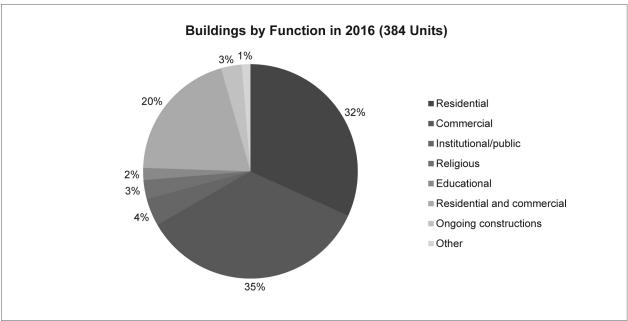
**Figs. 62–63** Functional changes in the same buildings from 1992 to 2016.

Nearly half (45%, 172) of the buildings recorded in 1992 had been subject to functional changes by 2016, and the most heavily affected category was residential buildings, which comprised the majority

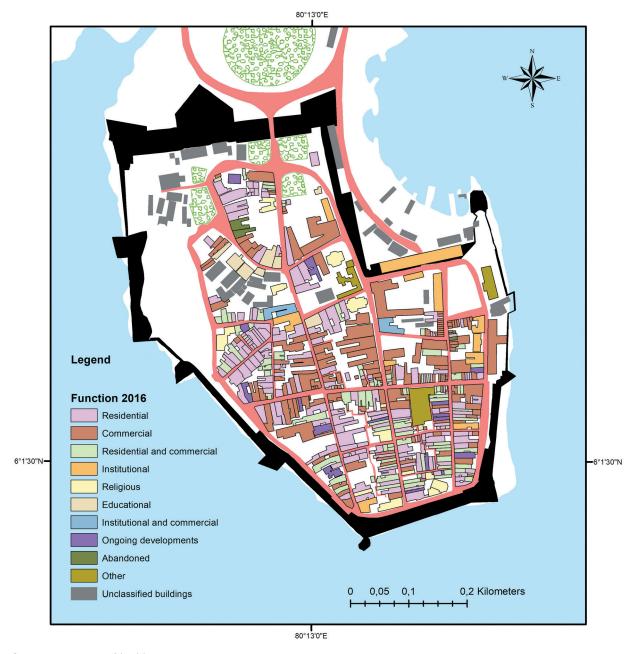
Fig. 65 Functions of buildings, 2016.

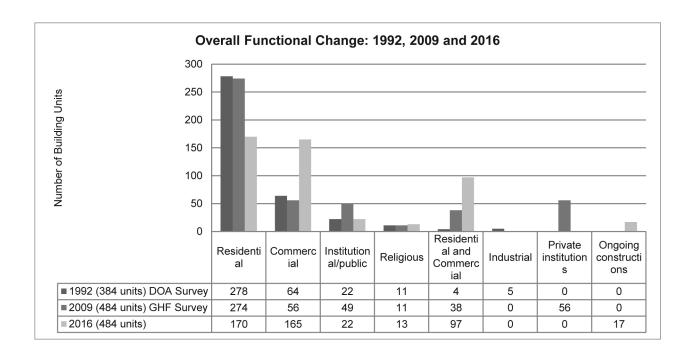
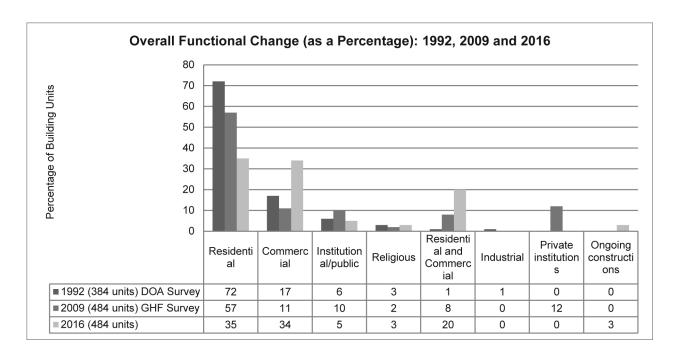
Figs. 66-67 Overall functional changes, 1992, 2009, 2016 (as a percentage and number of buildings).

mixed-purpose residential-commercial buildings can be identified (Figs. 66–67). By 2016, residential and commercial buildings were almost equal in number, at 35% (170) and 34% (165), respectively. Thus, the current situation might pose a threat to the provisions of the Special Regulations, 2009, which require maintaining at least 35% of the total building area for residential purposes (Article 70.10).

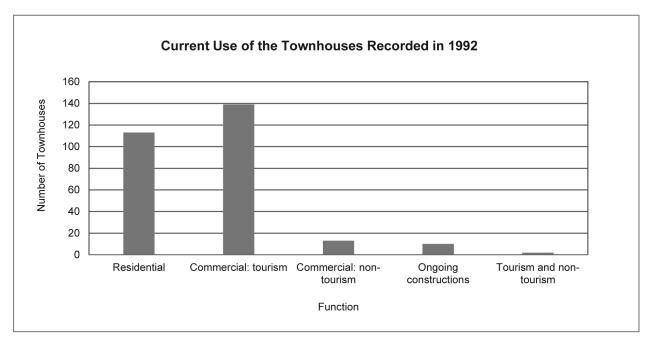
Fig. 68 Current use of the townhouses recorded in 1992.

It can be observed that this drastic functional change in the buildings, including townhouses, is a result of the flourishing tourism industry (Fig. 68), as more than half of the total buildings surveyed in 1992 are currently associated with tourism-related businesses. This includes half of the townhouses recorded in 1992. While 76 households became fully commercial establishments, 64 are associated with home-based businesses, such as bed and breakfast providers (hereafter also referred to as "B&Bs"), gem and jewellery shops, souvenir shops, etc., with the properties either owned or rented (leasing space is currently equally profitable, as discussed in sub-chapter 6.3.3). Thus, shophouses have become a significant category today, indicating the community's interest in obtaining economic benefits from tourism.

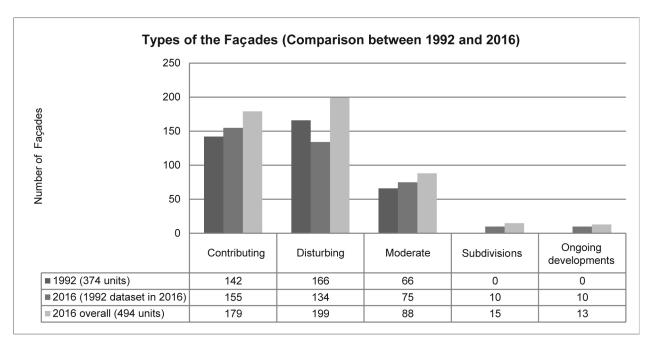
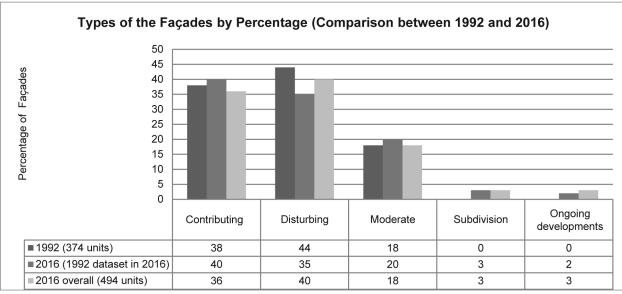
Figs. 84–85 Changes in building façades between 1992 and 2016.

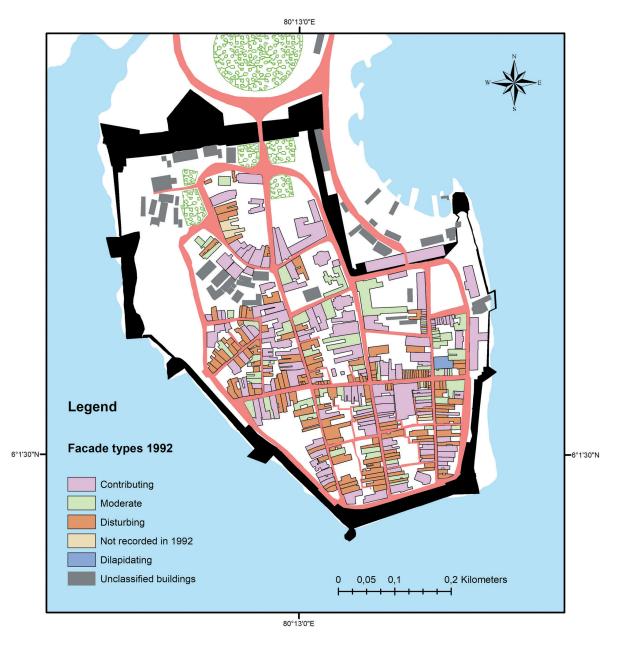
Fig. 86 Façade types, 1992 (source: Kuruppu and Wijesuriya, 2016).

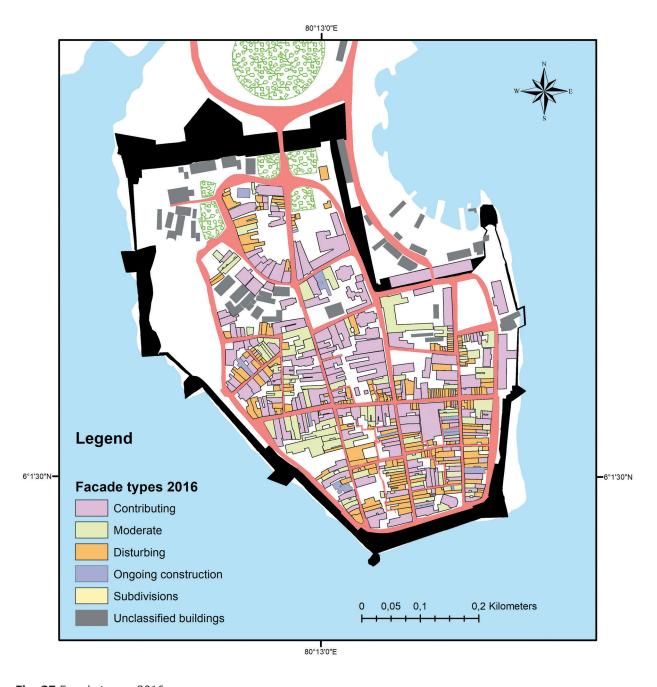
Fig. 87 Façade types, 2016.

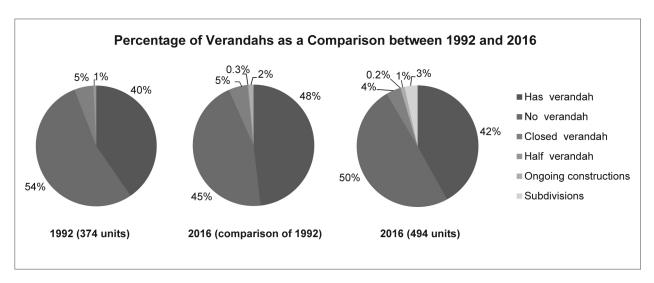
Fig. 102 Percentage of verandahs as a comparison between 1992-2016.

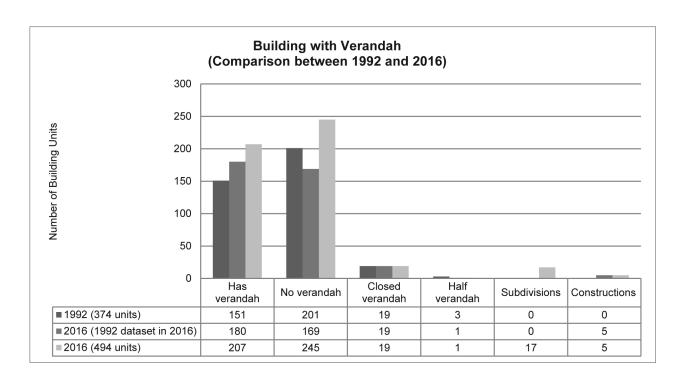
Fig. 103 Buildings with verandahs as a comparison between 1992 and 2016.

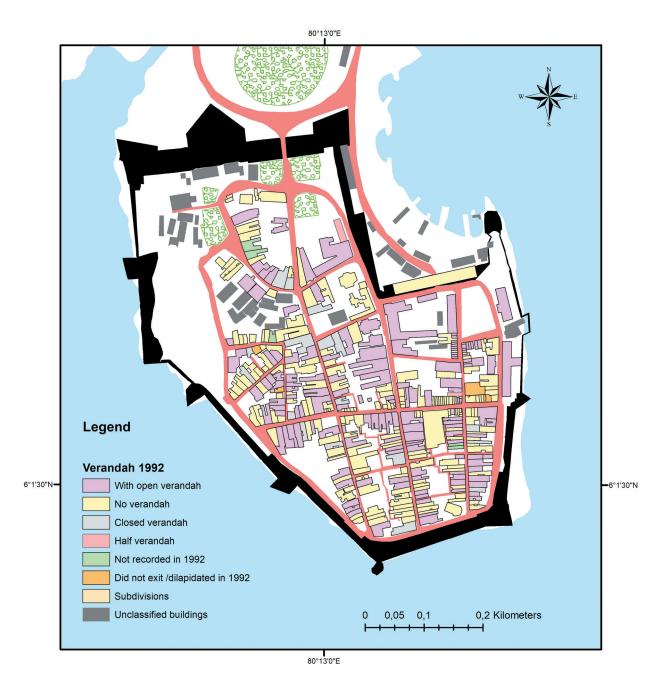
Fig. 104 Buildings with verandah, 1992 (source: Kuruppu and Wijesuriya, 1992).

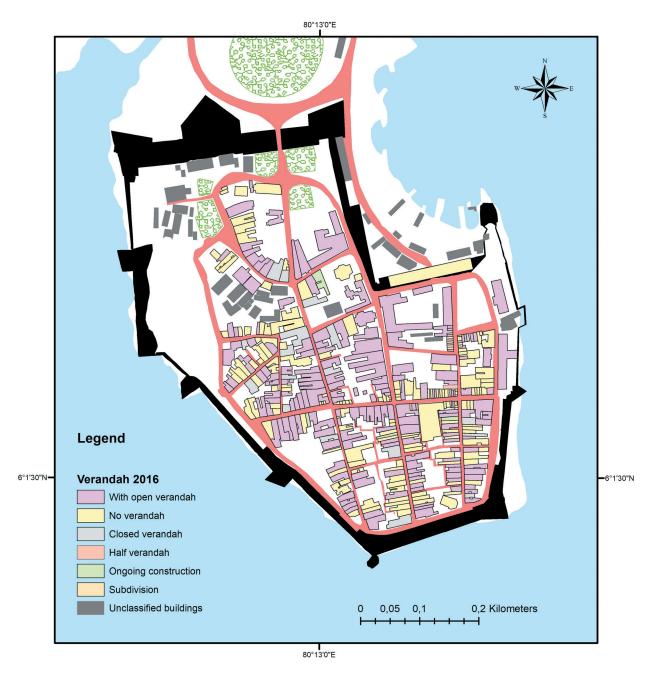
Fig. 105 Buildings with verandah, the same buildings in 2016.

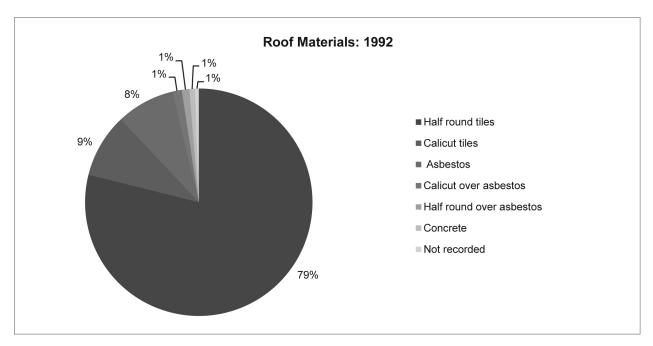
Fig. 129 Roof materials in 1992 (as a percentage).

material in the fort during the British colonial period, and even at the inception of the World Heritage project. The material, which was mostly limited to old buildings, was impractical due to frequent leakage, and was thus replaced by Calicut tiles and asbestos. Thus, the Planning Sub-Committee promoted half-round tiles over asbestos, primarily to prevent leaking while also maintaining the typical Lankan-colonial appearance.

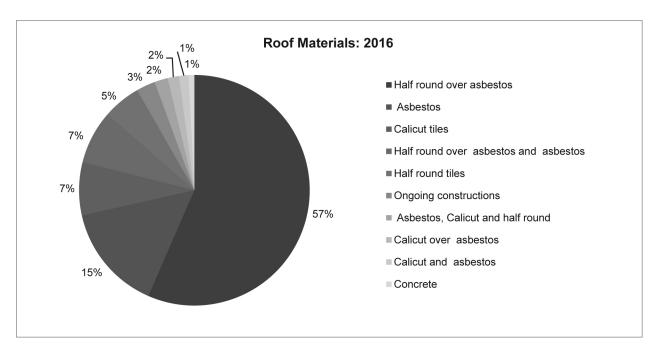
Fig. 130 Roof materials in 2016 (as a percentage).

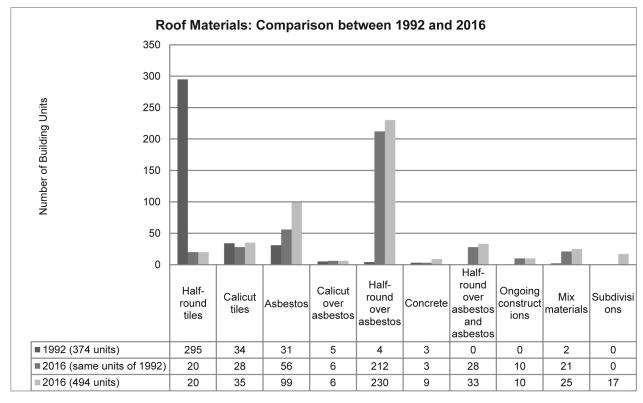
**Fig. 131** Comparison of roof materials between 1992 and 2016.

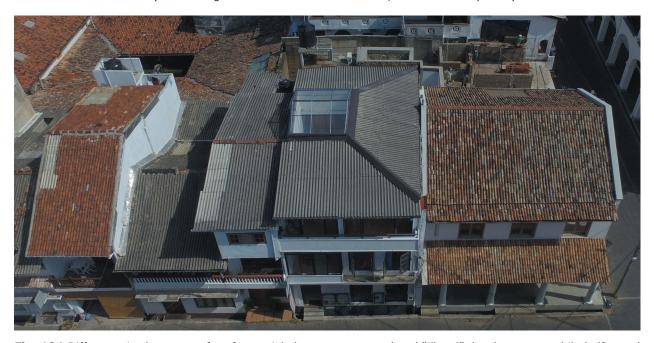
**Fig. 134** Difference in the usage of roof materials between approved and "illegal" developments: while half-round tiles over asbestos are used in approved developments (extreme left and right), the rest, in the middle, are covered with the prohibited asbestos.

It was observed by drone images that a number of buildings have half-round tiles only on the visible areas of the roof, while the rest is covered with asbestos. In addition, nearly 10% of the buildings have solar panels, a positive trend of using clean energy, especially popular with providers of tourist accommodation, both local and foreign.

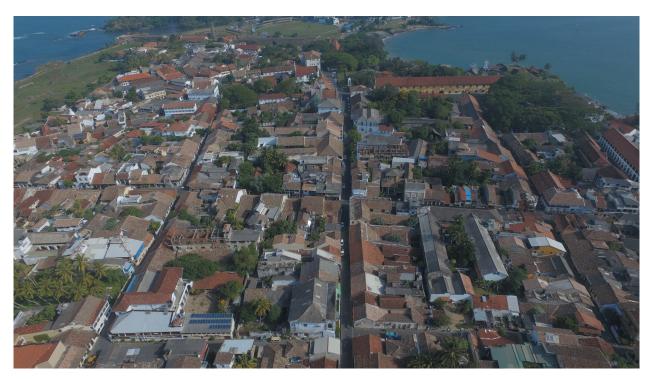
**Fig. 135** The roofscapes in 2016, showing more tiled roofs and a substantial amount of prohibited asbestos.

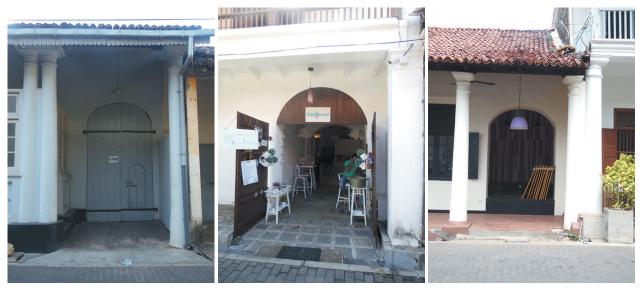
**Figs. 136–138** Three stables in different conditions: unchanged (the first one, on Church Cross Street); renovated with positive changes (the second, on Parawa Street); and an ongoing "unpermitted" change, in December 2017 (the third, on Pedlar Street).

Colonial stables can be identified as a disappearing element due to their increasing commercial value as shop spaces. Nine out of 12 stables/old garages are used for commercial tourism purposes, which coincides with mostly discarding their colonial characteristics. While one stable on Parawa Street has been positively converted without much architectural change, alterations in another on Pedlar Street have destroyed the authentic stable, according to the Project Planning Officer of Galle Heritage Foundation (Figs. 136–138).<sup>383</sup>

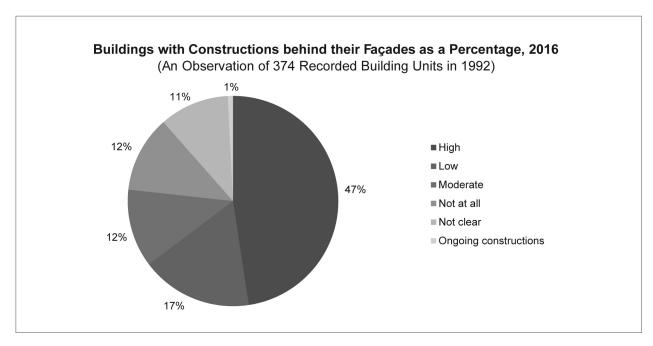
**Fig. 139** Buildings with constructions behind their façades in 2016 as a percentage (among the buildings recorded in 1992).

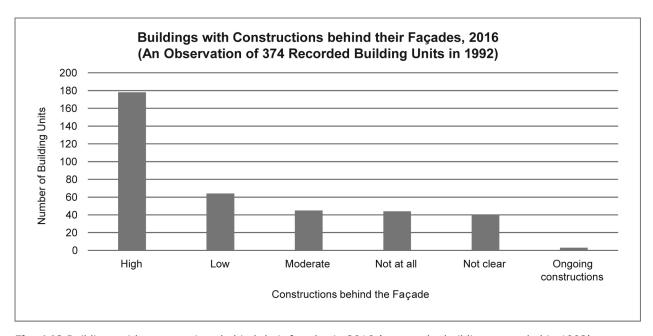
Fig. 140 Buildings with constructions behind their façades in 2016 (among the buildings recorded in 1992).

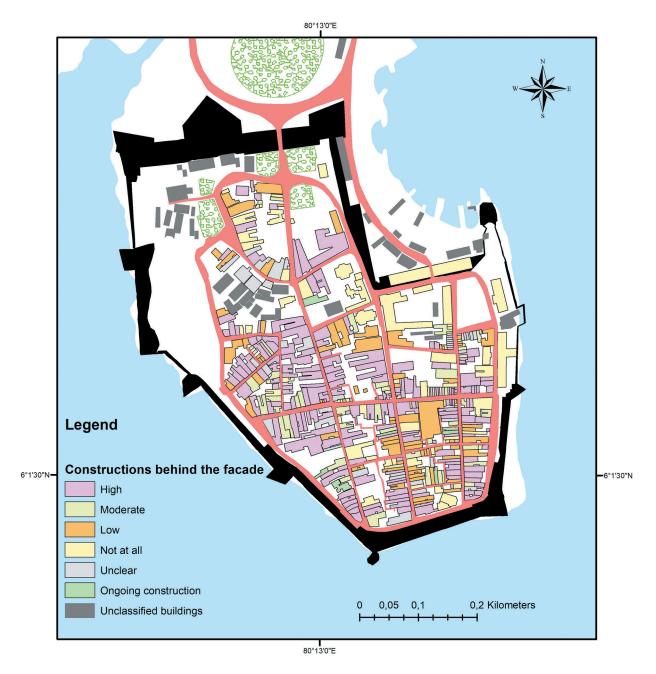
Fig. 141 Buildings with constructions behind their façades, 2016.

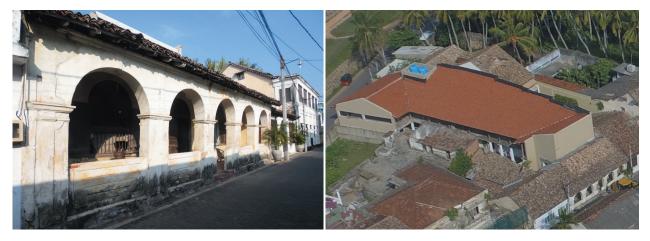
**Figs. 143–144** The British façade kept as it is (left) and the aerial view of the development of the same building behind the façade (right), an ongoing approved development of a boutique hotel (2016).

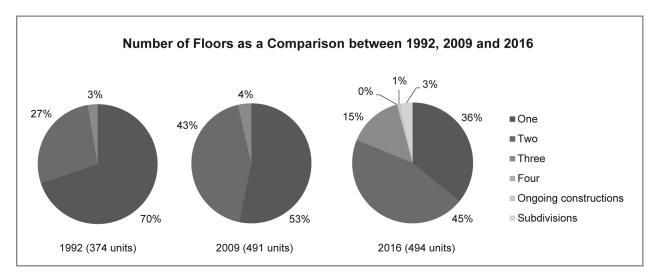
**Fig. 145** Number of floors as a comparison between 1992, 2009 (GHF Survey)<sup>385</sup> and 2016.

150). The same building stock changed drastically by 2016, with a sharp drop in single-storeyed buildings to almost half of the percentage of 1992 (36%), and the rise of two-storeyed buildings as the largest category (45%). In addition, there is a significant increase in buildings with three floors, totalling 15% (72), which are mostly "illegal."

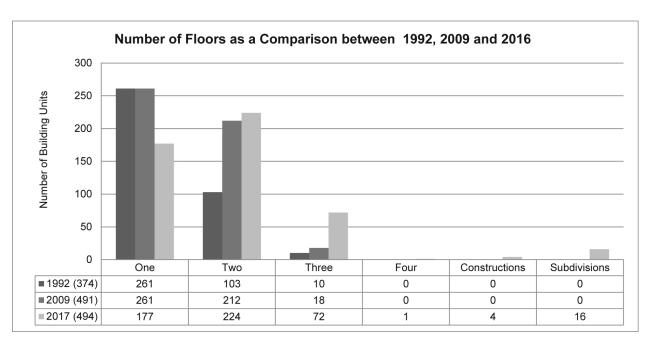
**Fig. 146** Number of floors as a comparison between 1992, 2009 (GHF Survey)<sup>386</sup> and 2016.

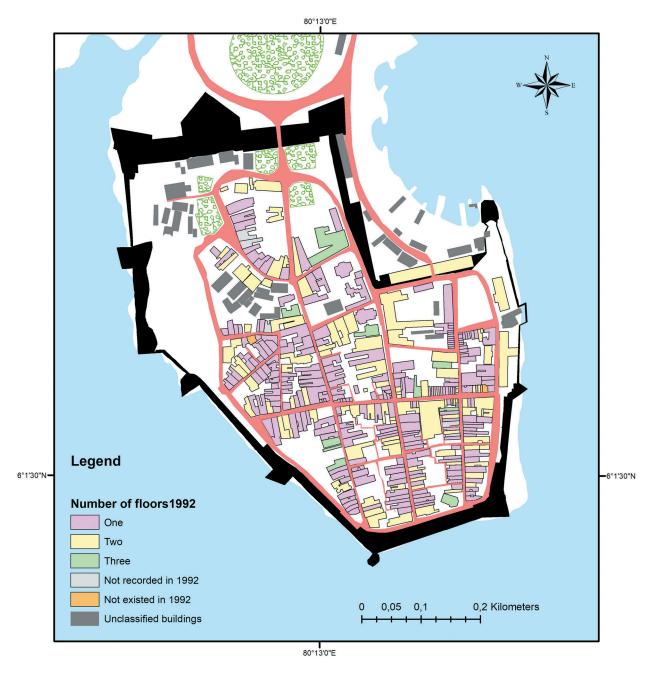
**Fig. 147** Number of floors, 1992.

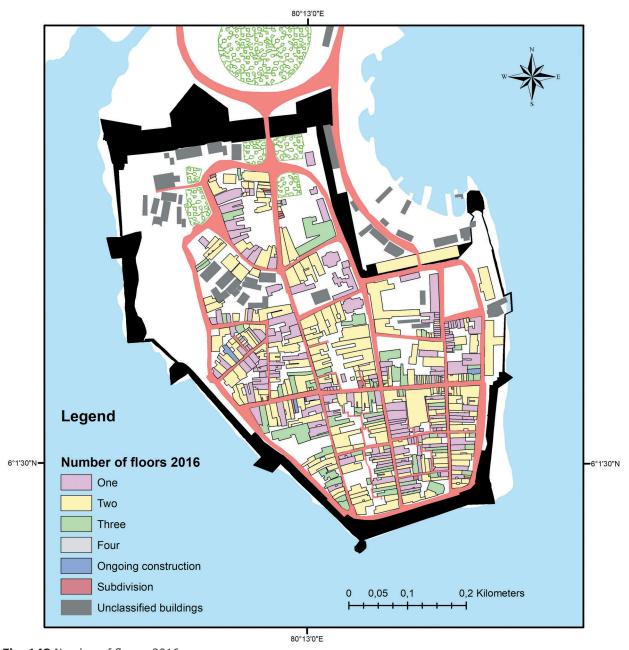
Fig. 148 Number of floors, 2016.

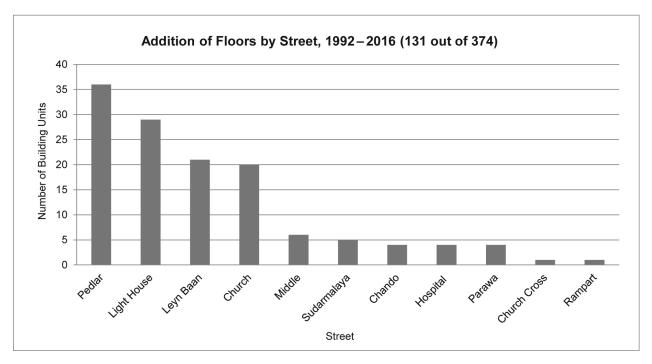
Fig. 152 Addition of floors between 1992 and 2016, by street.

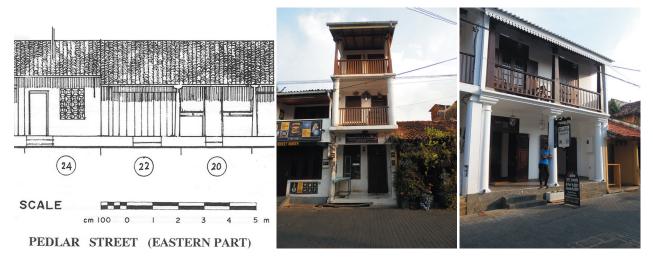
**Figs. 163–165** No. 22 (first image), a small boutique in 1992 (Kuruppu and Wijesuriya 1992, 141); the same building in 2016 with an "illegal" third floor (middle), and in 2018 (right), after its approved development (which also amalgamated the adjacent property).

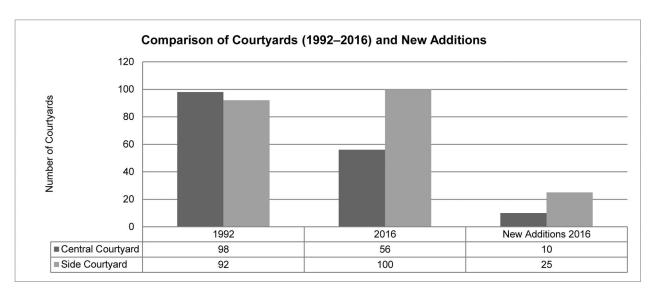
Fig. 170 Number of courtyards as a comparison between 1992 and 2016.

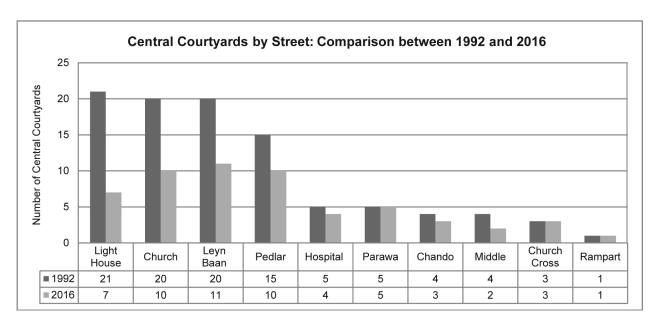
Fig. 171 Central courtyards by street as a comparison between 1992 and 2016.

had the highest numbers of courtyards at the inception of World Heritage project (Fig. 171). Light House Street is the most significant among them, as it has the highest number of central courtyards in 1992, but currently has the highest number of boutique villas. Interestingly, the number of side courtyards increased by 2% from 1992 to 2016 [24% (93) to 26% (100)]. This could be identified as the outcome of turning the central courtyard into a side courtyard as a result of new developments associated with tourism (Figs. 174-175). According to the observations of drone images, developments have also changed the placement and size of the original side courtyards. In contrast, the addition of central courtyards was not as common as the addition of verandahs, a compulsory element for new developments. On the other hand, central courtyards require more space, which is a financial loss in development due to the high land value. By 2016, only nine central courtyards and 25 side courtyards had been newly added to the units surveyed in 1992. Most of these new central courtyards were comparatively smaller in size and

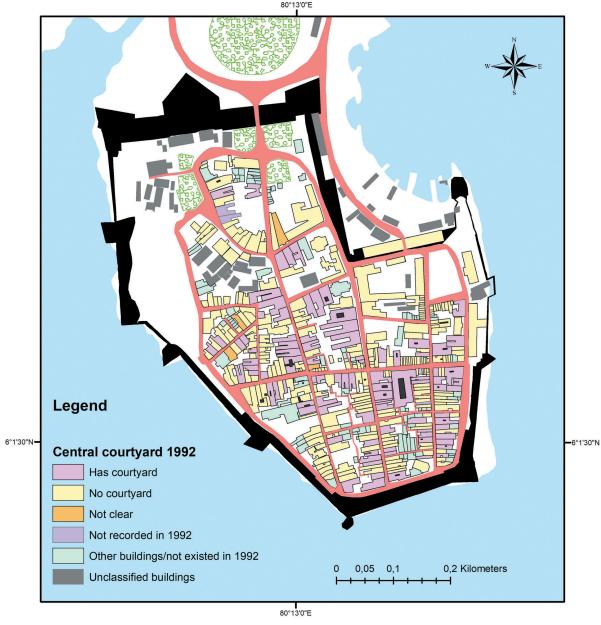
Fig. 172 Building with central courtyard, 1992 (source: Kuruppu and Wijesuriya, 1992).

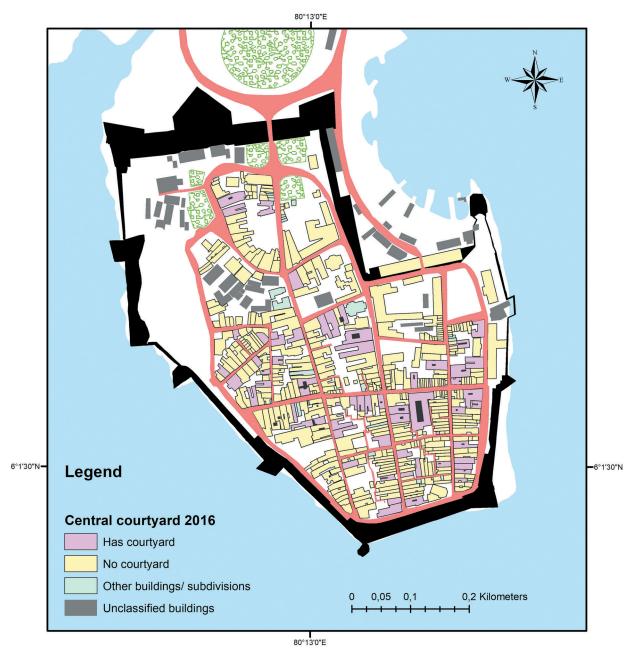
**Fig. 173** Building with central courtyard, 2016 (some of the buildings categorized as "no courtyard" in the map show courtyards. In fact, some of these are now converted into swimming pools).

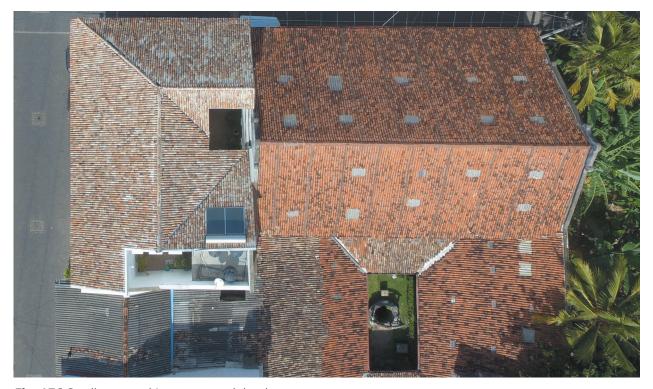
**Fig. 176** Small courtyard in an approved development at left vs. a (renovated) colonial central courtyard with a well at right, showing the change in the utilitarian function of courtyards.<sup>391</sup>
