Building Assyrian society: the case of the Tell Sabi Abyad Dunnu

Building Assyrian Society:

The Case of the Tell Sabi Abyad *Dunnu*

Proefschrift

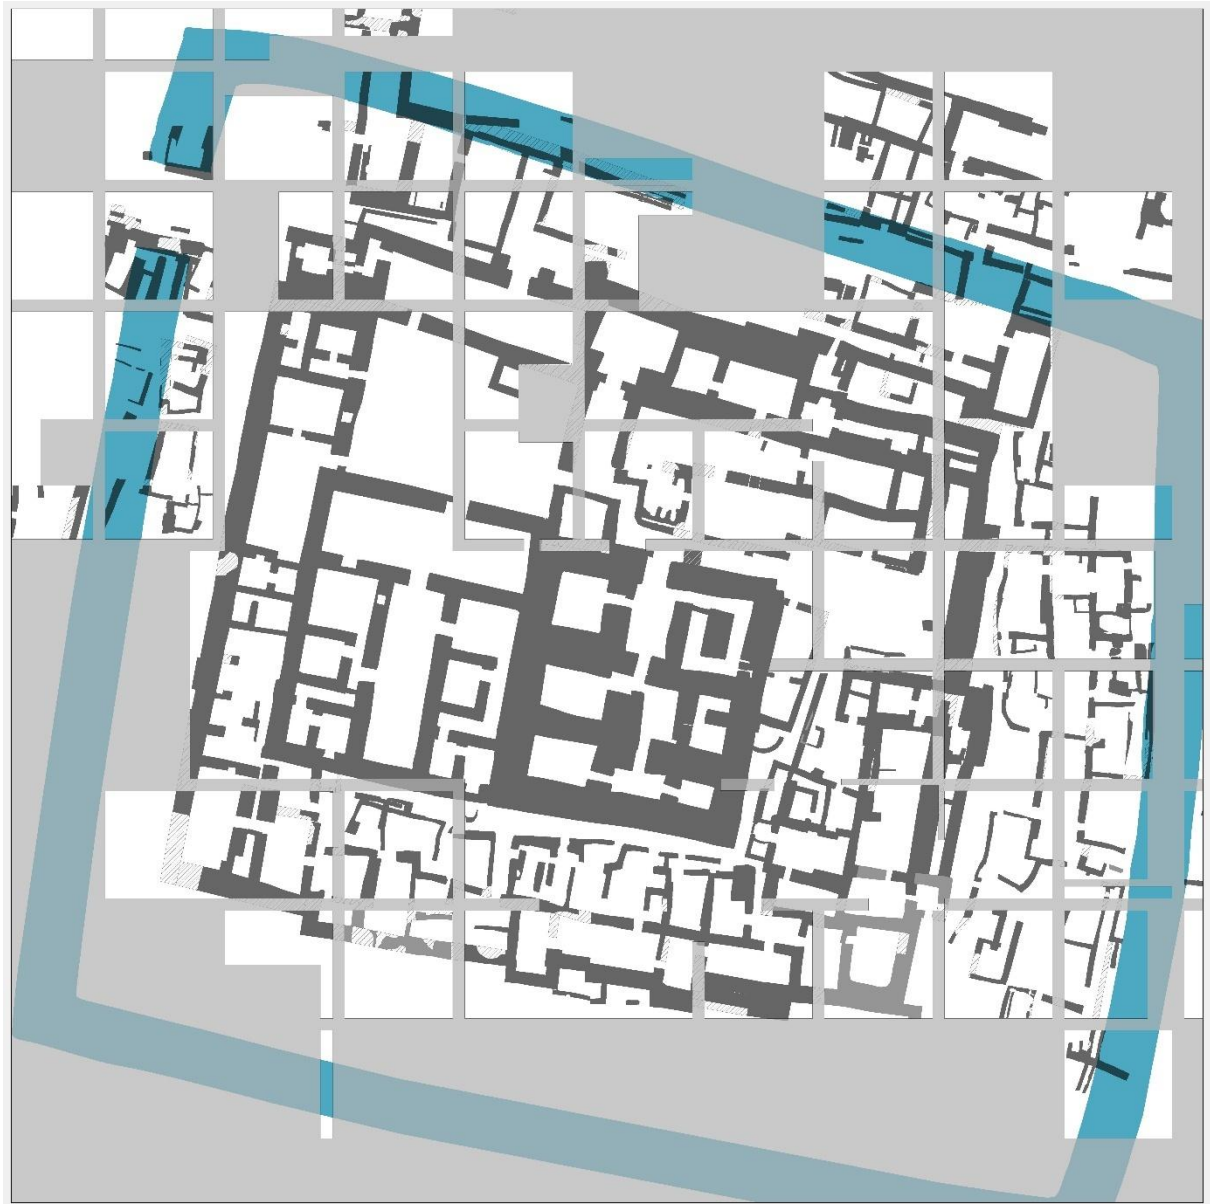
Figure 2. Plan of the Dunnu including all excavated architecture, all phases combined. In blue a fosse surrounding the settlement. Grid blocks are 10x10 meters.

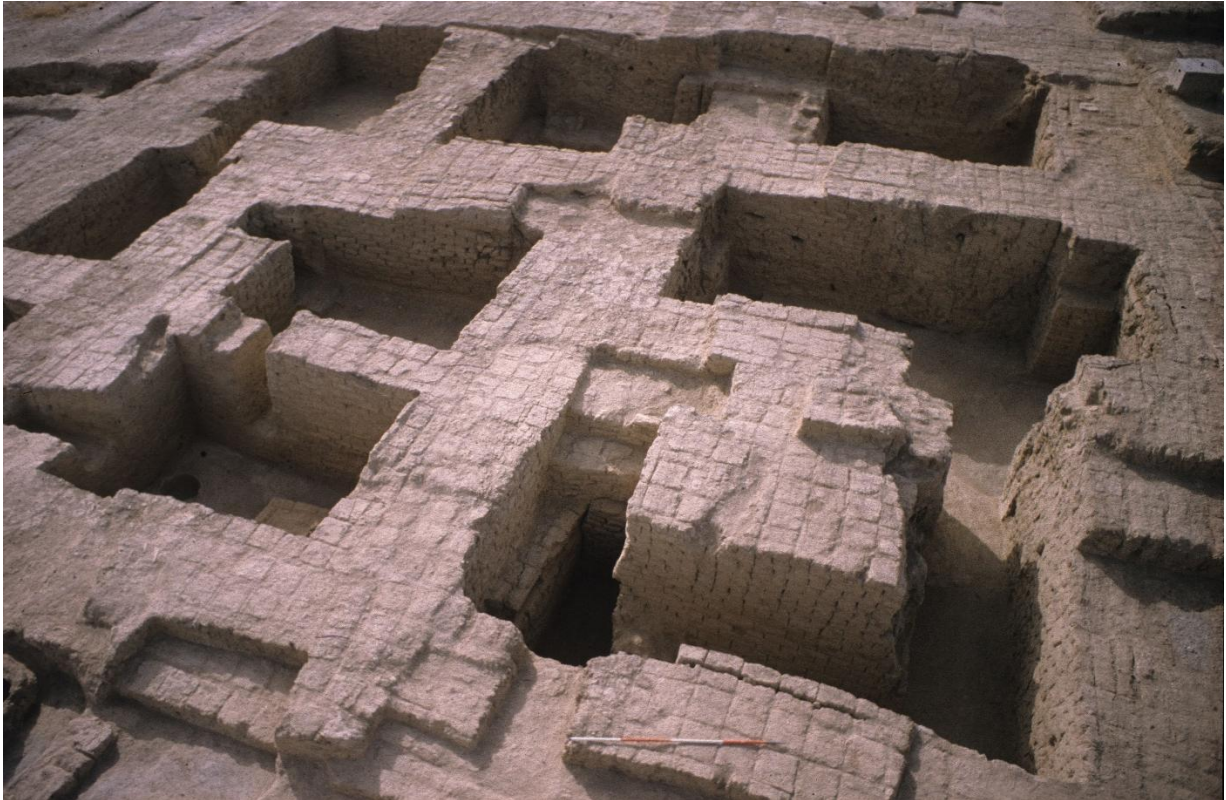
Figure 3. The excavated heavy walls of one of the Dunnu's most prominent buildings: "the tower". In the area in front, the remains of a large staircase (photo by P.M.M.G. Akkermans).

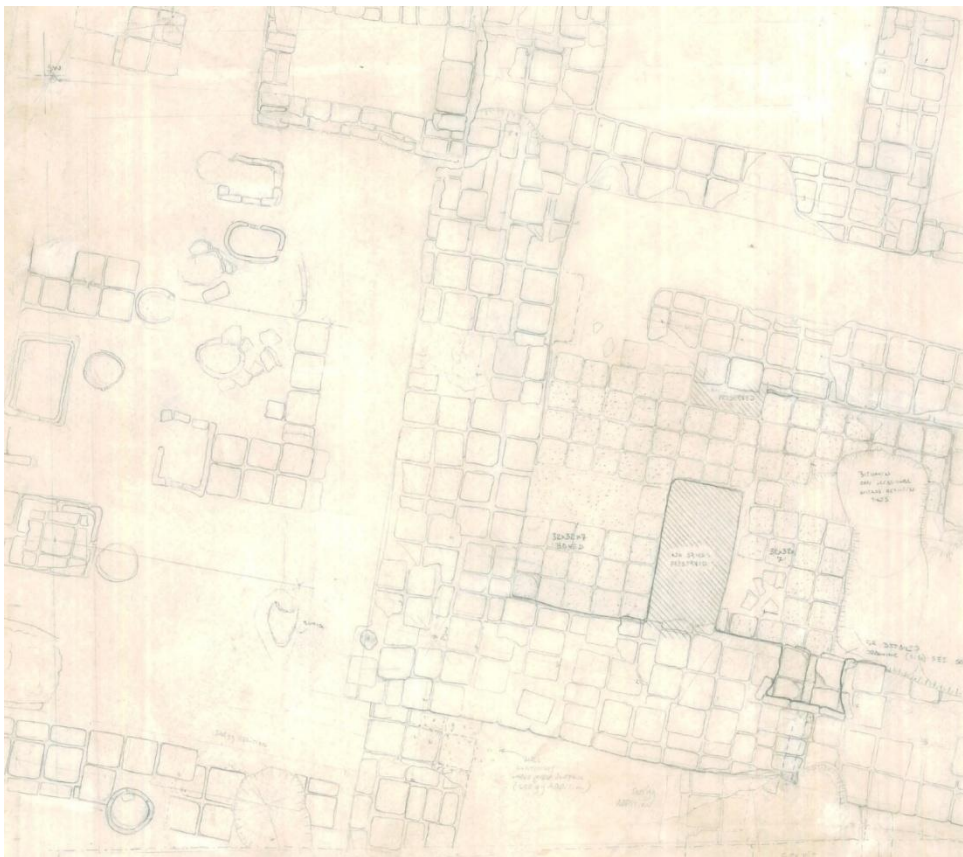
Figure 5. Example of a final square drawing, square H11.

Plan drawings of the architecture and other features were made on a daily basis in the field by trench supervisors. Final plan drawings, focussing on the architecture were hand drawn by a professional draughtsperson. The field sketches are often less accurate, but more complete. They include many features that did not end up on the final drawings. The final drawings are more accurate, and contain a lot of useful information about the brickwork and condition of the walls. They often include small elevation drawings next to the plans, which elucidate archaeological contexts that were not (accurately) described in the day reports. In addition, in post-excavation work, stratum drawings were made to accompany the stratum reports (discussed below). These are essentially phase plans for each individual square, and include all features found in excavation.

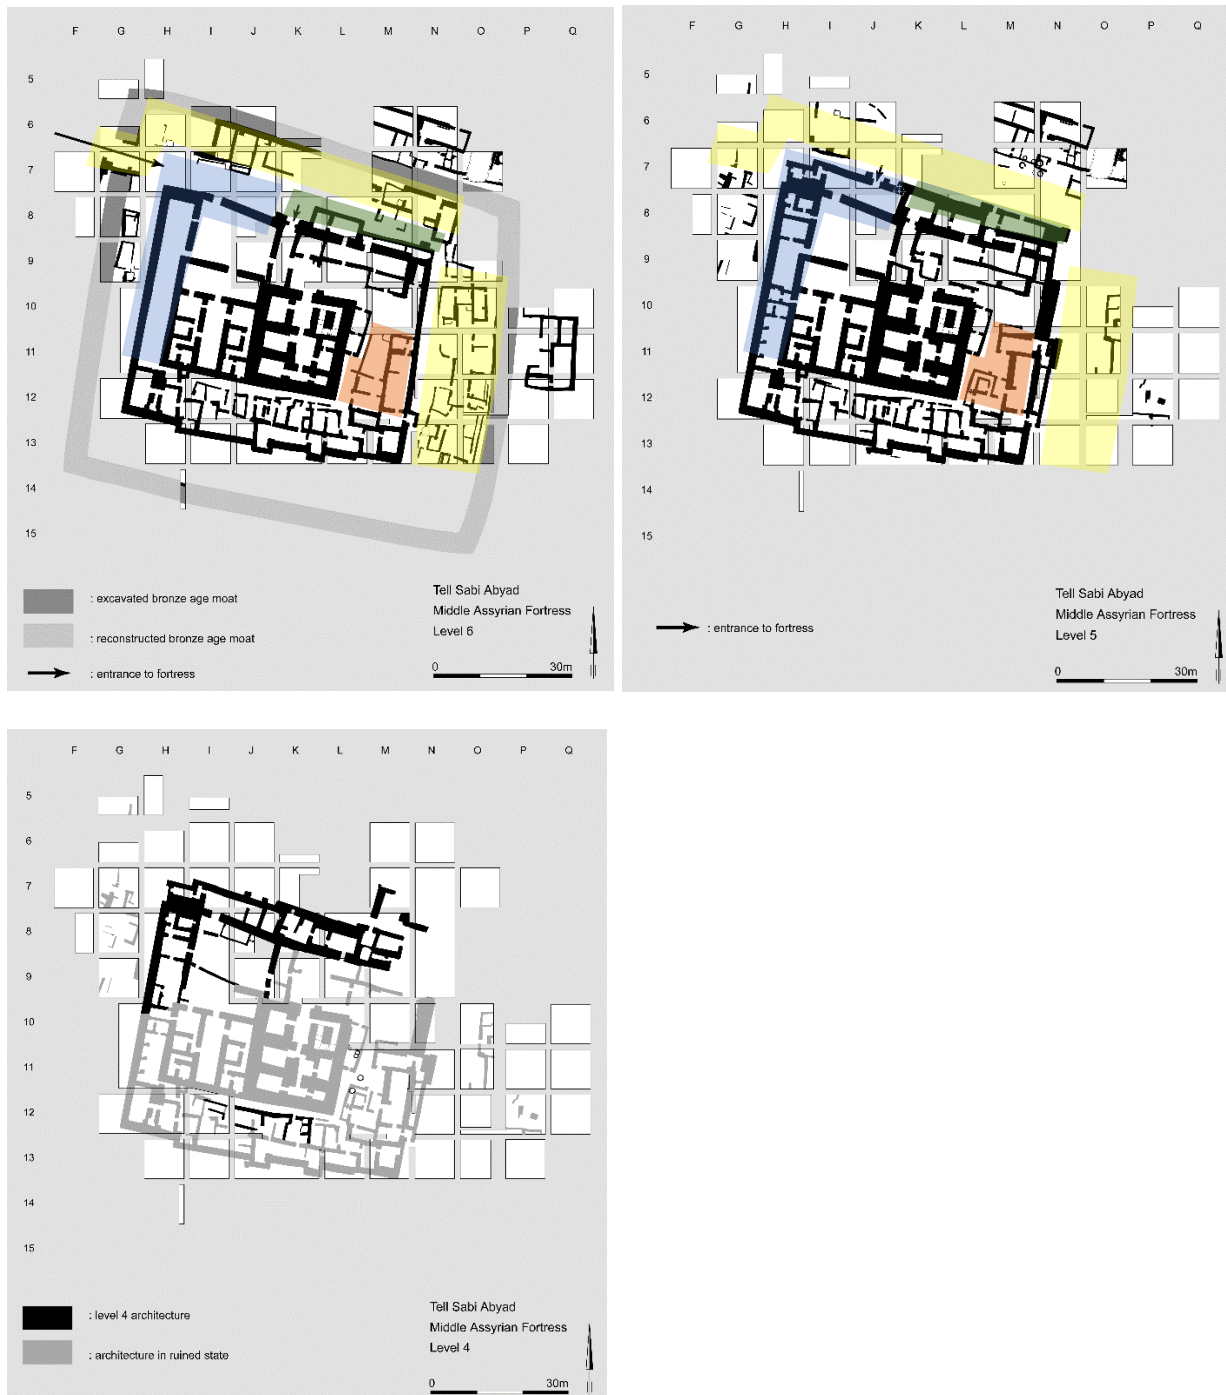
Figure 10. Plans made for levels 6, 5 and 4, colours indicating important zones of modification from level 6 to 5. Colours by author (after Akkermans and Wiggermann, 2015).

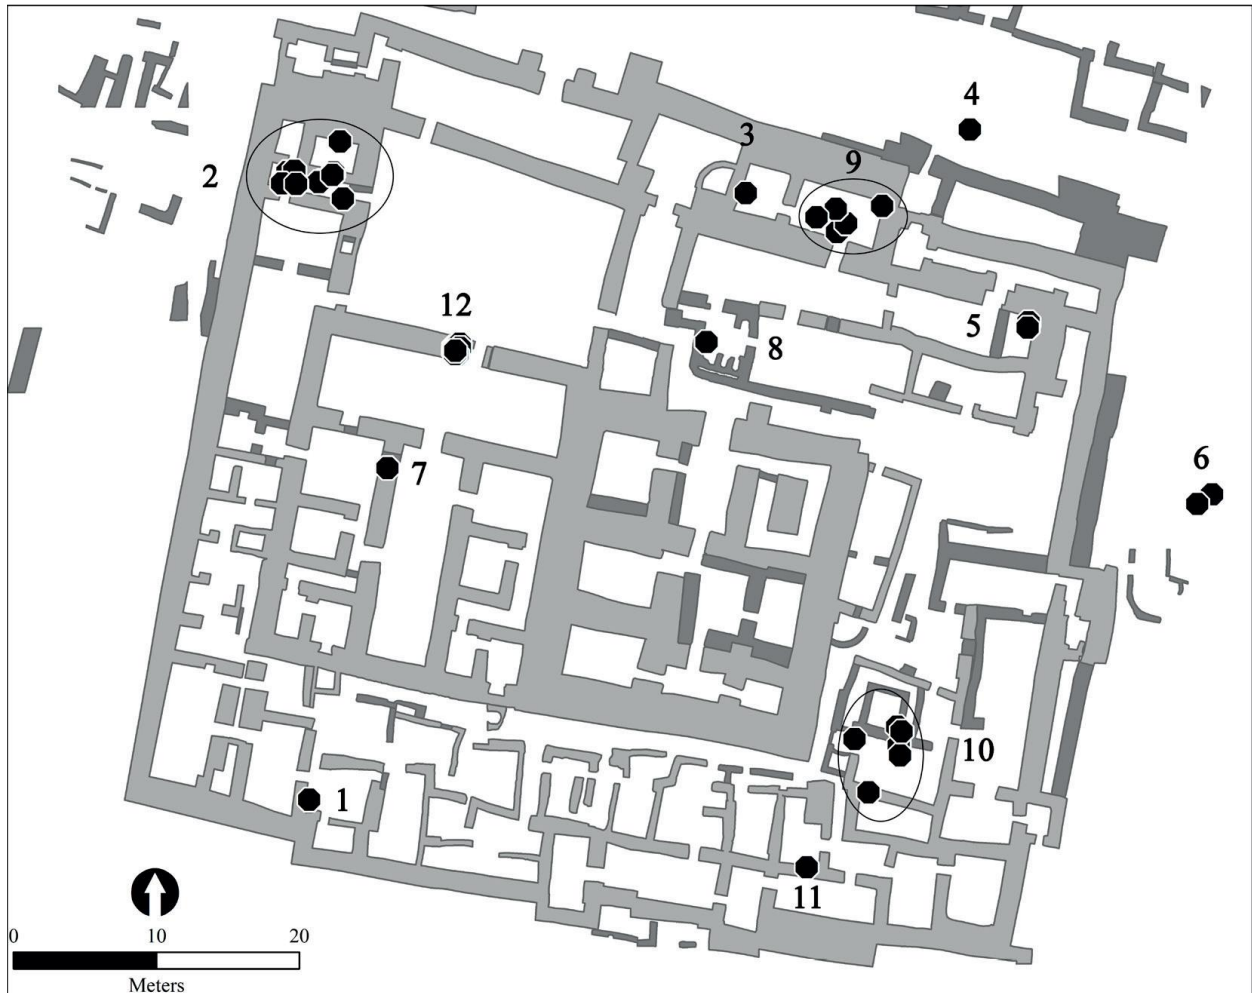
Figure 11. Location of tablets with *limu* dates (after Klinkenberg, 2016, fig. 4.31).

Accurate dating is possible both through dates mentioned on the cuneiform tablets, and C14 dating. A few tablets contain Assyrian *limus*, or year-names (Figure 11), which allows us to date administrative activity on the *Dunnu* from 1229 to 1184¹⁵ ¹⁶. However, by far the largest number of dated tablets are found in the range of the years 1197 to 1184, peaking in 1188-1187 (Figure 12). Moreover, only 3 of the 12 datable tablet collections contain tablets that belong to the period before 1197 (Figure 13). It is important to emphasize that this uneven temporal distribution of dates is not reflective of the intensity of administrative activity in certain periods, but a result of the habit of recycling clay tablets after their use has expired. Only some tablets are preserved, for instance if they contain information that must be preserved or more accidentally as part of random discards that were not recycled (Klinkenberg and Düring, 2023). As regards to the latest dated sources, a few tablets referring to a certain ‘lord’ Kidin-Sîn seem to post-date the primary use-phase. Nonetheless, the main administration of the Assyrian *dunnu* stopped in or just after 1184.

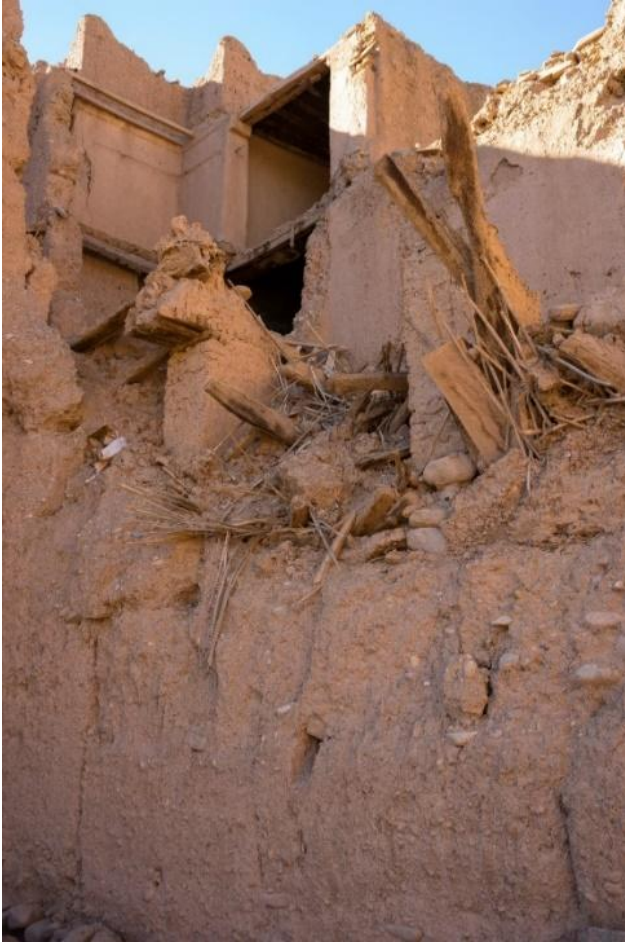
Figure 14 (previous page). Different types of mud brick site formation processes.

Left: Collapse, fortified town near Agdz, SE Morocco. Note that nearly all debris falls inside the building in this case, causing a stark difference in stratigraphy outside and inside.

A large part of our understanding of these archaeological sites comes from documenting and analysing the sequence and relative amounts in which these elements occur in the stratigraphy of a site, building or enclosed space. For instance, layers of eolian sediments interspersed with mud brick erosion deposits reveal a building that is open, and gradually decaying for an extended period of time.²⁴ Large amounts of unstratified mud brick rubble indicates sudden and fast collapse, while multiple distinguishable layers of mud brick rubble indicate multiple collapse events. Besides these obvious signs of decay following abandonment, a mud brick settlement is continuously in a state of decay. The rain, sun, and wind cause erosion and chemical weathering, resulting in a continuous formation process characterised by addition and removal of sediment (Torraca, Chiari and Gullini, 1972; McIntosh, 1974; Friesem, Karkanas, *et al.*, 2014). To this are added the cultural factors resulting from human activities of construction, levelling, digging, backfilling and demolition, and all economic and domestic activities that cause and move waste (Schiffer, 1983; Stein, 1987; Schiffer, 1996). Together, these result in the complex archaeological phenomenon that we call a ‘tell’ or settlement mound (Figure 14, Figure 15).

debris to end up on the outside of buildings, the tendency is that it falls to the inside as result of the instability create by the roof collapse (Figure 14, top left). Also, when people demolish a building on purpose, it is most practical to have the debris fall on the location of the building.

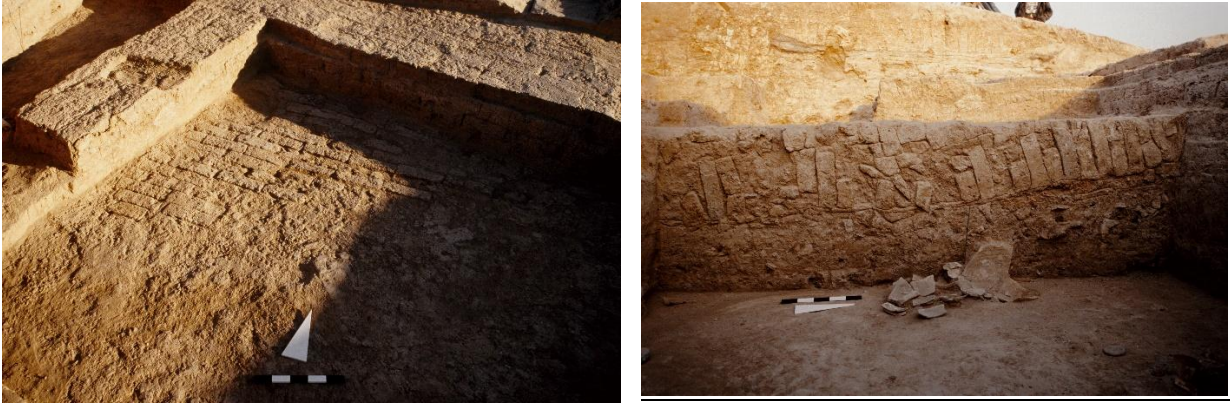
Figure 22. Wall segment found high up in the fill of a room in square L08 (photo: Tell Sabi Abyad project/Peter Akkermans).

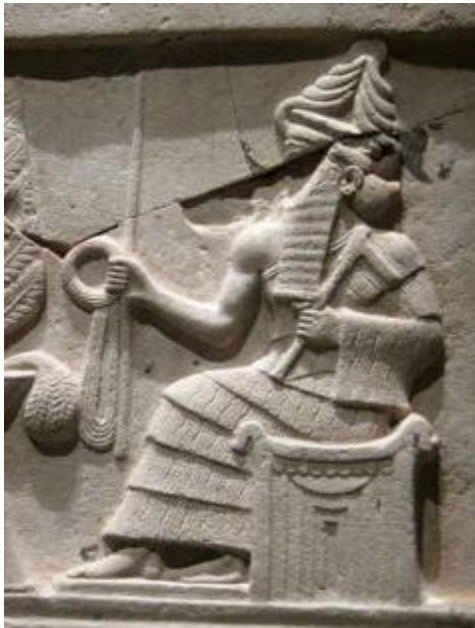
Figure 44. Nanna handing a measuring rod and a line partly on a coil to king Ur-Nammu on the Ur-Nammu stela. These were the basic instruments to mark the outline of a building.

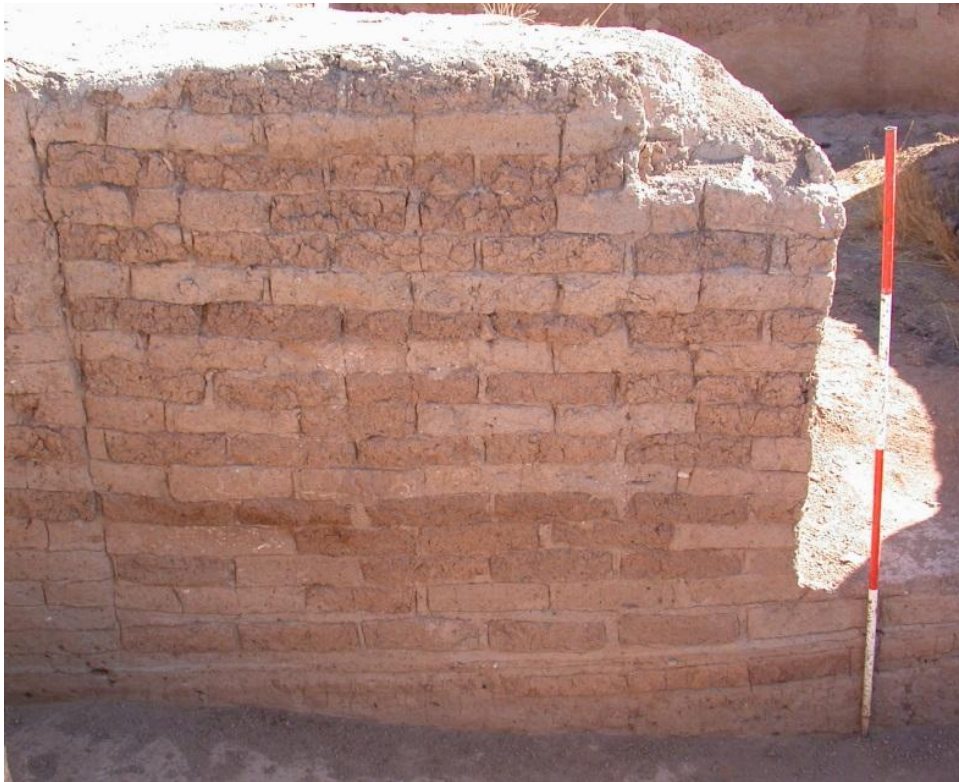
Figure 59. The use of interchanging courses of crumbly reddish brown and denser brownish grey mud bricks in the residence. 'Interchanging courses' may be a slight exaggeration of reality. It was not applied this neatly in all walls of the residence, and even this photo of the 'best example' shows quite some randomization in the placement of mud bricks of different colours.

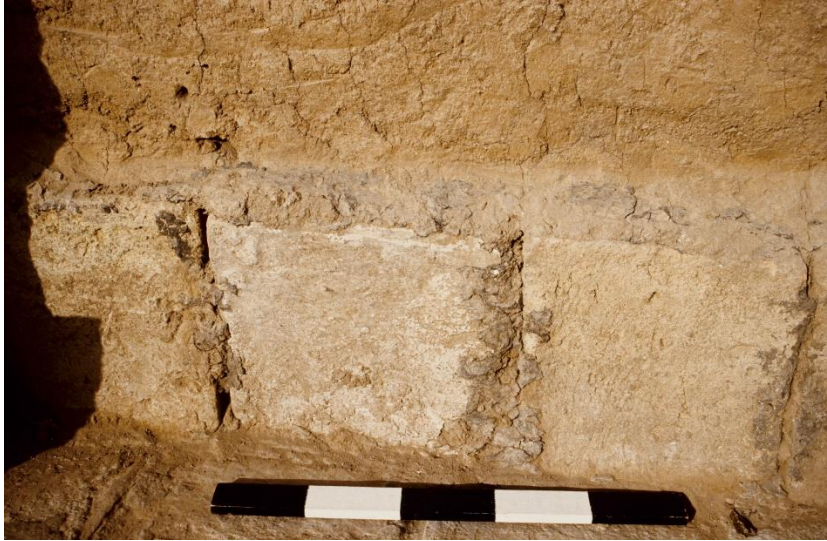
Figure 65. Example of the use of bitumen as mortar between the baked tiles of the bathroom in square M08.

In the *Dunnu* bitumen is primarily found in the bathrooms. These are areas of intensified water-contact and places where some degree of hygiene was required (Figure 64, Figure 65). It was used as mortar between the fired bricks of the floor and plinth, and as a coat of bitumen plaster to cover the entire surface. The

precise composition, e.g. additives such as sand or vegetal matter, is unknown. Interestingly, not in all bathrooms it was applied the same way. In the bathroom in M08 it was applied over a coat of gypsum/lime plaster. The bathrooms in the residence only use bitumen, and no white plaster is recorded. However, not *all* bathrooms were constructed using bitumen. For the bathroom in I07 only a very hard white (lime?) plaster was used. Why for some bathrooms bitumen was used while for others it was not, is unclear. It could have been a matter of availability, and/or related to the status of the people using the bathroom.

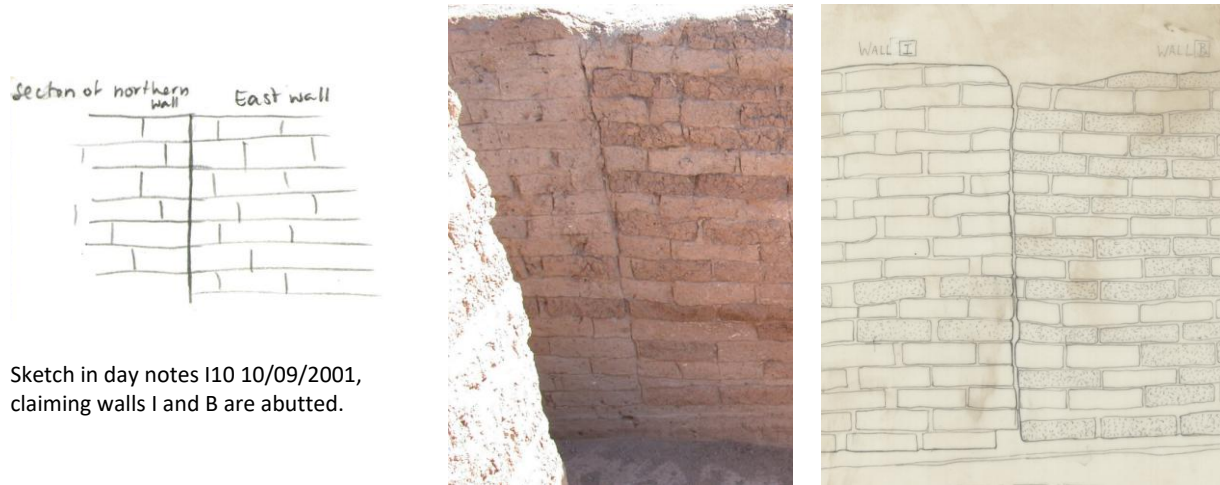
Figure 77. Wall relationships found in the Dunnu

At the meeting of two load bearing walls in a corner, a corner bond is needed. In a few cases with larger buildings, interior walls are also bonded to the exterior walls at T-junctions. Bonding at corners and T-junctions is often applied only every other brick layer. This makes using the plan drawings for establishing the presence of a bond unreliable, since generally only the visible course is documented. Although wall relationships are required to be filled in on the feature forms, this has not always been done. There are also possible cases where unique bonding patterns are overlooked by excavators unfamiliar with the potential variability of mud brick building techniques. An example is the way the long interior walls of the residence are bonded to the exterior walls (Figure 78, Figure 79). These are load bearing walls, and one would thus expect solid T-bonding with the northern and southern exterior walls. However, bonding is attained using

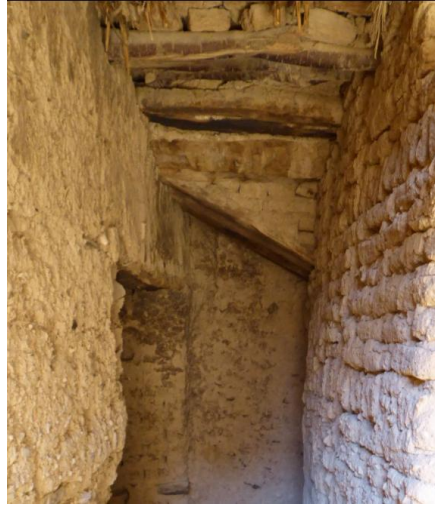
Figure 108. An example of a stair with mud brick spine wall in a ruinous house in Morocco. Like in Figure 49, the mud brick steps are put on a palm trunk base. The mud bricks have now degenerated to a precarious loam slide which the author climbed up to roof (photos by author).

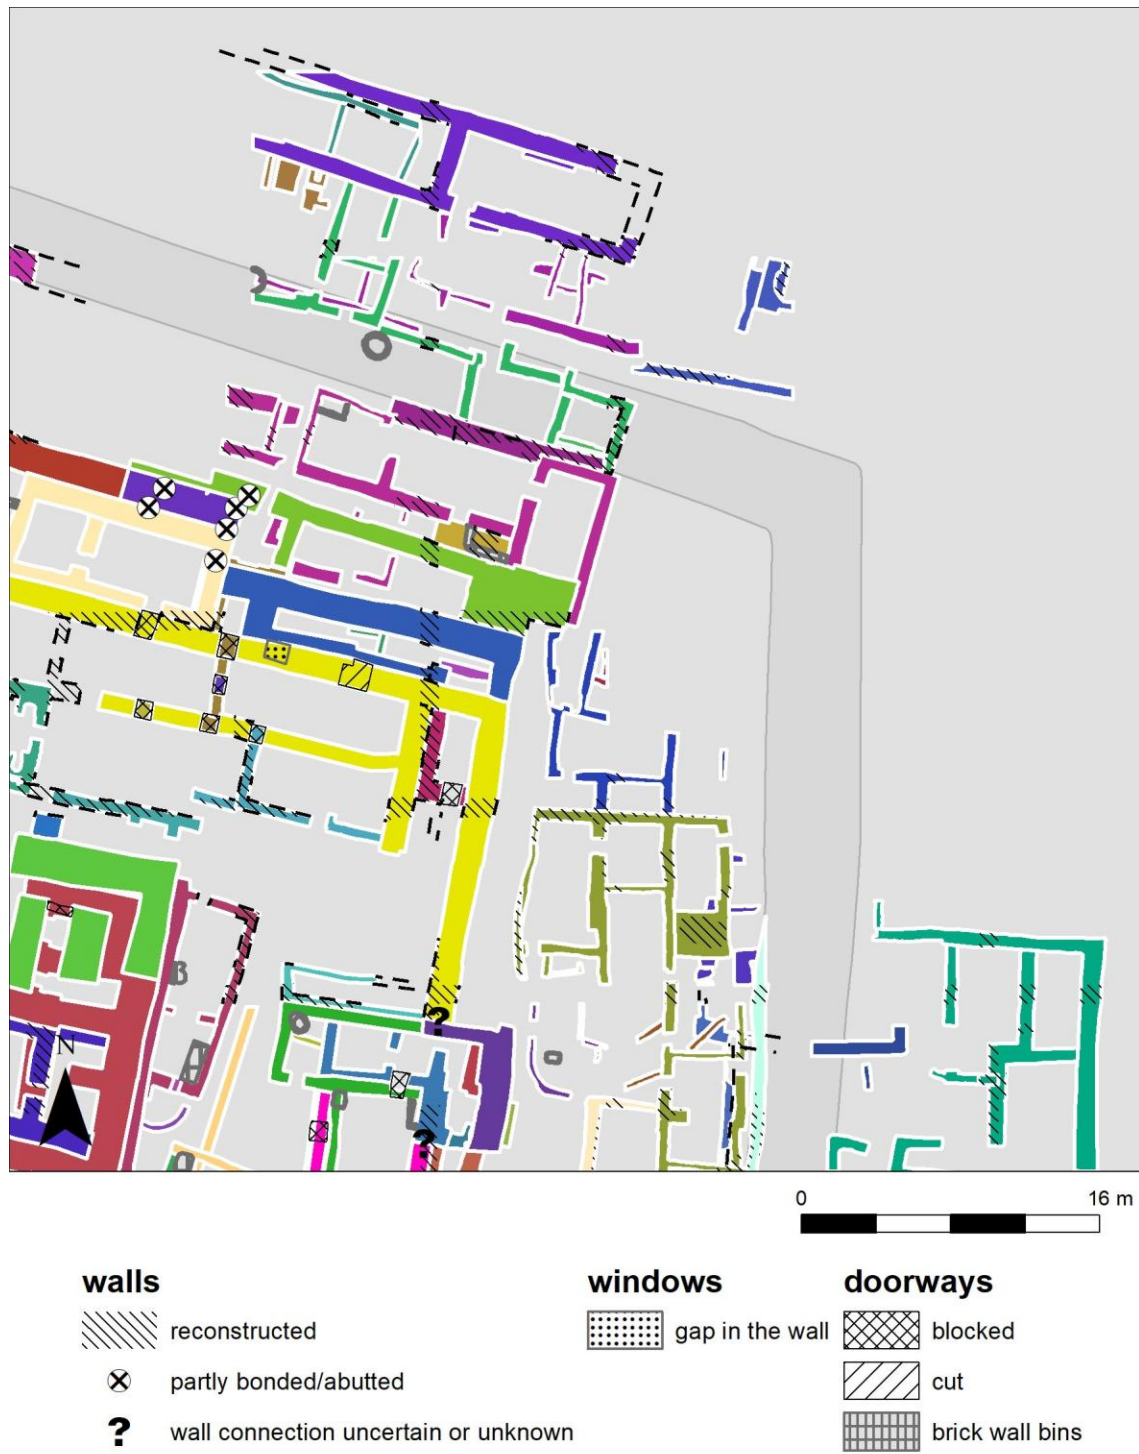
Figure 127. Construction units north-east.

Each of these aspects have been discussed in the preceding chapters. The decision to whether a group of walls belongs to a constructional unit is a result of an assessment of a combination of the above factors. Naturally, the incompleteness of the data ensures there are many uncertainties. This is also the reason that multiple factors were taken into account, as a multitude of positive matches may reinforce the idea that certain elements should be considered a constructional unit. The results are shown in the figures Figure 126 to Figure 129.

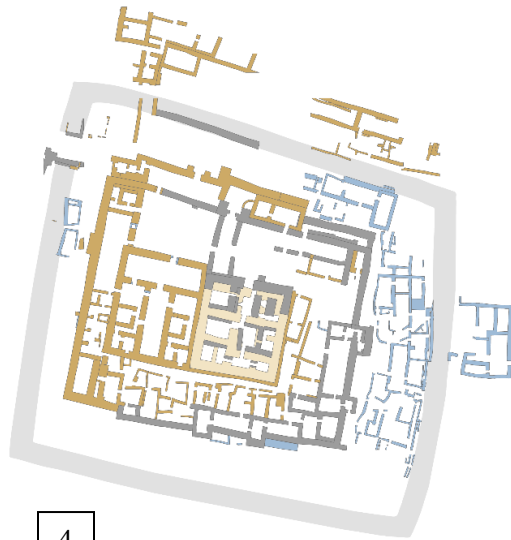
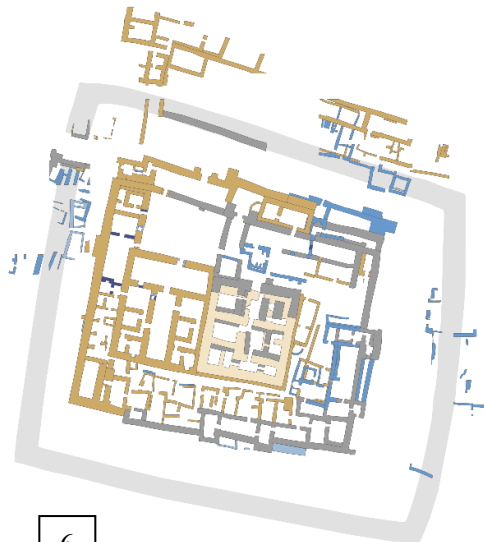
Figure 130 (previous page). Alternative site phasing. This is just one of various options possible.

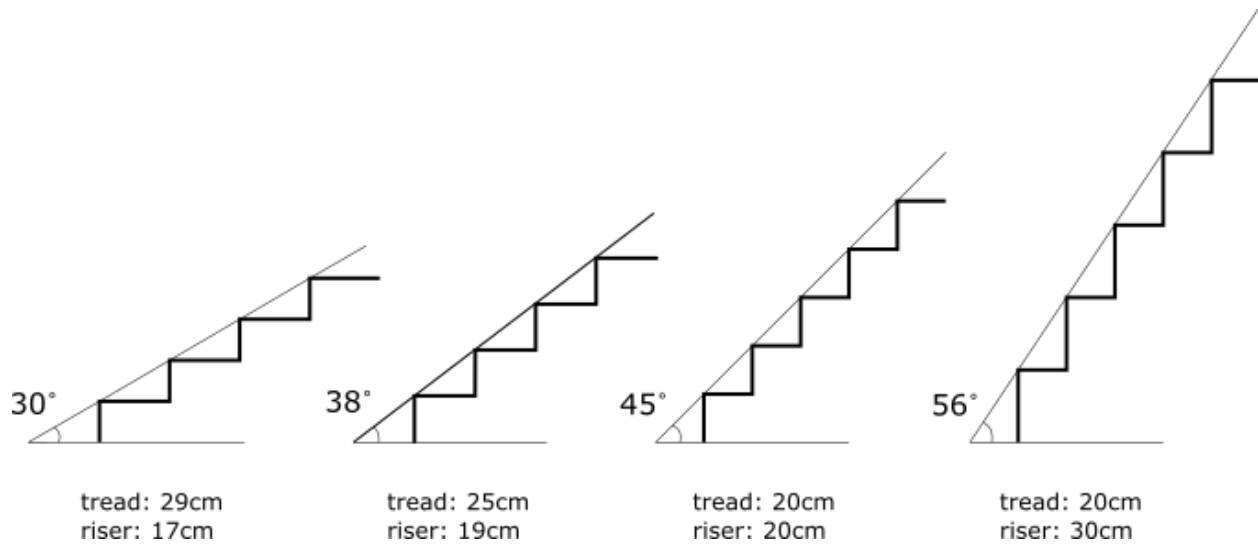
Figure 150. Step dimensions and incline. The two on the left are common dimensions of stairs in modern houses in the Netherlands. In the past, house stairs were steeper.

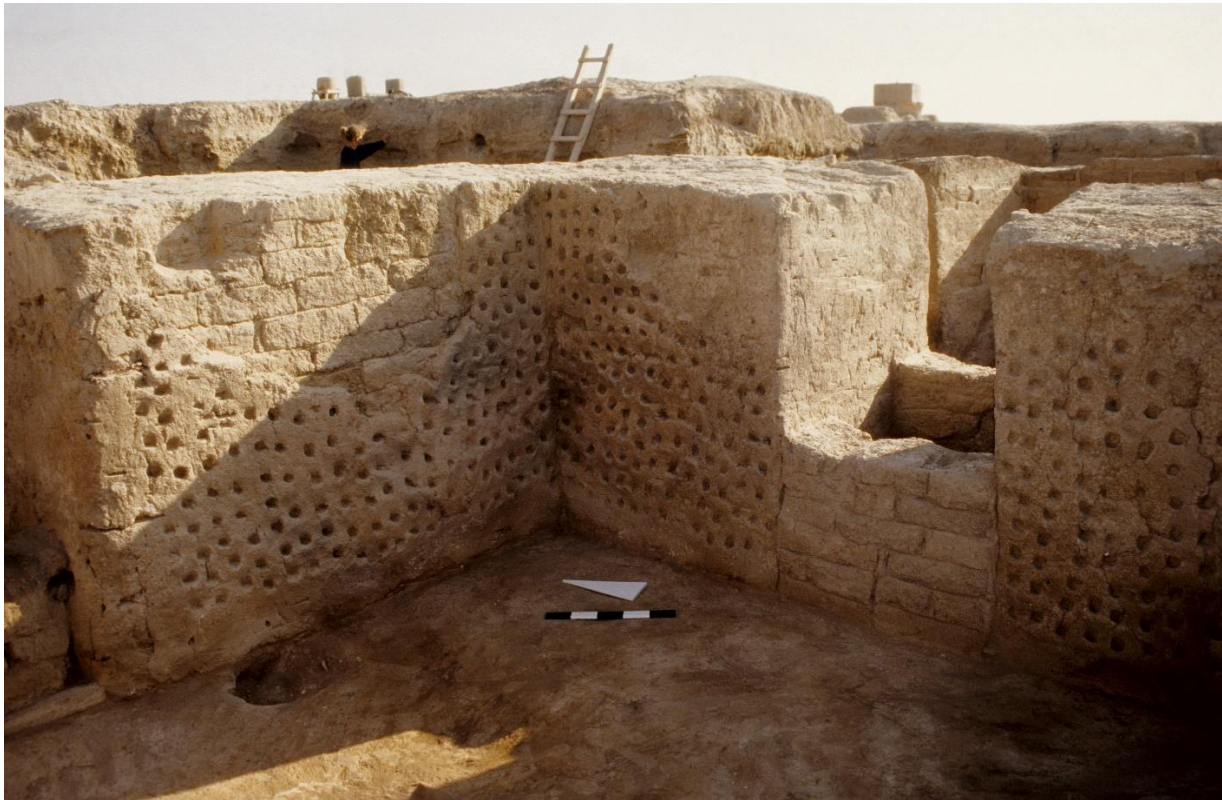
Figure 164. Windows or doorway blockings in residence room 2a (photo by Peter Akkermans).

Two additional features, equally ambiguous in interpretation, are found in room 2a of the residence (Figure 163). We seem to deal with modified doorways, although it is possible that for one of them an original 'window function' was intended (the one on the right on the picture). The latter would have been an interior window, and therefore probably somehow related to the practical functioning or visual control within this building. As these are later modifications, they may relate to a phase that the residence had lost its original functions and therefore hint at a change of use. They may simply be considered as doorway blockings rather than creation of windows.

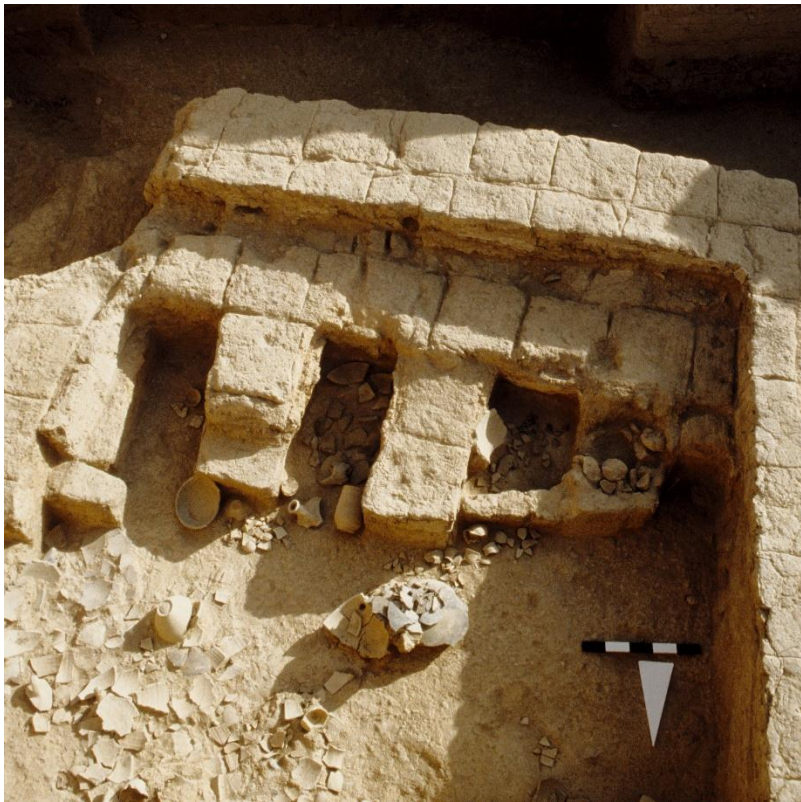
Figure 184. A row of three or four fireplaces integrated in the architecture in space NE-9c. These are simple stoves that could hold large pots above a fire. There is a cavity in the wall, plastered on the inside, which may be a kind of chimney, or simply point at an architectural modification (photo by P. Akkermans).

curious cavity in the south wall could even imply some kind of integrated smoke duct. The arrangement suggests that cooking for large groups could have taken place here. It is interesting to note however, that this building is a relatively late addition to the *Dunnu*. Excavation never continued below its floors, so it is unclear what was replaced: the previous version of this “kitchen”, another building, or simply open space? Various smaller clusters that include much larger ovens of up to 1.90 in diameter, are found outside the fortification walls in the eastern and north-eastern *Dunnu*. It is uncertain what their size means, and whether it is indicative of a different function, or a larger production. Apart from the conspicuous clusters, there are many spaces that have just a single oven or hearth. In many cases, such spaces are highly likely roofed. Their isolated occurrence in closed spaces may imply small scale or private usage. It may be a tentative conclusion to link these to individuals or families that are resident of the *Dunnu*. If this type of reasoning is followed, then the clusters must be somehow related to larger scale and public usage, or in other words: cooking and bread baking for larger groups.

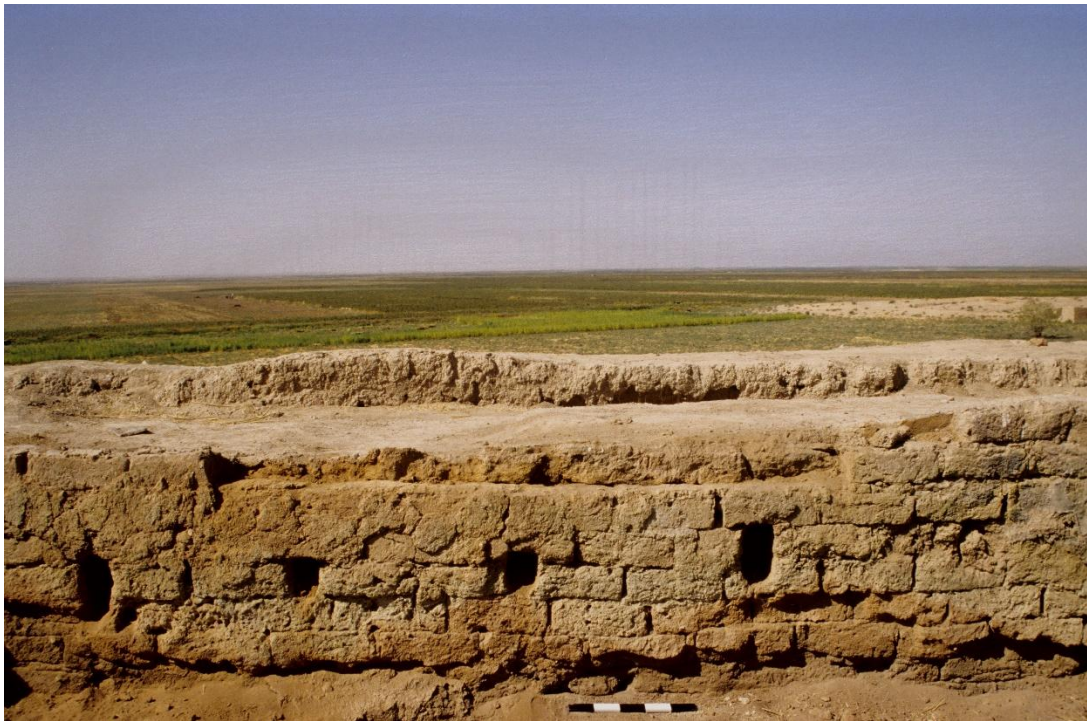
Figure 190. Holes on the interior face of the fortification wall in space NW1.

In square H08, in the elongated space directly west of the residence, a series of seven holes in the interior face of the fortification wall were found (Figure 190). The holes are found 70 to 75 cm above ground level, and are unevenly spaced at 65 to 120 cm. Some are partially covered by plaster, implying a loss of use at some point. The latter supposes that these holes originally fulfilled an architectural function at some point, in which case they would have been slots that held a structural member made of a decayable material. They resemble putlog holes, universally seen in hand made and hand-maintained architecture, but for that they are too close to the ground. Besides, constructions with putlog holes have nowhere else been found in the *Dunnu*, which makes this isolated usage very implausible. The holes could have been used as slots for

beams for a raised floor or platform construction. We should however note that no matching holes across the space were found, so it was certainly no construction that covered the entire width of the space. Their irregular spacing makes this interpretation less plausible, however. Another, more interesting, option would be that these slots held the horizontal members of a kind of partition walls (Figure 191). They thus created a series of partitioned spaces of variable size. A possible use for such structure are stables for various types of animals. Since the space connects directly to both the large central courtyard and a small entrance to side of the residence, a tentative interpretation is they are private stables belonging to the residence. The massive amount of burned organic material with a fibre structure, potentially straw, found here may be related to its use as stables. The burnt remains show a significant difference from the spaces inside the private court of the residence, which was filled mainly with burnt barley and wood. On the other hand, considering the probability of atypical usage in the final stages of the *Dunnu*, this burnt material may be unrelated to the original usage of this space.

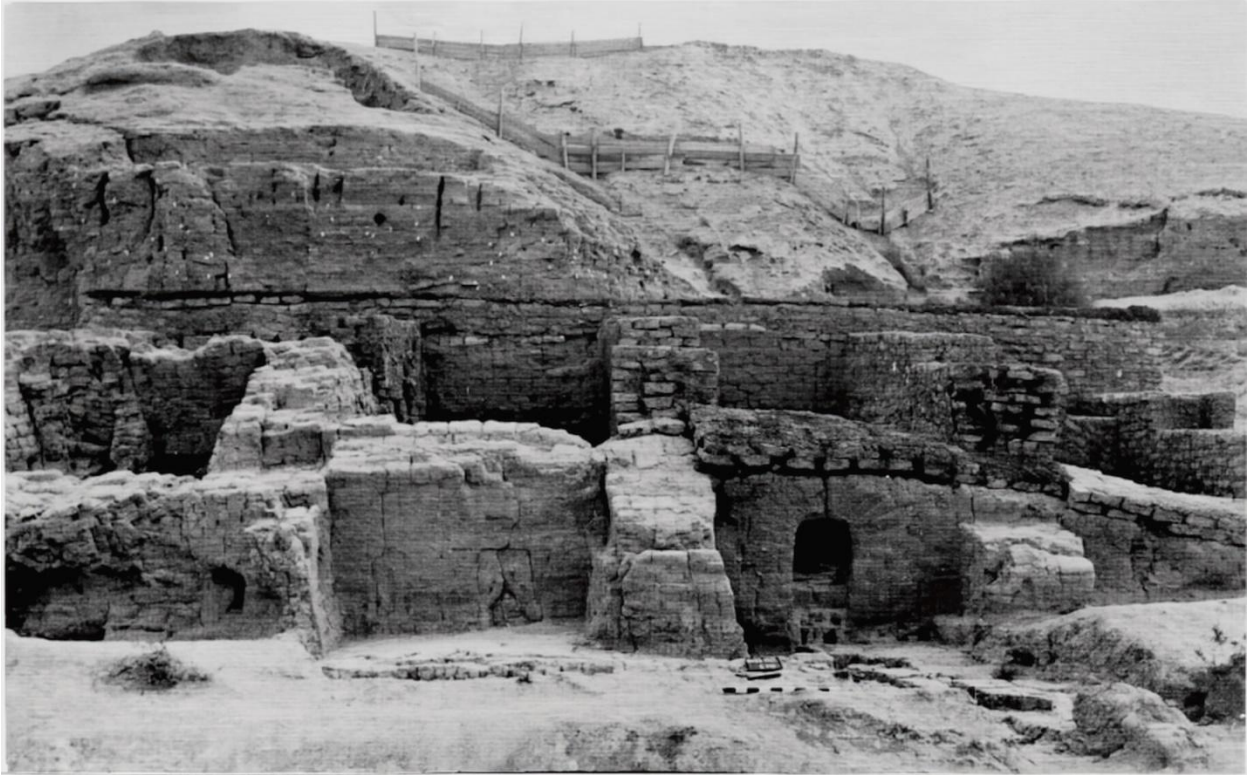
Figure 214. Middle Assyrian building P at the slopes of tell Sheikh Hammed, with the completely preserved arched doorway (after Kühne, 1983, fig. 2).

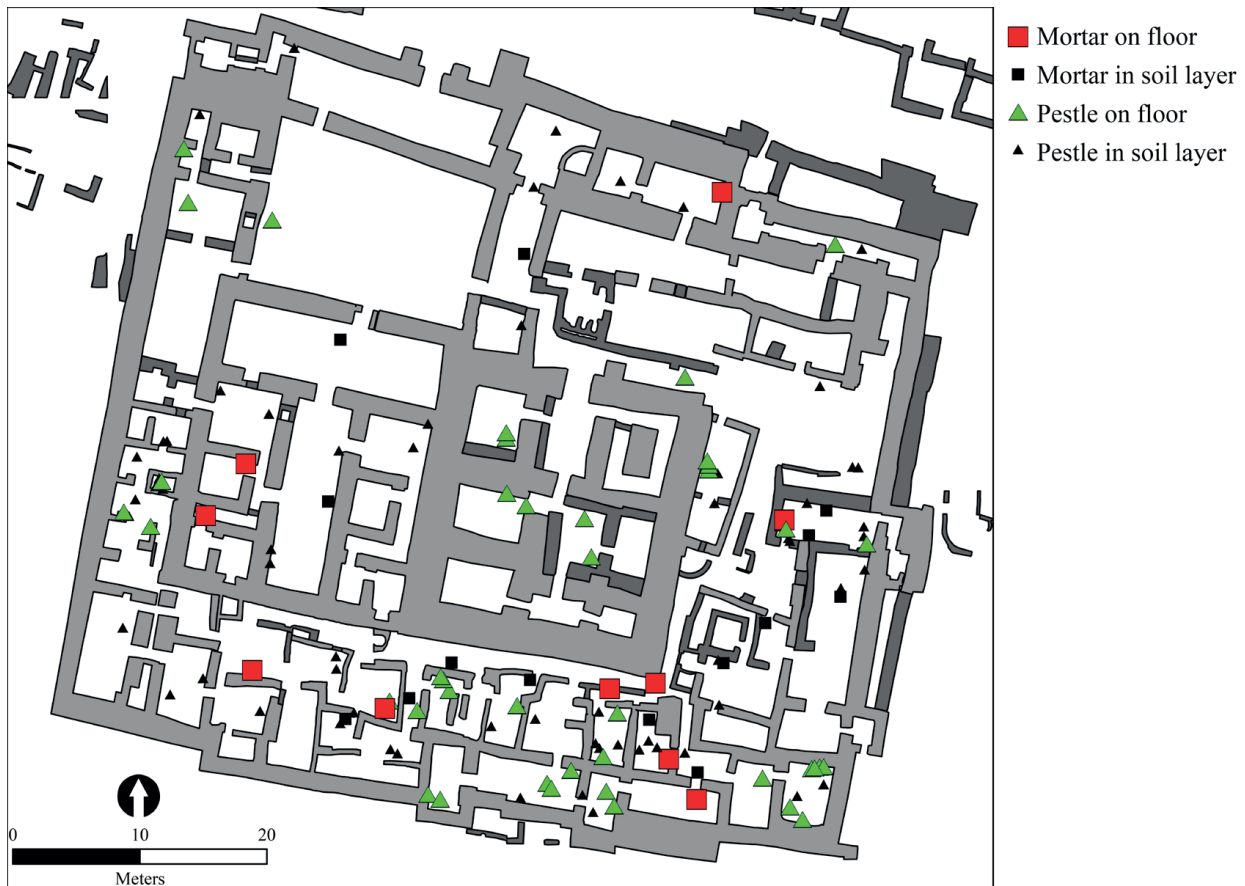
Figure 219. Distribution of grinding tools in level 5 (after Klinkenberg, 2016, fig. 4.7).

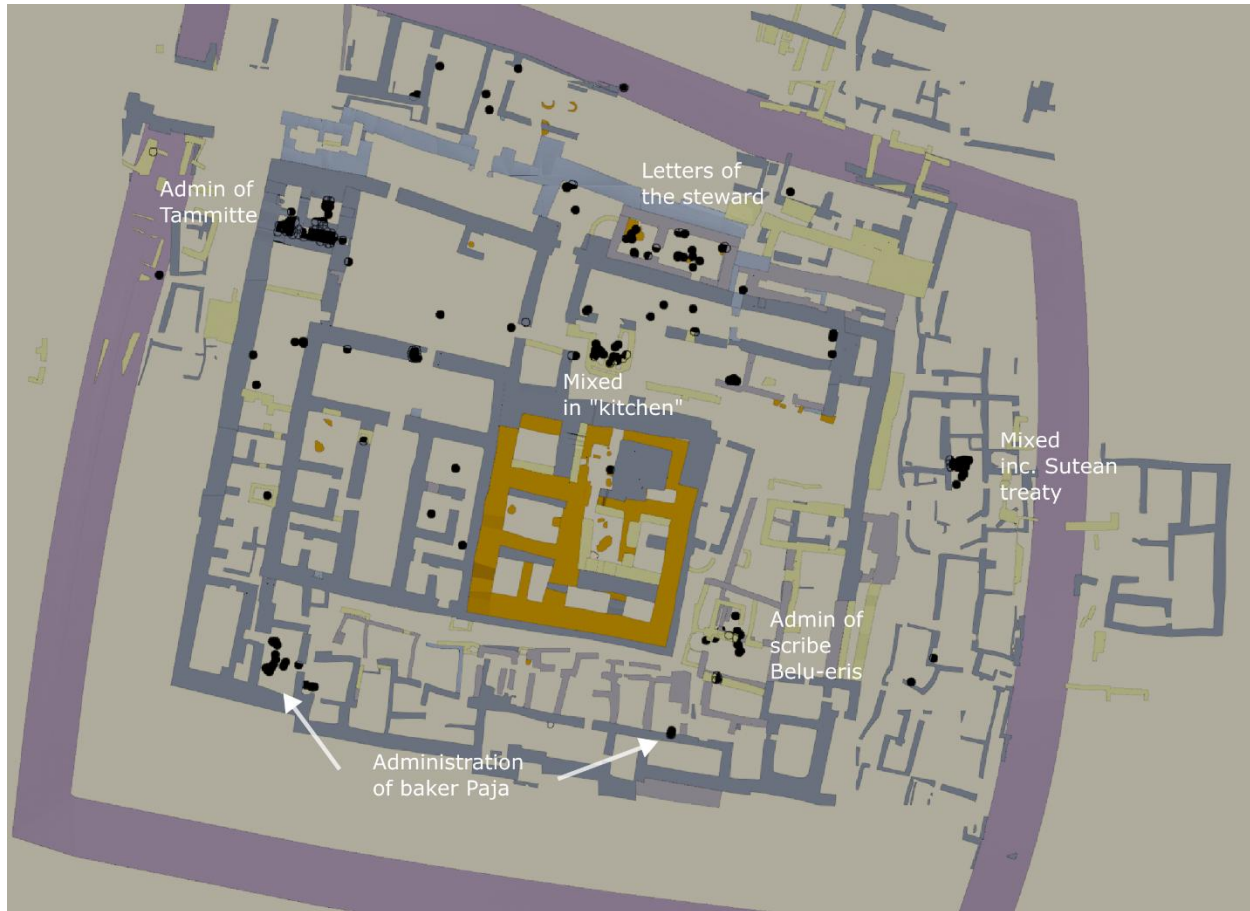
Figure 220. Distribution of cuneiform tablets.

The cuneiform tablet concentrations, indicative of administrative activities, also have a distinct spatial distribution (Figure 220). The presence of two administrative archives near the two gates, the main gate and the postern gate, in small buildings with a similar layout and is hardly likely coincidence. Both buildings have a movement controlling location in the plan of the *Dunnu*. People had to pass through or along the front entrance of these buildings. Moreover, as the contents of these archives point at daily administration of incoming goods and people, it appears that we are dealing with strategically located “offices”. Although
