Building Assyrian society: the case of the Tell Sabi Abyad Dunnu

IV. Archaeological deposits in the

Dunnu

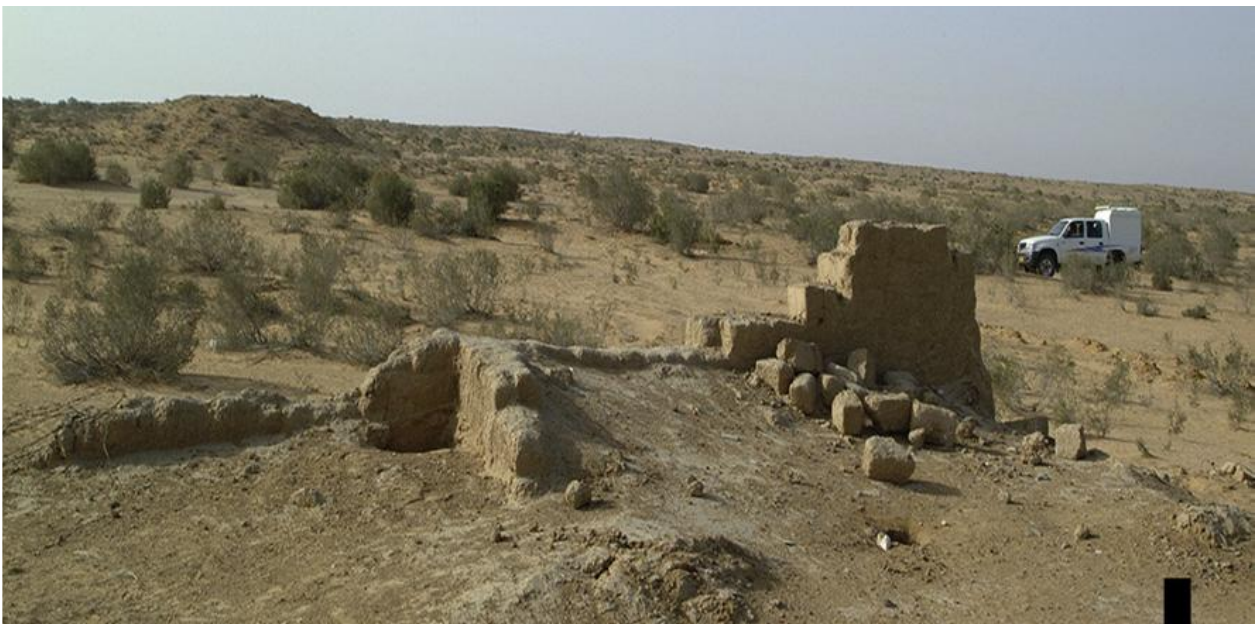
Figure 14 (previous page). Different types of mud brick site formation processes.

Left: Collapse, fortified town near Agdz, SE Morocco. Note that nearly all debris falls inside the building in this case, causing a stark difference in stratigraphy outside and inside.

Right: Water- and gravity-based erosion and sedimentation, same place as previous. Photo by author.

Below: Gradual decay and eolic infill, Gvulot, Israel. Eolic sediments form half of the contents of this experimentally excavated abandoned mud brick house (after Friesem et al. 2011).

A large part of our understanding of these archaeological sites comes from documenting and analysing the sequence and relative amounts in which these elements occur in the stratigraphy of a site, building or enclosed space. For instance, layers of eolian sediments interspersed with mud brick erosion deposits reveal a building that is open, and gradually decaying for an extended period of time.²⁴ Large amounts of unstratified mud brick rubble indicates sudden and fast collapse, while multiple distinguishable layers of mud brick rubble indicate multiple collapse events. Besides these obvious signs of decay following abandonment, a mud brick settlement is continuously in a state of decay. The rain, sun, and wind cause erosion and chemical weathering, resulting in a continuous formation process characterised by addition and removal of sediment (Torraca, Chiari and Gullini, 1972; McIntosh, 1974; Friesem, Karkanas, *et al.*, 2014). To this are added the cultural factors resulting from human activities of construction, levelling, digging, backfilling and demolition, and all economic and domestic activities that cause and move waste (Schiffer, 1983; Stein, 1987; Schiffer, 1996). Together, these result in the complex archaeological phenomenon that we call a ‘tell’ or settlement mound (Figure 14, Figure 15).

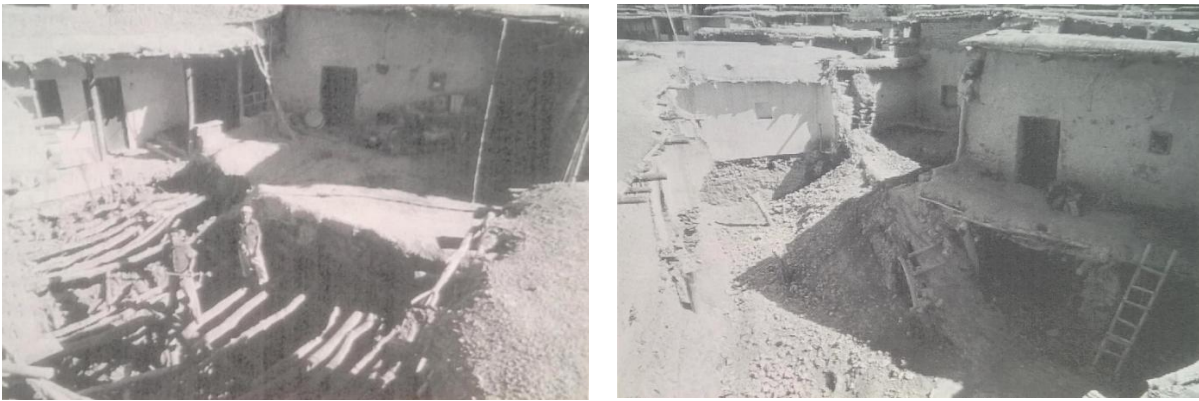
Figure 20. Demolition of a village house in the early 1980s, west Iran. Left: salvaging of roof beams. Right: the same house three years later. Much rubble is lying on the ground, but its distribution is very uneven. The house on the right is still inhabited (After Friedl & Loeffler 1994, figs.6 & 8).
