## **Building Assyrian society: the case of the Tell Sabi Abyad Dunnu**

## V. Constructing the *Dunnu*

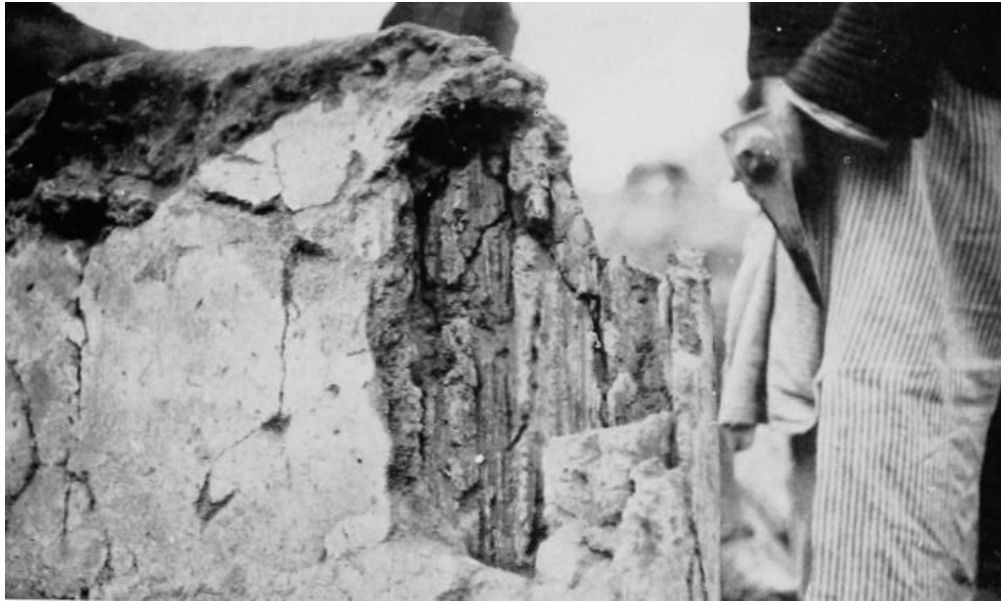
Figure 41. A rare example of a partition wall made of reed and loam unearthed at Nuzi by Starr (after Starr, 1939, Plate 24B).

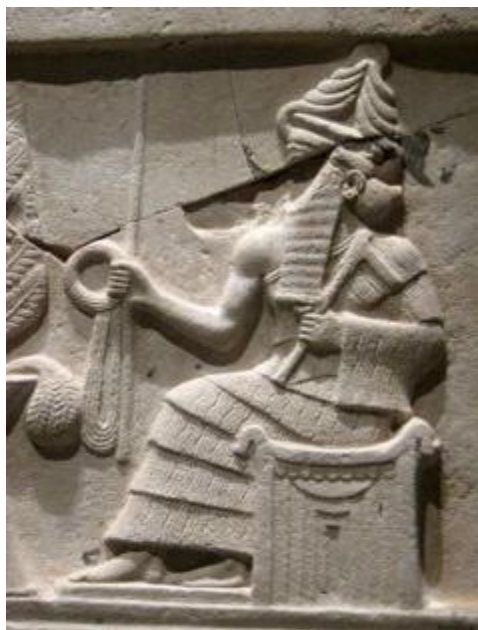
Figure 44. Nanna handing a measuring rod and a line partly on a coil to king Ur-Nammu on the Ur-Nammu stela. These were the basic instruments to mark the outline of a building.

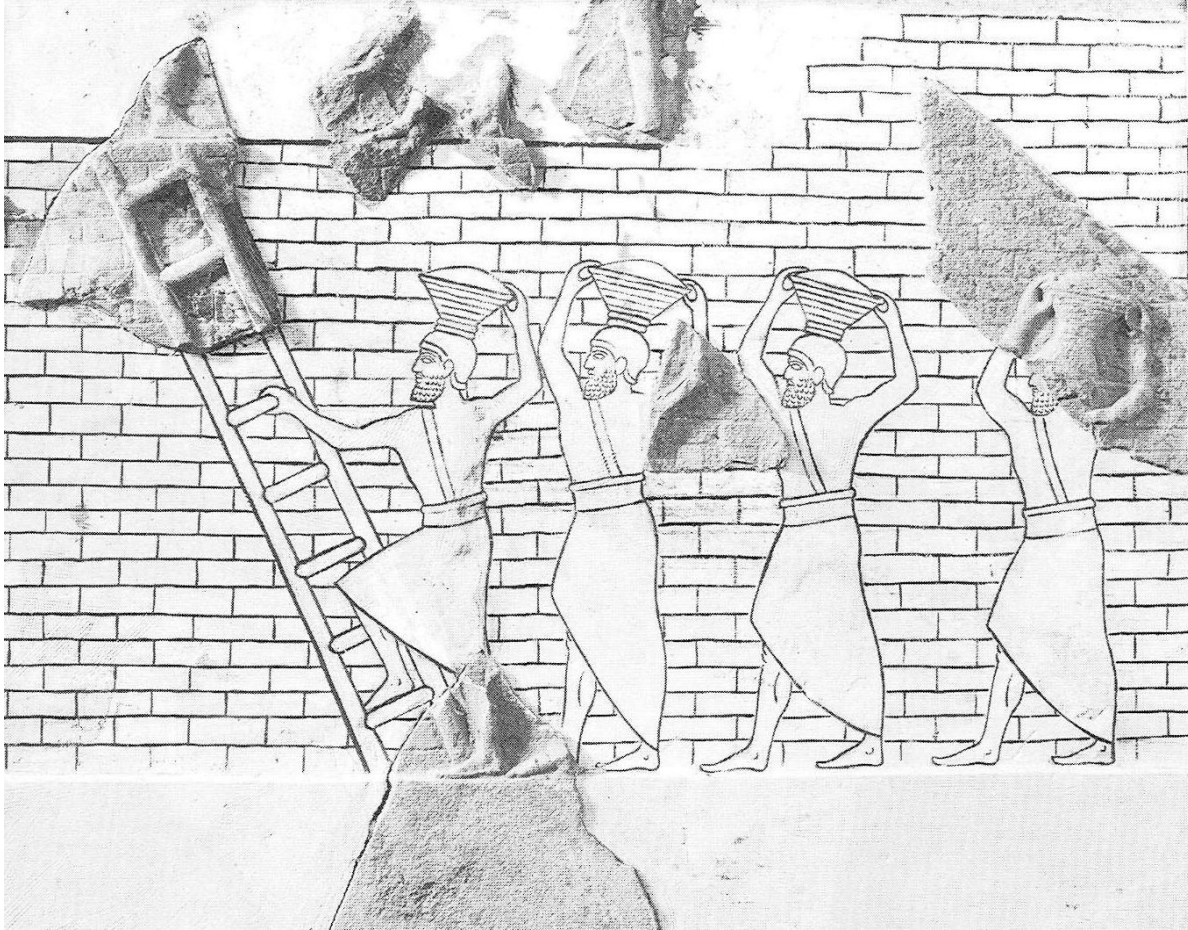
Figure 47. Part of the 3rd register on the obverse side of the Ur-Nammu stela. It is heavily reconstructed, but the subject seems clear: workers walking with baskets of loam mortar in front of a large wall (after Woolley, 1974).

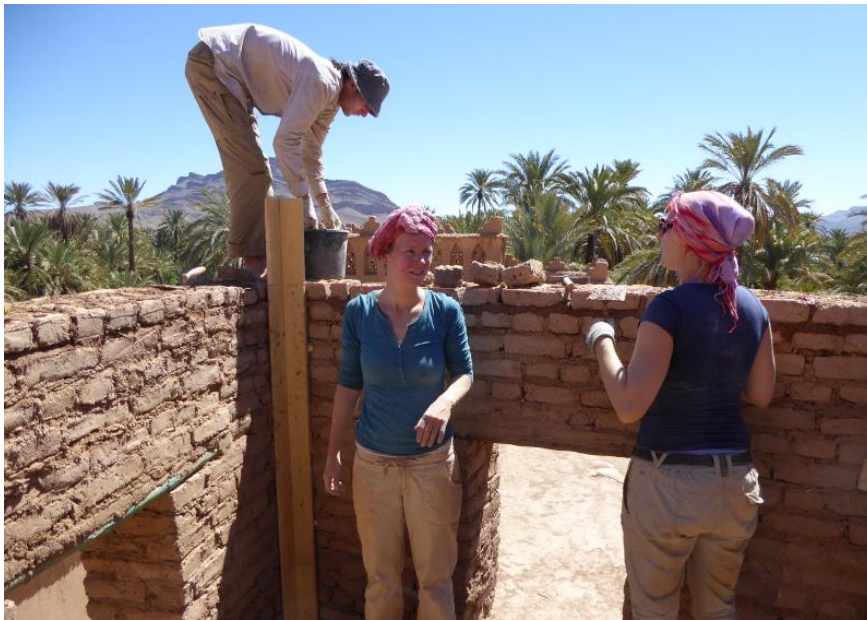
Figure 49. Bricking up a wall while standing on top of it. No scaffolding needed. Scaffolding was however regularly used on this project. This approach developed by coincidence while looking for an efficient way to finish the last part of the wall without having to adjust the scaffolding. Photo made by author during a loam construction workshop near Agdz, Morocco.

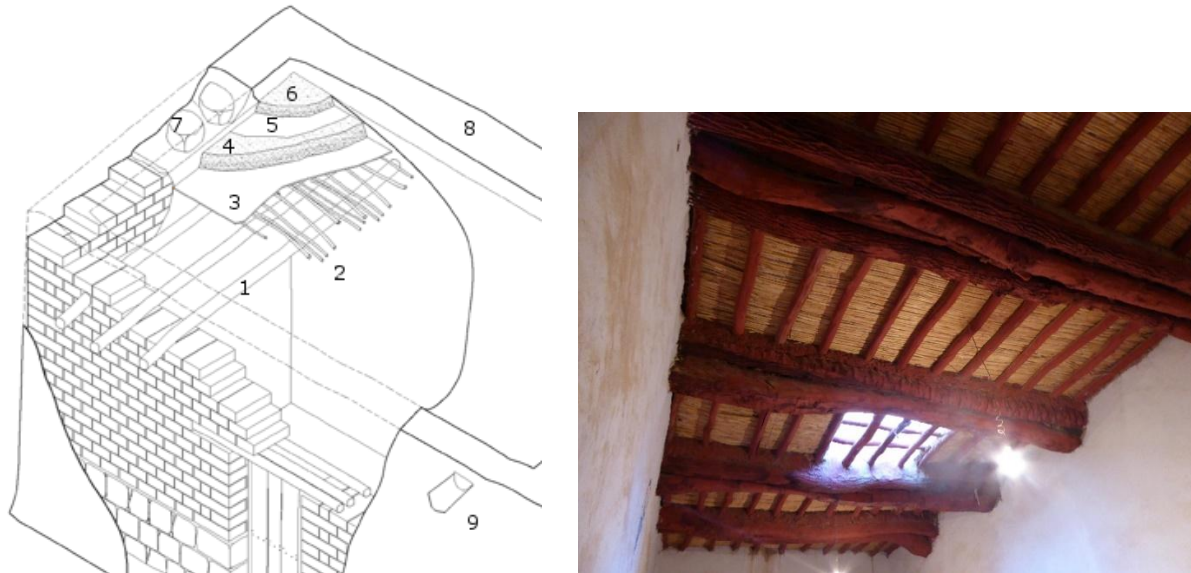
Figure 53. Roof construction methods. Left: common roof construction of houses in northern Syria. 1. Joists of poplar. 2. Purlins of brushwood. 3. Matting. 4-6. Layers of loam mortar with plastic sheet in between. Final layers mixed with dung or very fine clay to increase waterproofing. 7. Stone reinforcement. 8. Low parapet. 9. Water discharge. (after Dipasquale, Onnis and Paglini, 2009, fig. 63). Right: roof construction for a room with a larger span. The joint beams are a combination of trunks of date palm and tamarisk. It is a construction method that can be used when strength is required, but proper timber is not available. Top floor in a fortified building in south-eastern Morocco (photo by author).

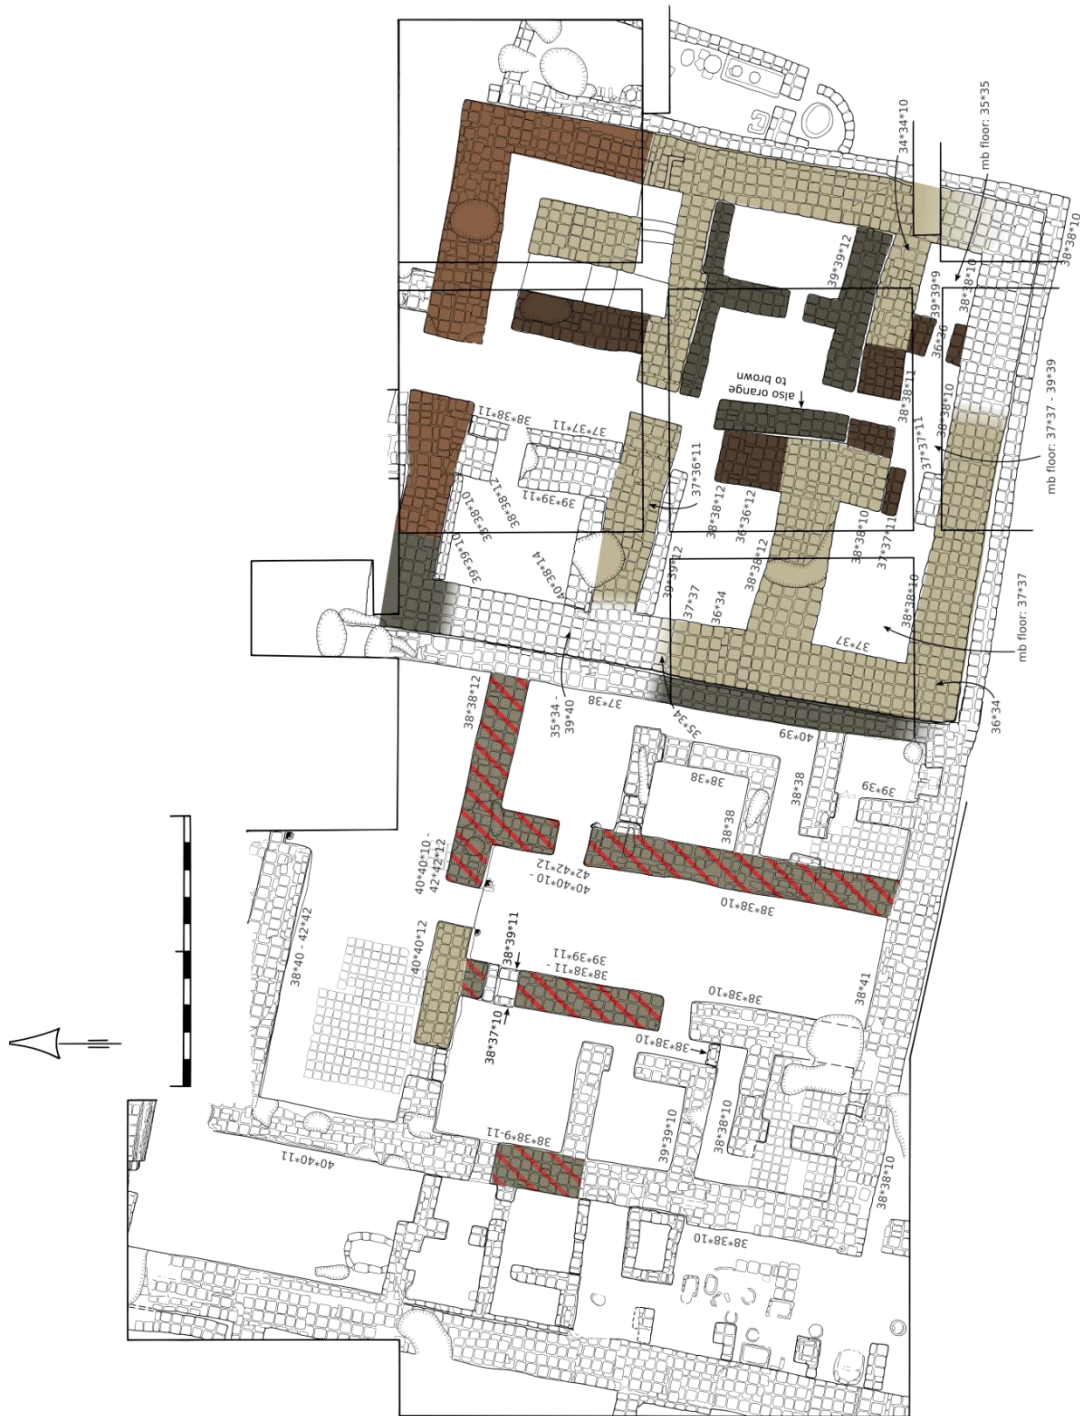
Figure 58. Brick colour, texture and size of the two largest buildings. No colour means no data. Light brown: brown crumbly brick. Darker brown: brown medium compact brick. Dark brown: compact brown. Grey brown: brown and grey compact bricks. Brown with red stripes: greyish brown compact and reddish brown crumbly bricks.

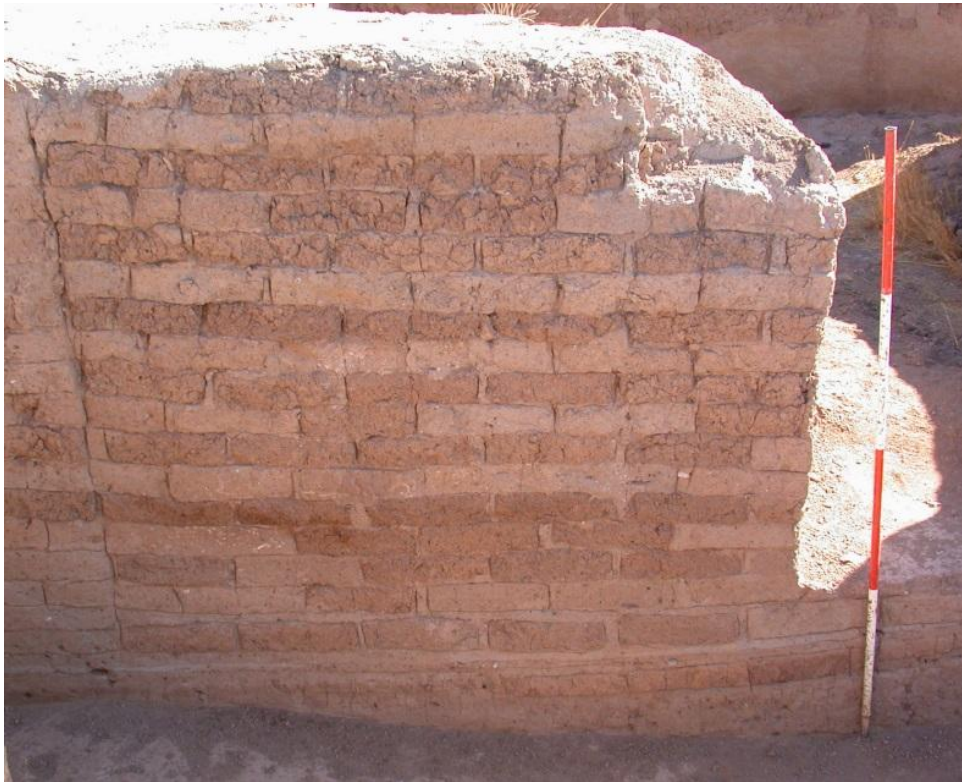
Figure 59. The use of interchanging courses of crumbly reddish brown and denser brownish grey mud bricks in the residence. 'Interchanging courses' may be a slight exaggeration of reality. It was not applied this neatly in all walls of the residence, and even this photo of the 'best example' shows quite some randomization in the placement of mud bricks of different colours.

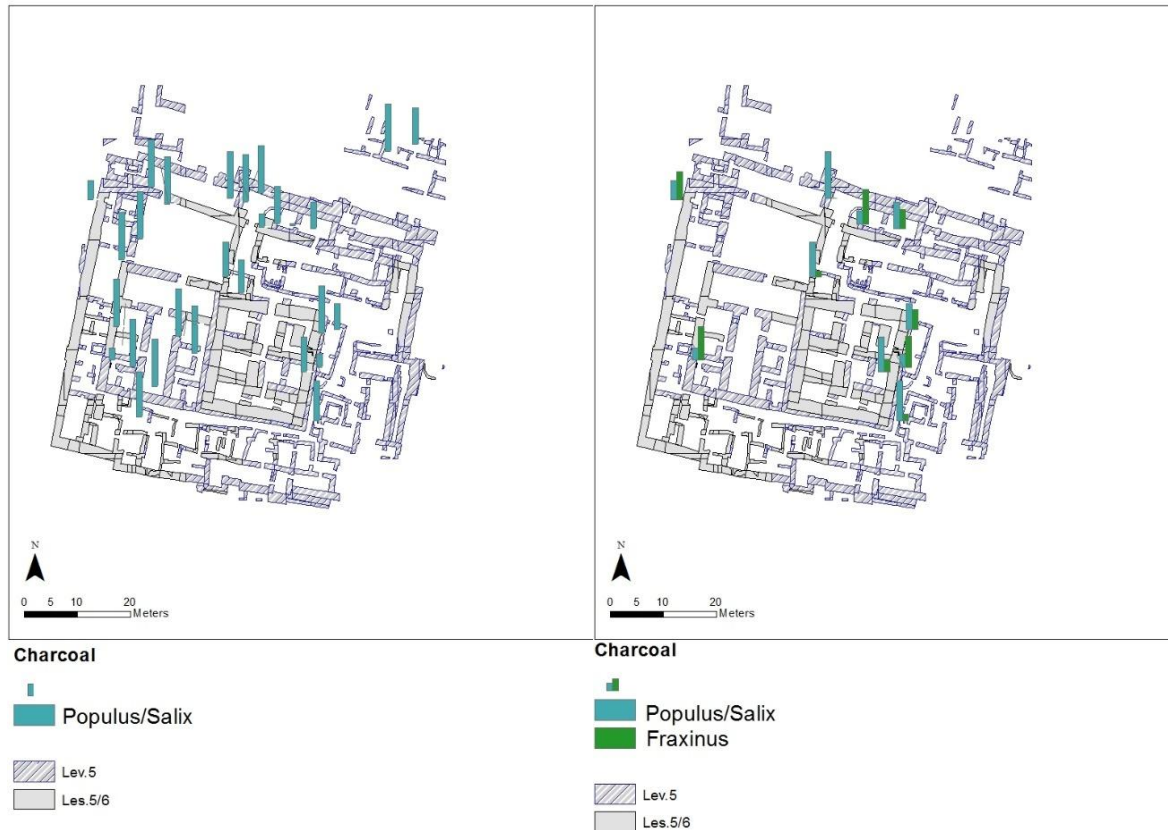
Figure 60. Identified wood species based on analysed charcoal found in the Dunnun. Left: poplar/willow. Right: relative quantities of fraxinus against willow/poplar (figures produced by Federica Fantone).

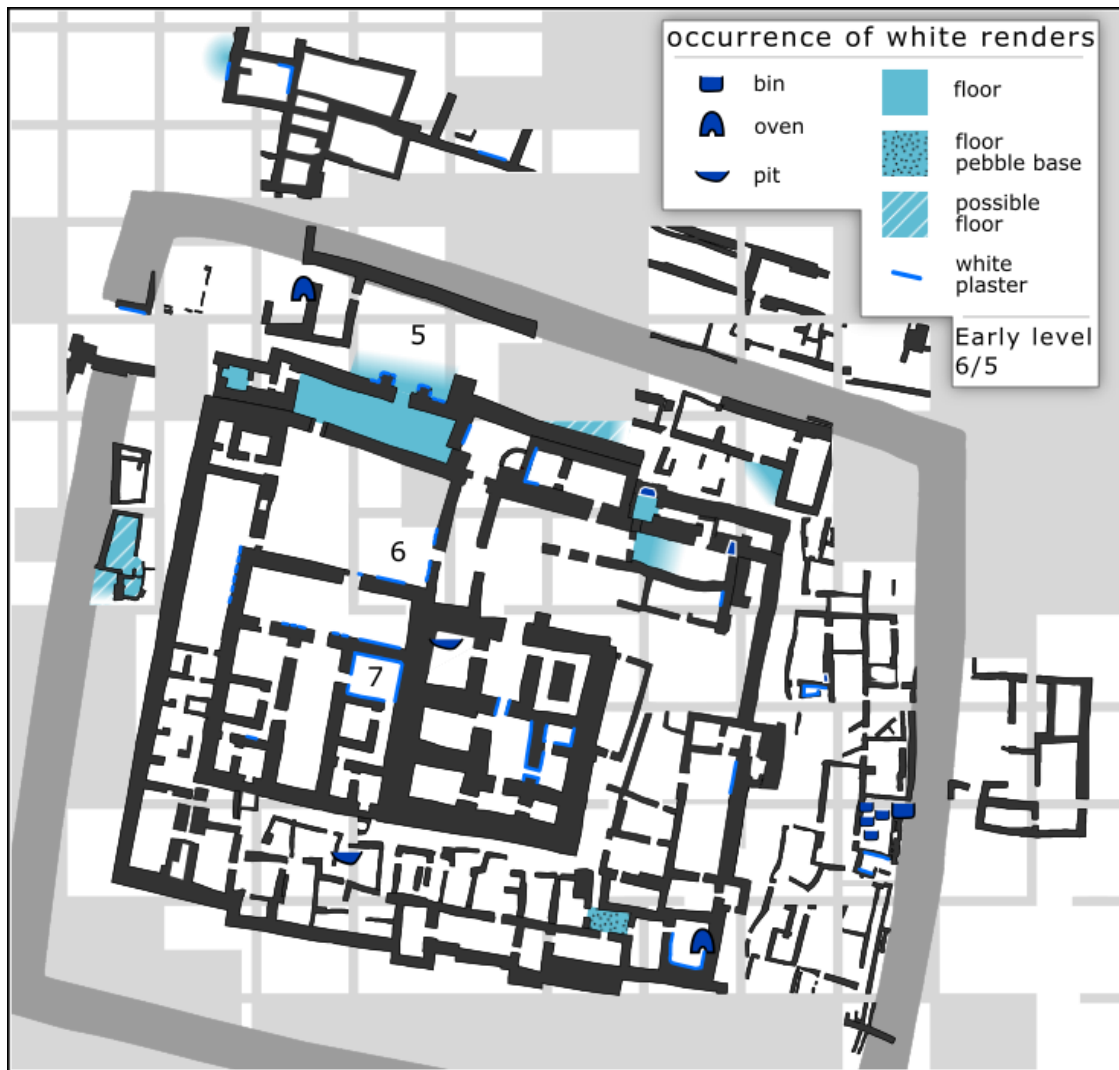
Figure 62. Early level 6/5 evidence for white renders in the Dunnu.

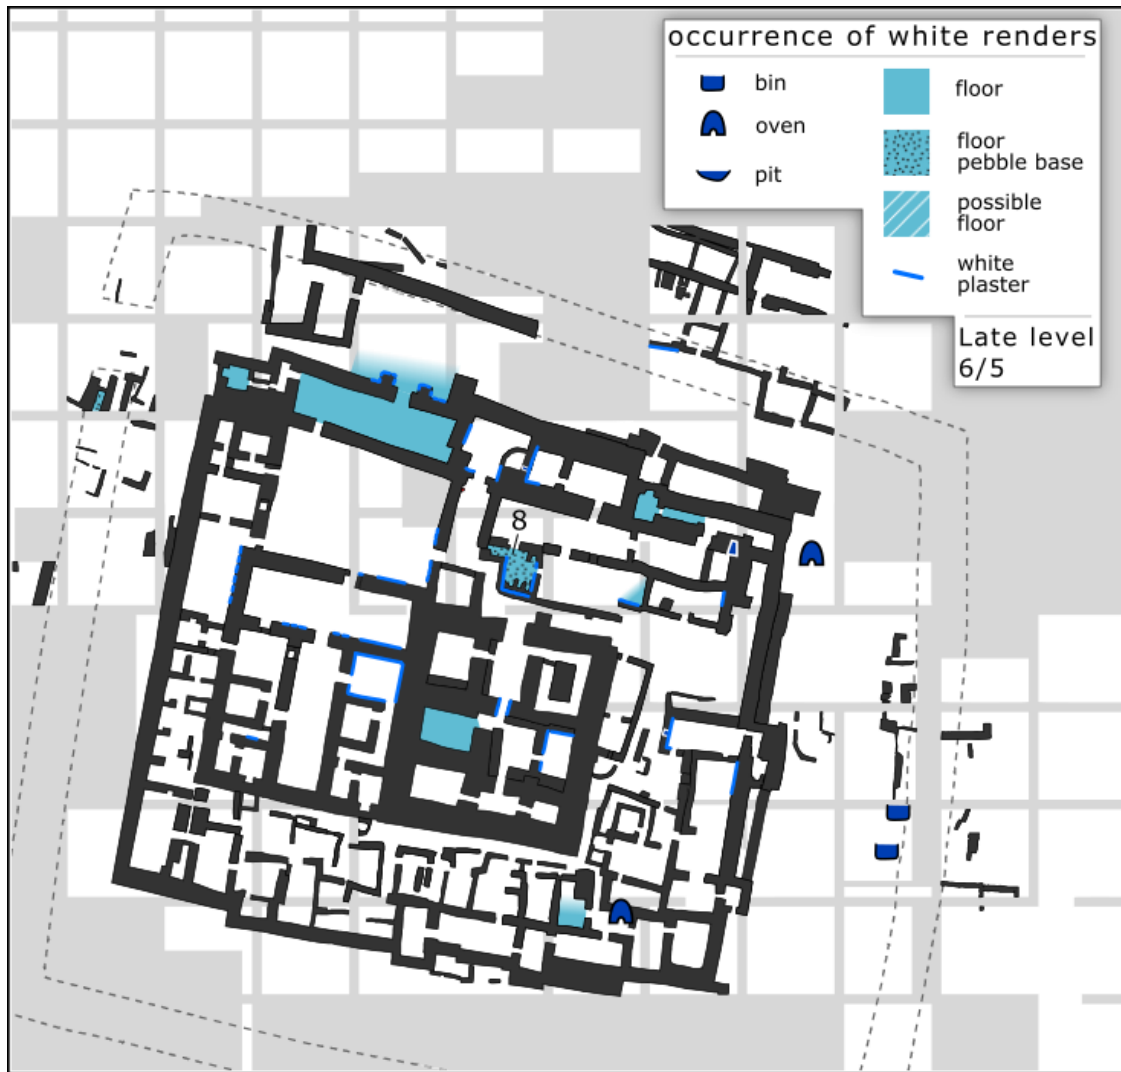
Figure 63. Late level 6/5. Evidence for white renders in the Dunnu. For some areas indicated on the figure, already rendered in early level 6/5, it is uncertain whether the white render was maintained also in late level 6/5.

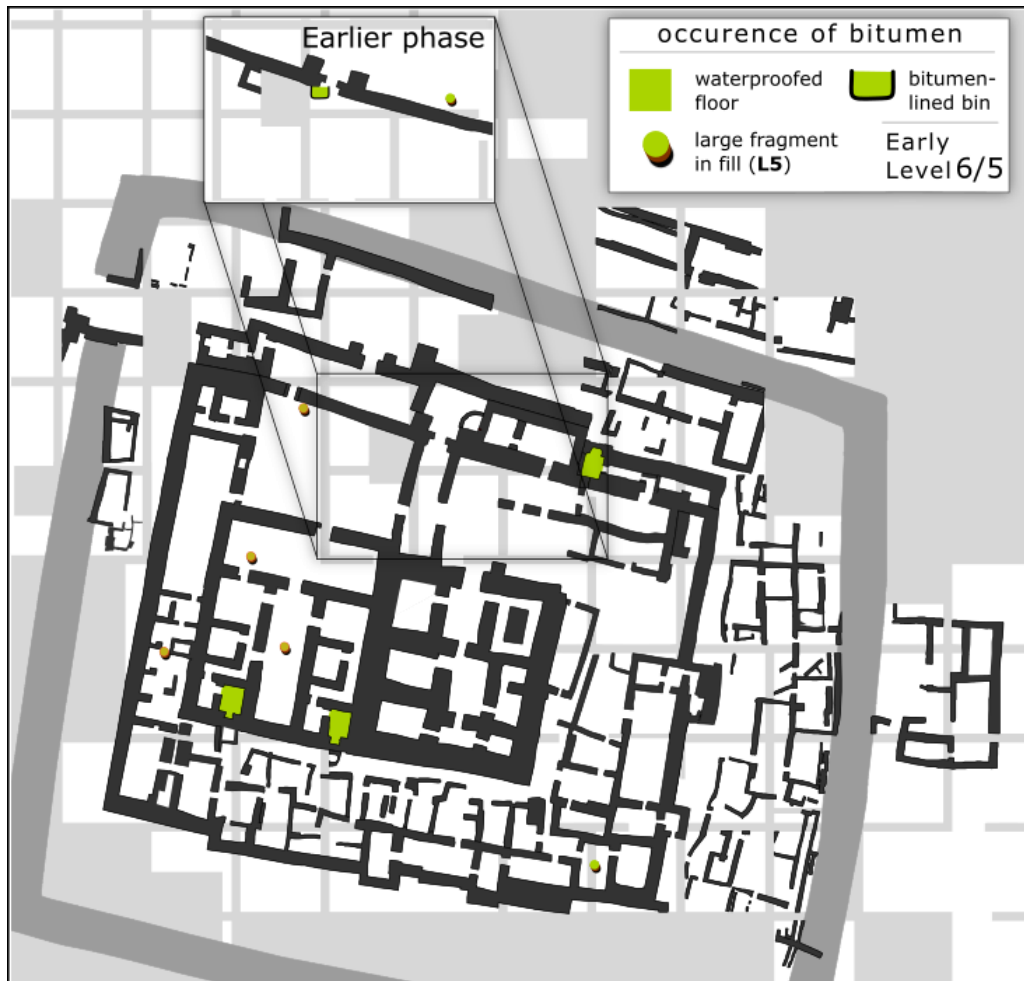
Figure 64. Early level 6/5. Occurrence of bitumen in the Dunnun.

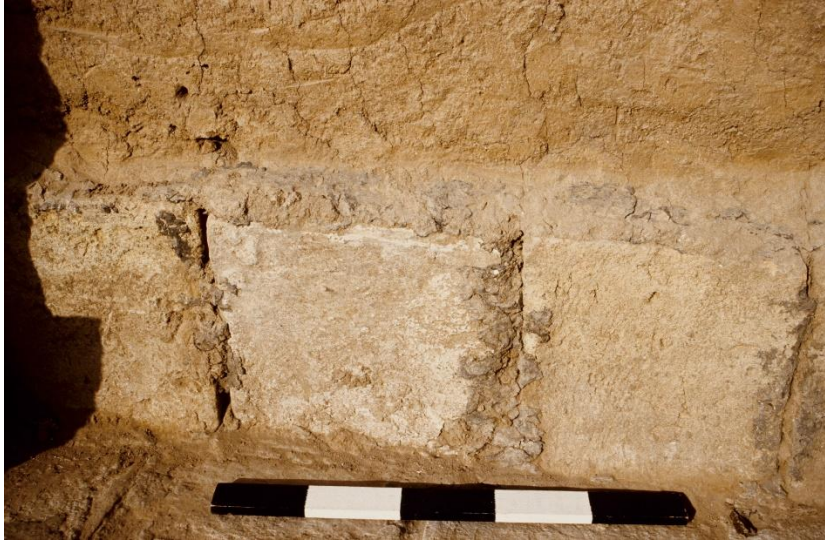
Figure 65. Example of the use of bitumen as mortar between the baked tiles of the bathroom in square M08.

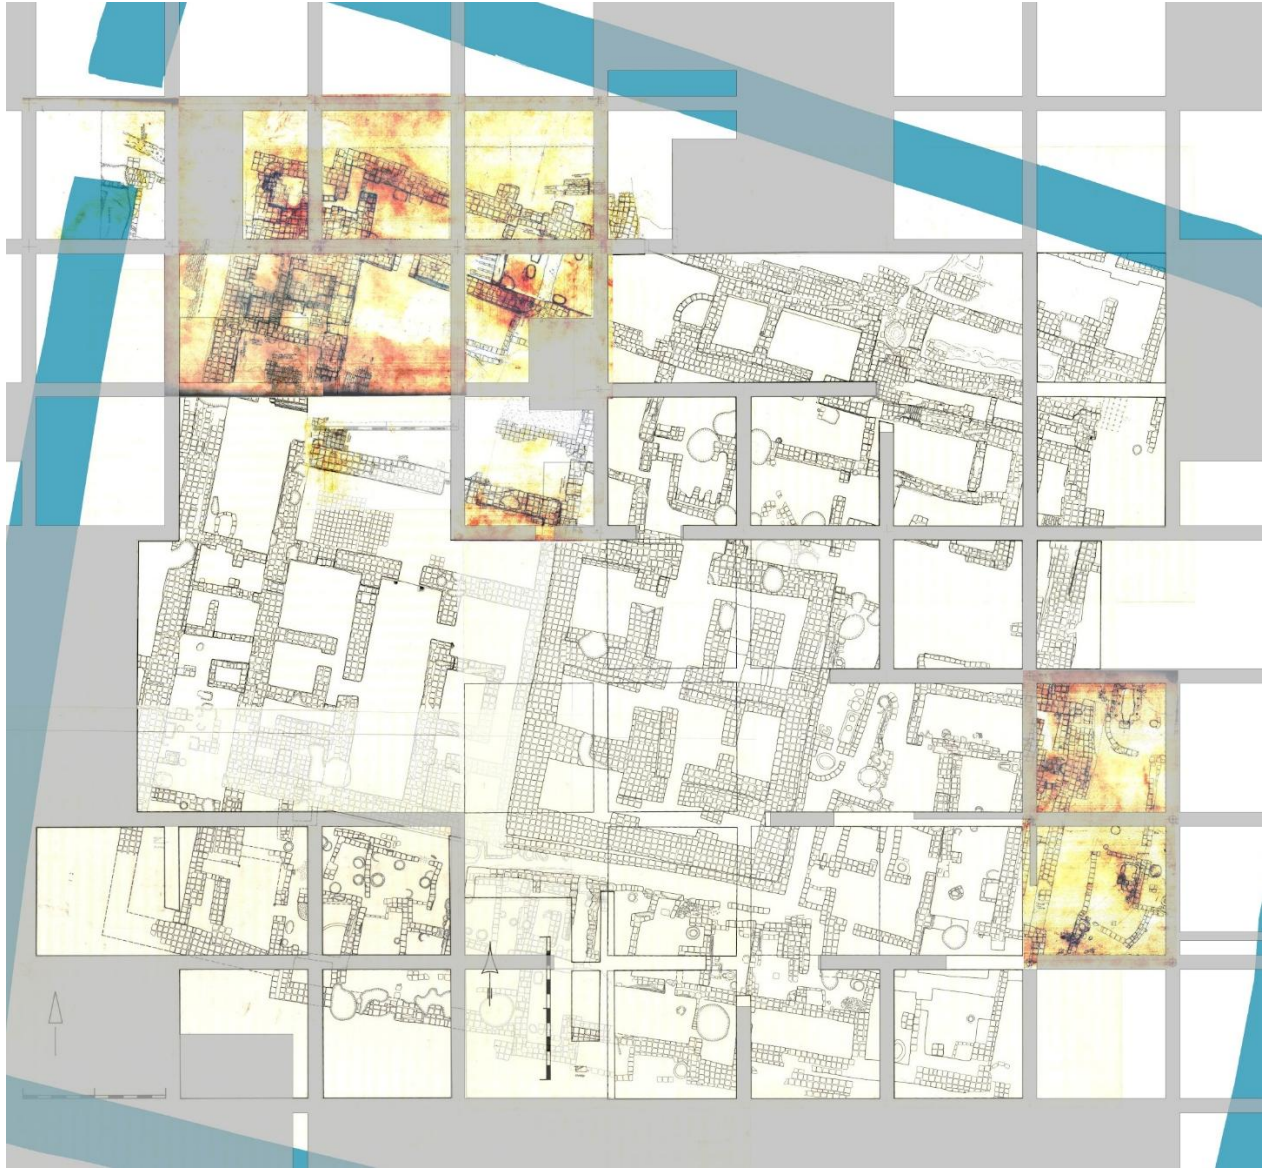
Figure 72. Plan of the Dunnu with all mud bricks drawn.

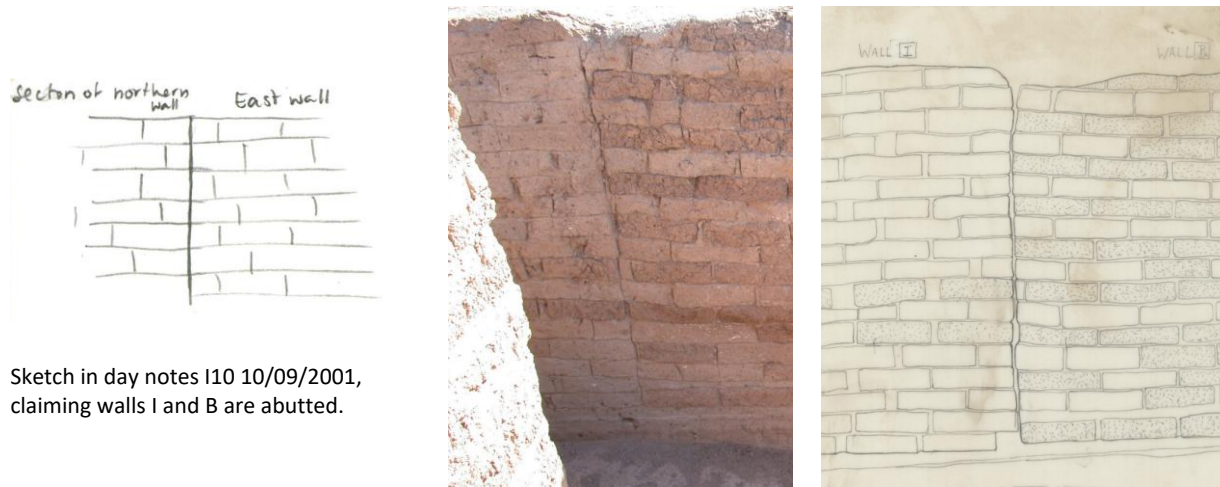
Figure 78. Abutted or bonded? All documentation of the connection of these walls suggests they were abutted. The top was disturbed by a grave, and the other side was not investigated with the same rigour. The mirroring set of walls across the central room however suggest that bonding was done by just one brick on one side of the wall (Figure 79).

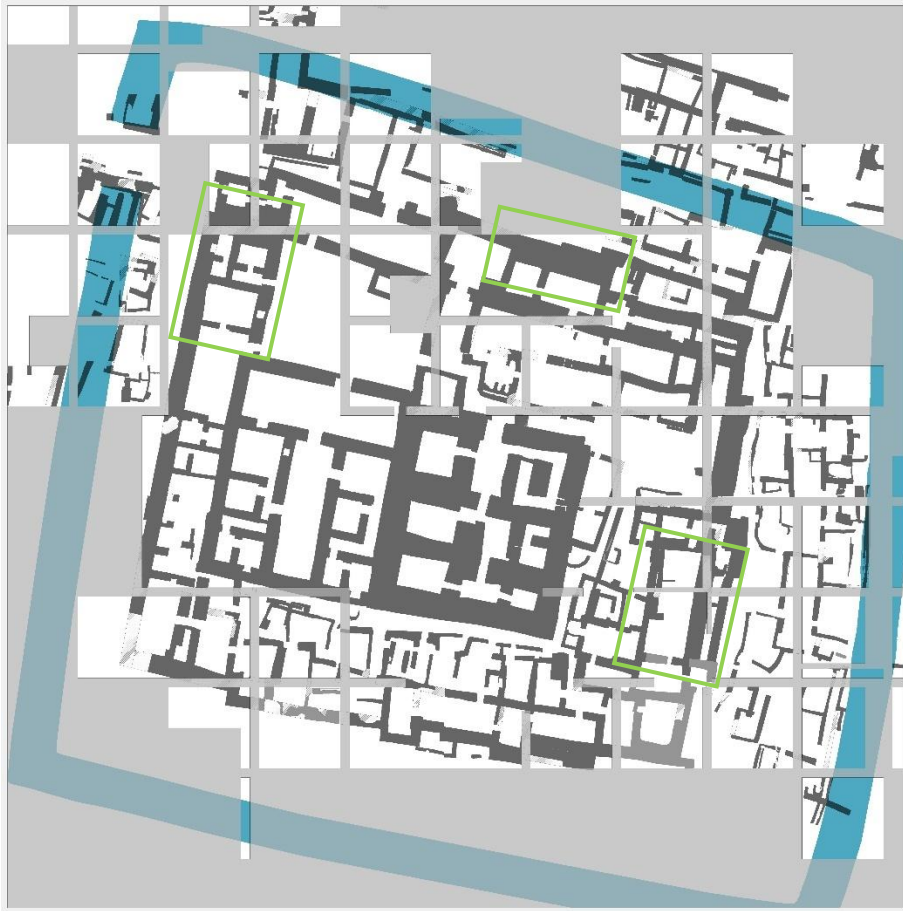
*Figure 83. Areas with layered or complex wall construction discussed in the text.*

In some cases of wall construction in the *Dunnu*, a type of constructional layering has been documented (Figure 85-Figure 88). These are characterised by transitions of brick material or bonding type within the same wall, or blocks of multiple, separate walls joined in construction. These wall complexes are remarkable as they appear to have been constructed as separate abutments near the base, but are integrated as bonded structures higher up. This raises questions regarding their manner of construction, their function,

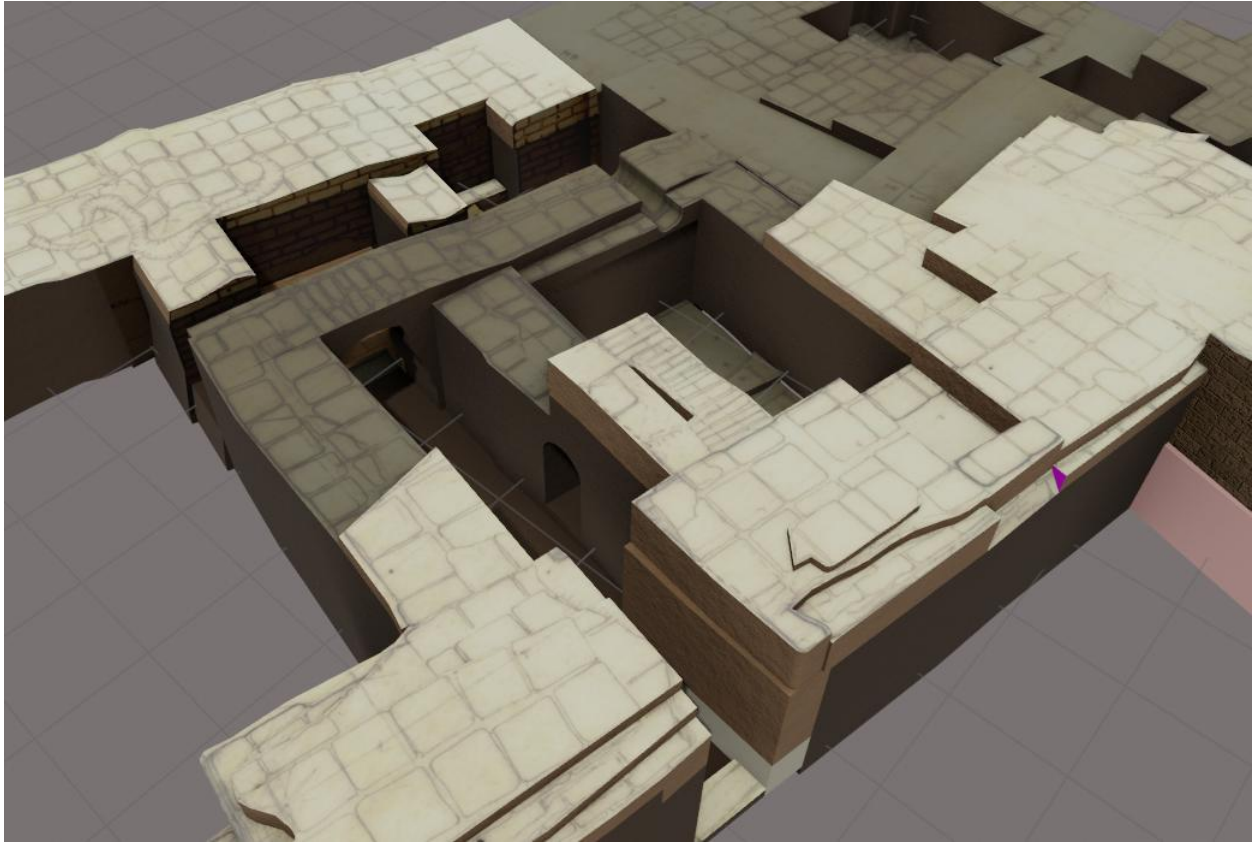
*Figure 86. Layered differences in masonry material and structural characteristics, indicative of either a renovation phase, or logistics of construction. North-western corner, building NW-3.*

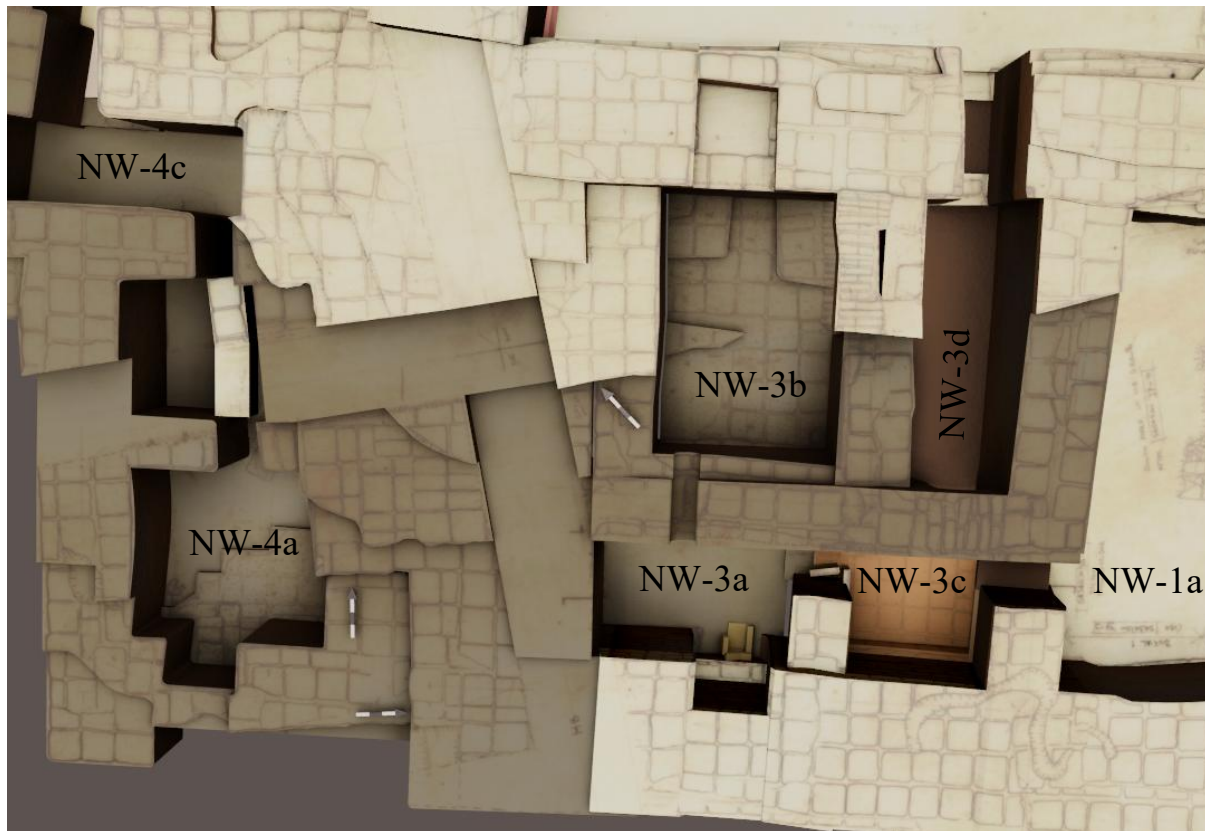
Figure 87. 3D plan of north-western corner of Dunnu, characterised by a massive masonry block. Below a certain level, walls are abutting, while in higher segments, they are bonded. This corresponds to the height of the renovation of the western wall of the main courtyard (Figure 84). Arrows point at abutting seam lines.

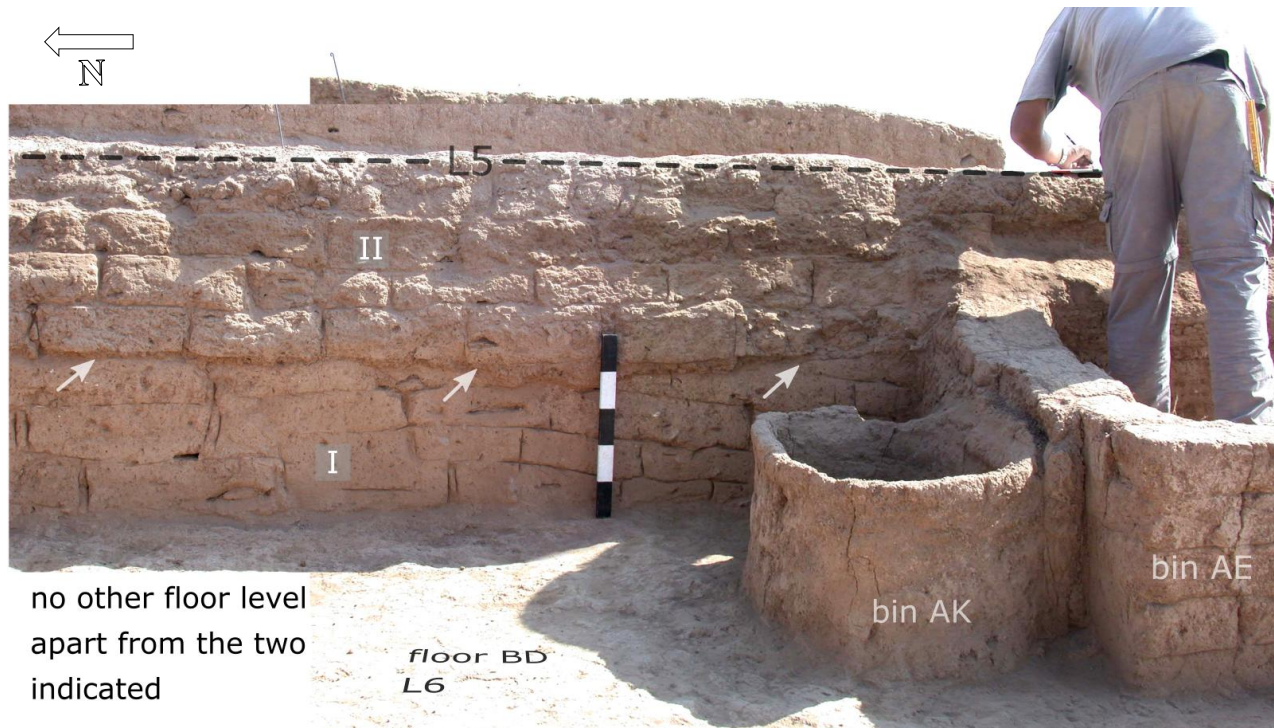
Figure 91. Two noticeably different brick layers in the eastern fortification wall on top of each other. Based on the excavation notes and photos it is unclear whether bin AE abuts both wall layers, or just the lower one. There is no evidence for a floor associated with the level of the joint line, although one has been postulated by the excavators.

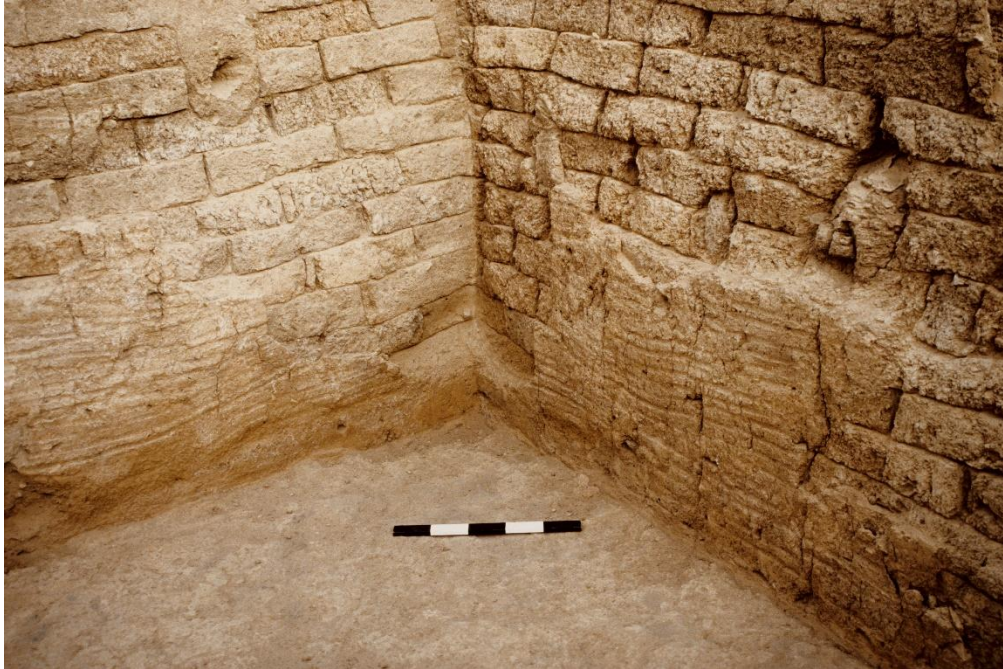
Figure 94. Grooved loam plaster, most likely a base layer for the application of a fine red pigmented plaster.

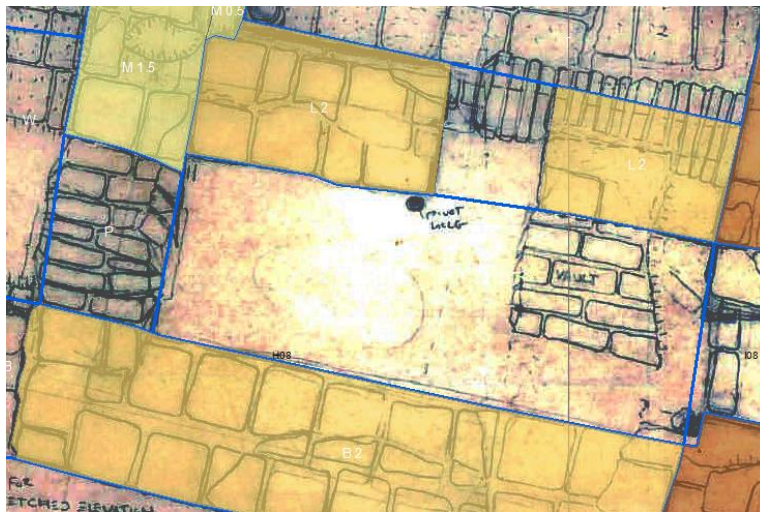
Figure 98. Remains of vault of corridor space NW-3d, "Tammitte's office". On the left the part that covered the doorway, which was lower thus better preserved. It applies wholes and 1/3-size bricks. The row of mud bricks placed on their side in the room directly to the north, may also indicate the pitched brick vaulting technique was used.

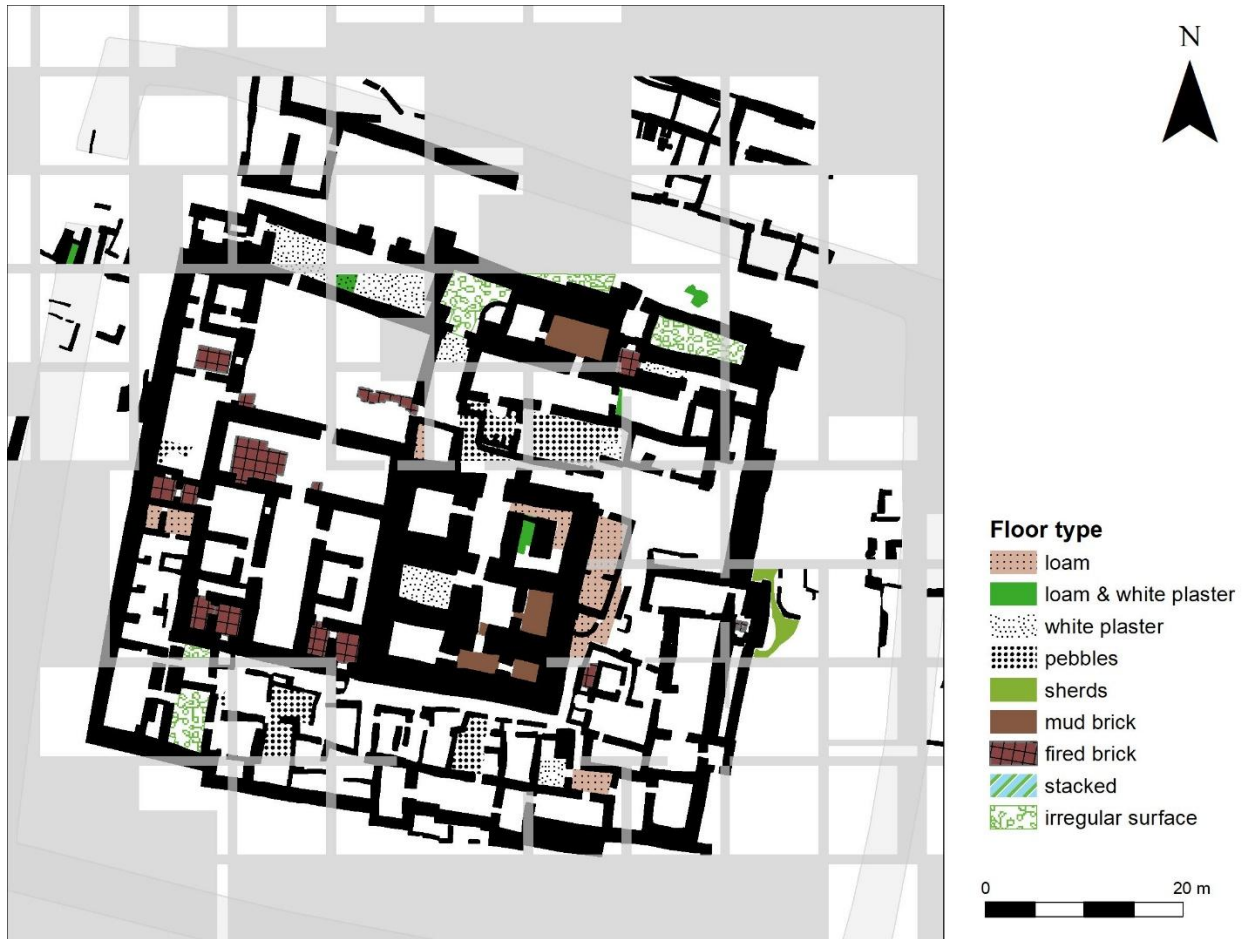
Figure 101. Floor/surface material types.

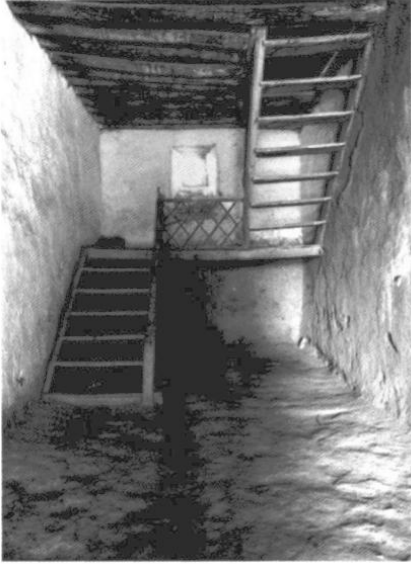
Figure 106. Timber stairs. Left: stairs in a house in Cafer Hüyük, Turkey. These U-shaped stairs are supported by a landing made of large beams embedded in the wall (after Aurenche *et al.*, 1997, fig. 4.13). Right: a common type of wooden stair construction. It uses so called newels, or vertical posts, to suspend the entire structure (drawing by Bill Bradley).

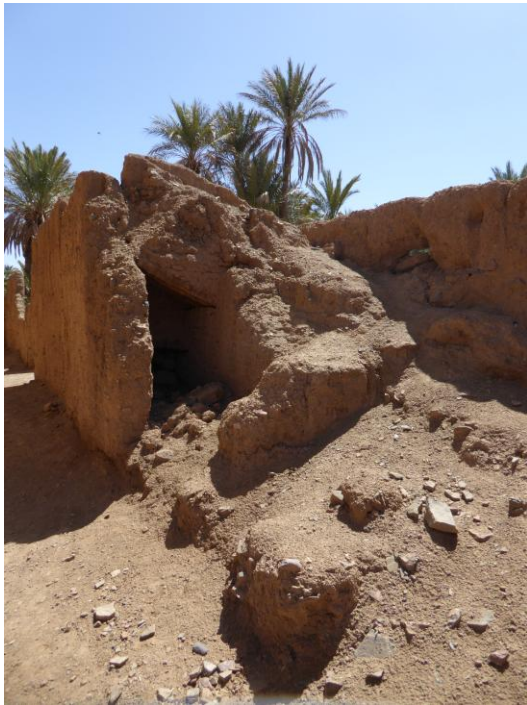
Figure 107. Ruined staircase in Morocco. The mud bricks of the steps have weathered to an unrecognizable degree. The wooden base construction still holds and protects the empty space under the stairs, but when it gives way the stairway would only be recognizable by the walls of the stairwell (photo by author).

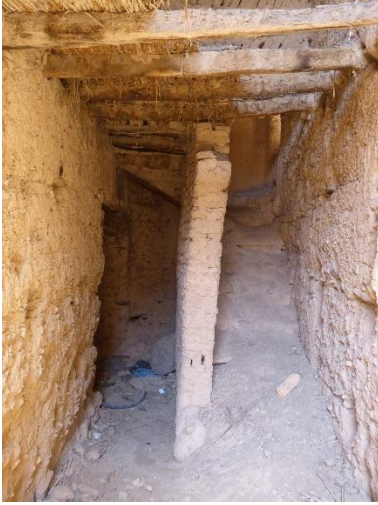
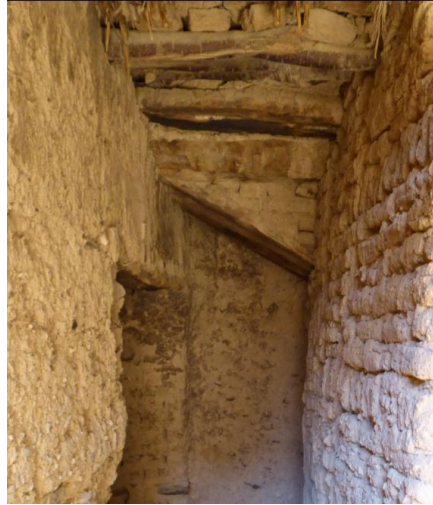
*Figure 108. An example of a stair with mud brick spine wall in a ruinous house in Morocco. Like in Figure 49, the mud brick steps are put on a palm trunk base. The mud bricks have now degenerated to a precarious loam slide which the author climbed up to roof (photos by author).*

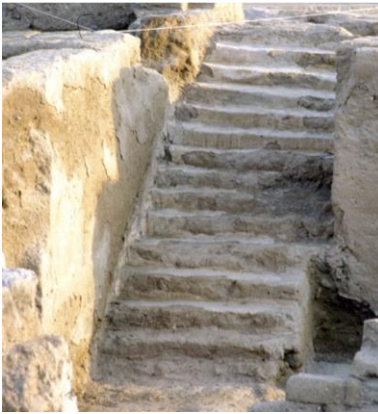
*Mud brick stairs plastered with loam plaster in the Red House of Tall Šēḫ Hamad*

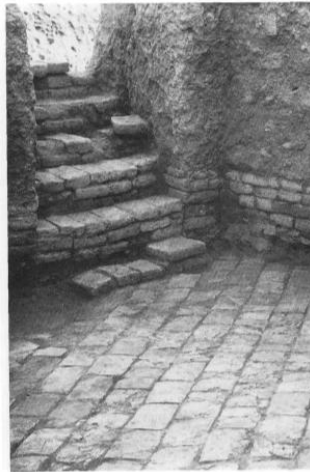
*Baked brick stairs in old Babylonian Ur, unplastered. Each step is three bricks high*

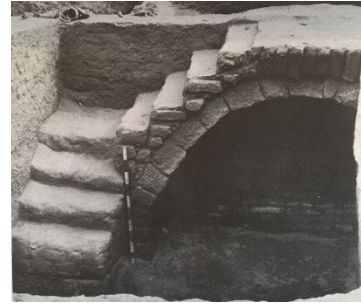
Small stairs in a house in Nippur. The single half arch is a remarkably slender construction (after McCown, 1967, Plate 48B).

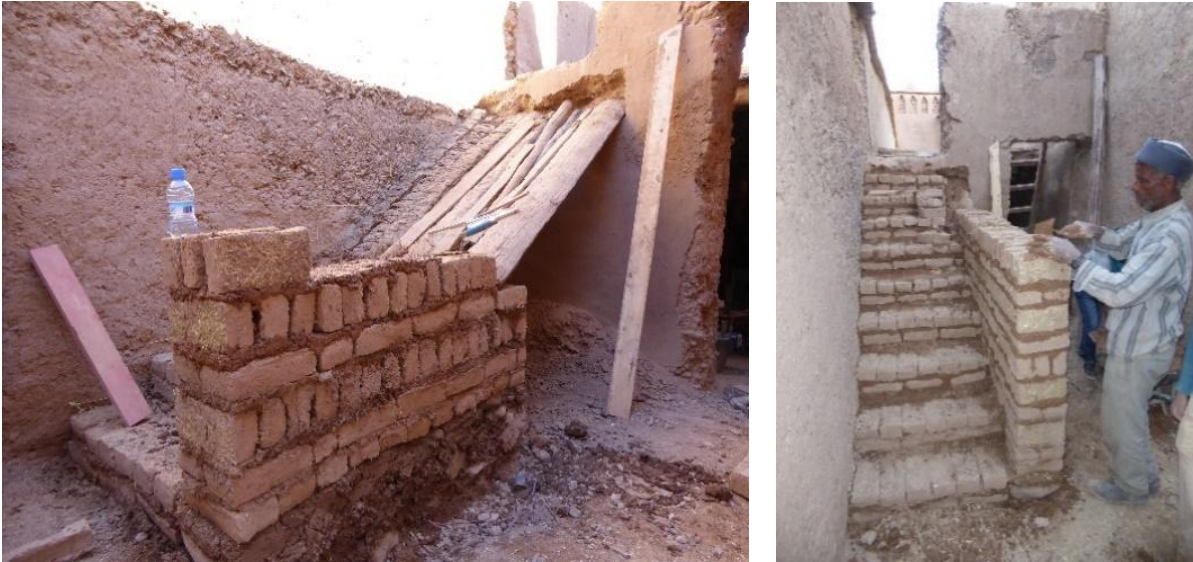
Figure 110. A stair with a solid base and retaining wall of masonry and a timber superstructure under construction in Morocco. It was constructed in just over one day by a master builder and (unexperienced) assistant (photos by author).

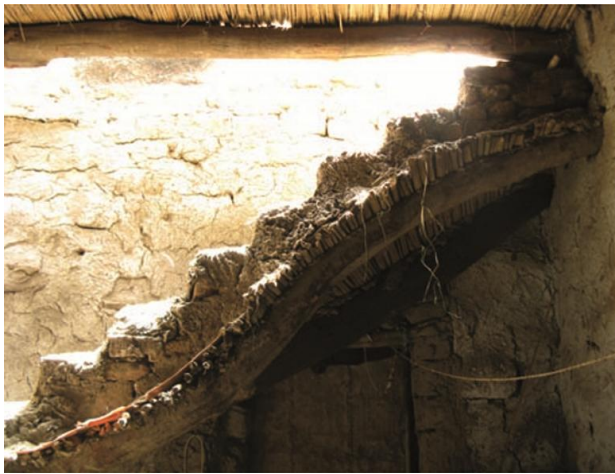
Figure 111. A variation on stair construction from Egypt. Here, just two beams form the support of the stairs, while a strong layer of reed stem mats support the mud brick steps (after Correias-Amador, 2011, p. 16).
