## **Building Assyrian society: the case of the Tell Sabi Abyad Dunnu**

## V. Constructing the *Dunnu*

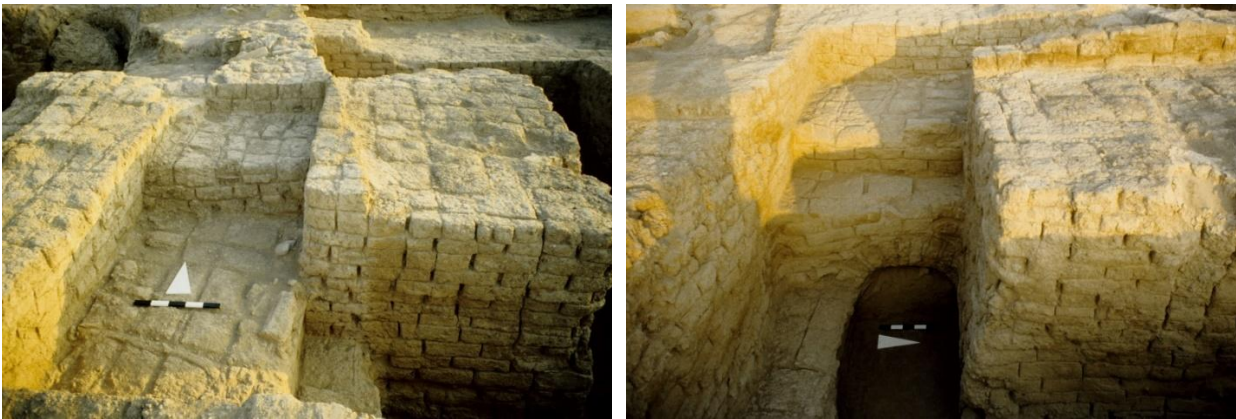
*Figure 112. The heavy revolving staircase of the central building. Left: the remains of the steps. Right: the vaulted construction that supported the steps (photo's by the Sabi Abyad excavation project).*

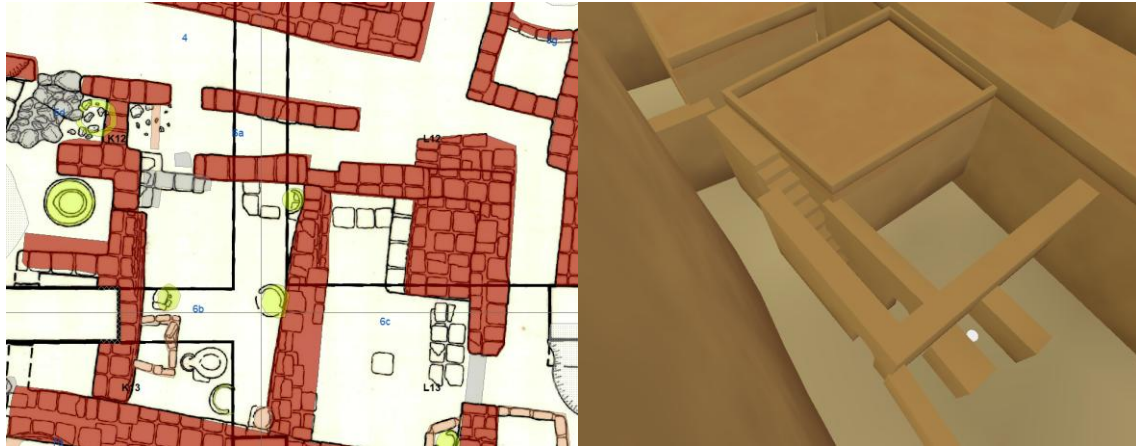
Figure 113. Possible location of staircase in building SW-6.

One of the two more likely cases is found attached to the north of building SW-6 (Figure 113). Another is found attached to the north of building SE-2 (Figure 114: left). Just to the west of the former, we find another potential candidate for a staircase against the eastern side of building SE-1. This case is however less certain. A narrow, elongated space is found here between the building and a single wall that seems otherwise to have no clear function. However, it does seem that if here was a staircase, it would belong to

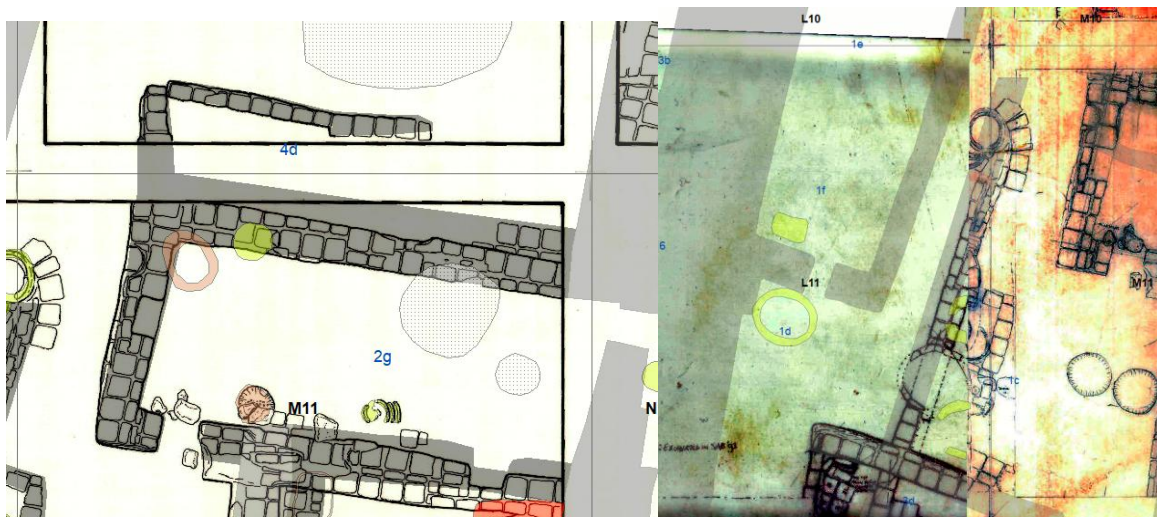
Figure 114. Two potential locations for staircases, judging from the elongated nature of the space. Left: north side of building SE-2. Right: In between building SE-1 and a separate stretch of wall without further apparent function.

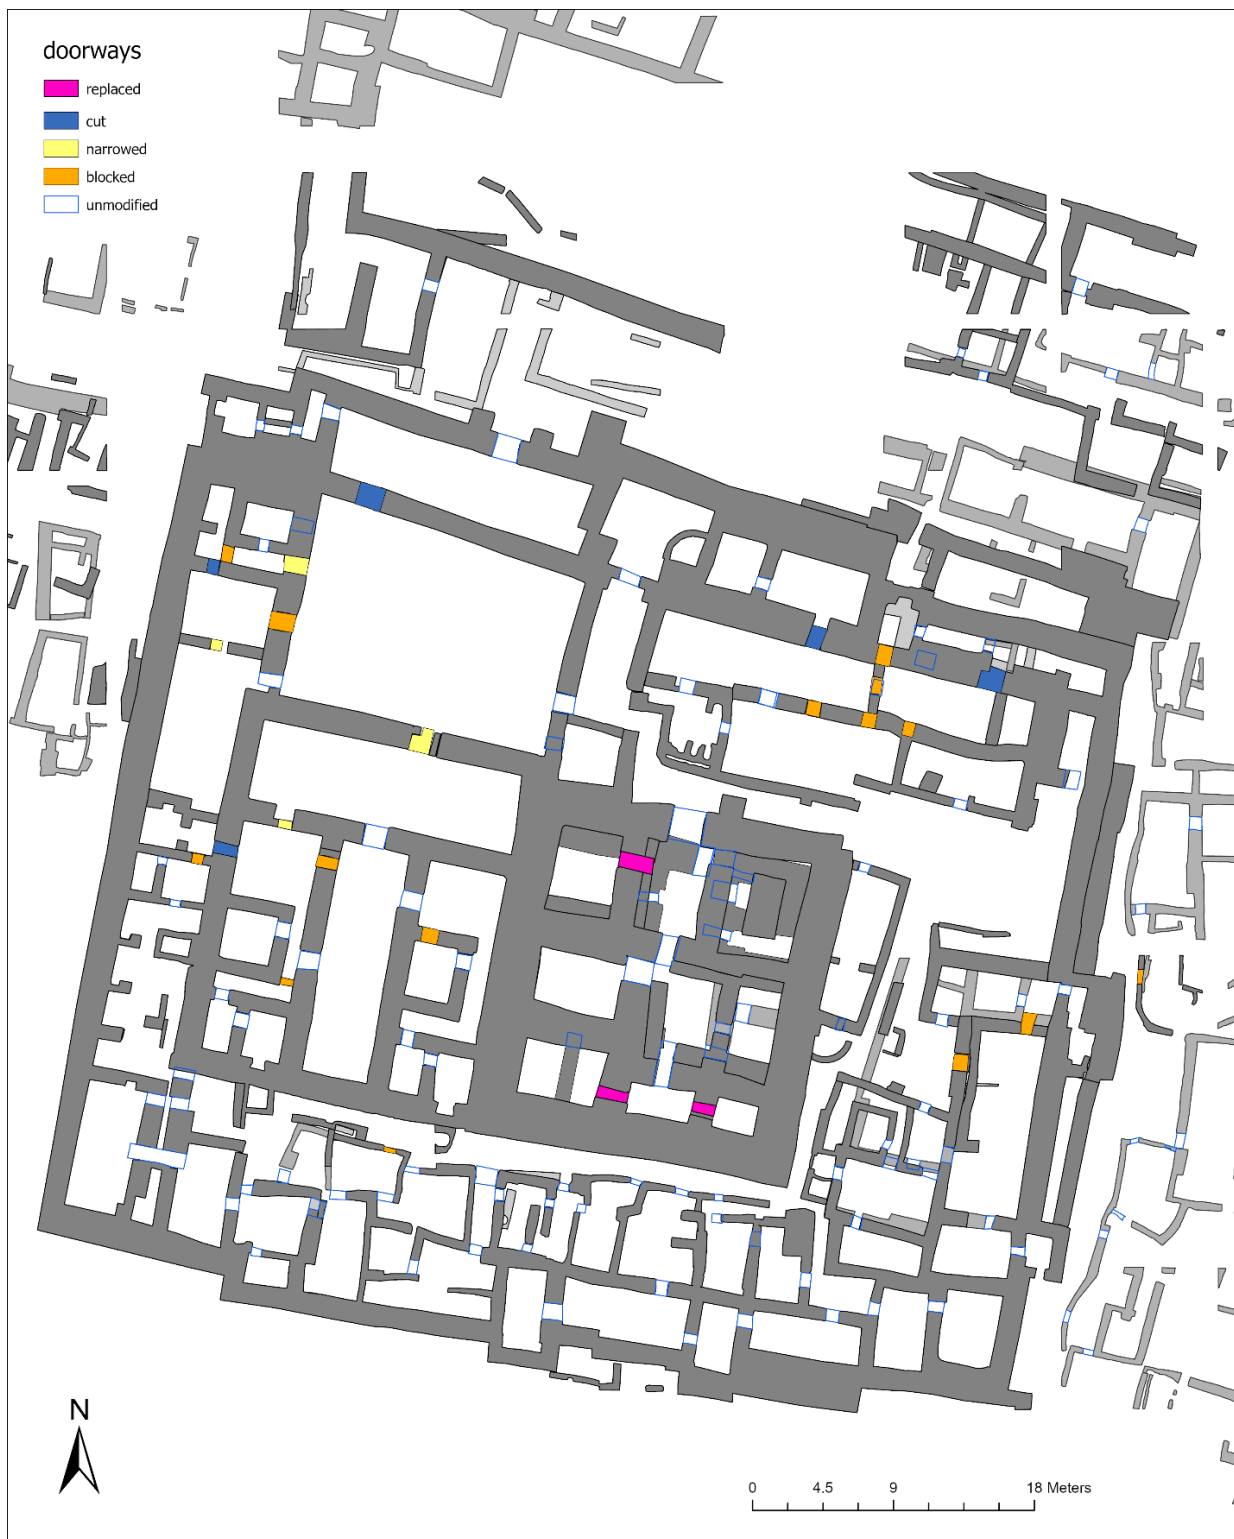
Figure 118. Plan showing various types of doorway modification.

The cutting of an opening for a new doorway in existing walls may be recognized in several ways. The first is that the end-bonding of the jambs may show unusual brick sizes, supposedly created by the cut at an odd location. Also, the cutting activity may have caused an irregular face of the door jamb. Both are problematic in terms of archaeological detection, as the sides of doorways are often damaged by erosion and building collapse. A second characteristic is the presence of a bonded threshold. In buildings of the *Dunnu*, generally, the bottom of doorways possesses no threshold, and are flush with the floor surface. The presence of a bonded threshold may therefore indicate the remains of a once uninterrupted wall. In such a case, the doorway may have been cut above foundation level due to the raising of floor levels. We can however not completely rely on this characteristic, as bonded thresholds may be part of the original construction and therefore do not always indicate such a doorway was cut later. A few examples can be drawn from the data of the *Dunnu*, for instance, various internal doorways in the residence clearly possess a bonded threshold which must have been part of the original construction. However, a small exterior doorway present on the north-western side of the residence has been interpreted in the excavation reports as a later, cut doorway, while there is no good evidence to exclude the possibility that it was part of the original construction of this building just as well. There are some interesting repercussions in terms of the spatial functioning of the *Dunnu*, and the hypothetical functional role of certain areas, as a result of how one views the construction of this doorway, that will be discussed later. On the other hand, unbonded thresholds, that were thus constructed after the creation of the doorway, may indicate the doorway was cut at a later point in time. However, it may also be indicative of an approach to construction that involved putting in the threshold last.

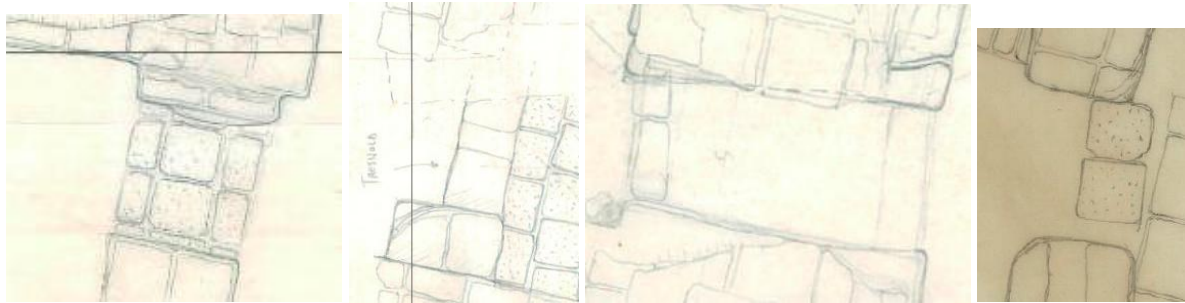
Figure 121. Different threshold constructions in the Dunn. 1: full width of wall, bonded with jambs. An example of a neatly constructed one in the residence. 2: Consisting of two baked tiles with some space between, probably a gutter for drainage of the main court. 3: Bricks on their sides applied on both ends of a doorway, which functioned as small retaining walls for a loam fill in the middle. 4: two bricks without special features.
