## **Building Assyrian society: the case of the Tell Sabi Abyad Dunnu**

## VI. Architectural analysis

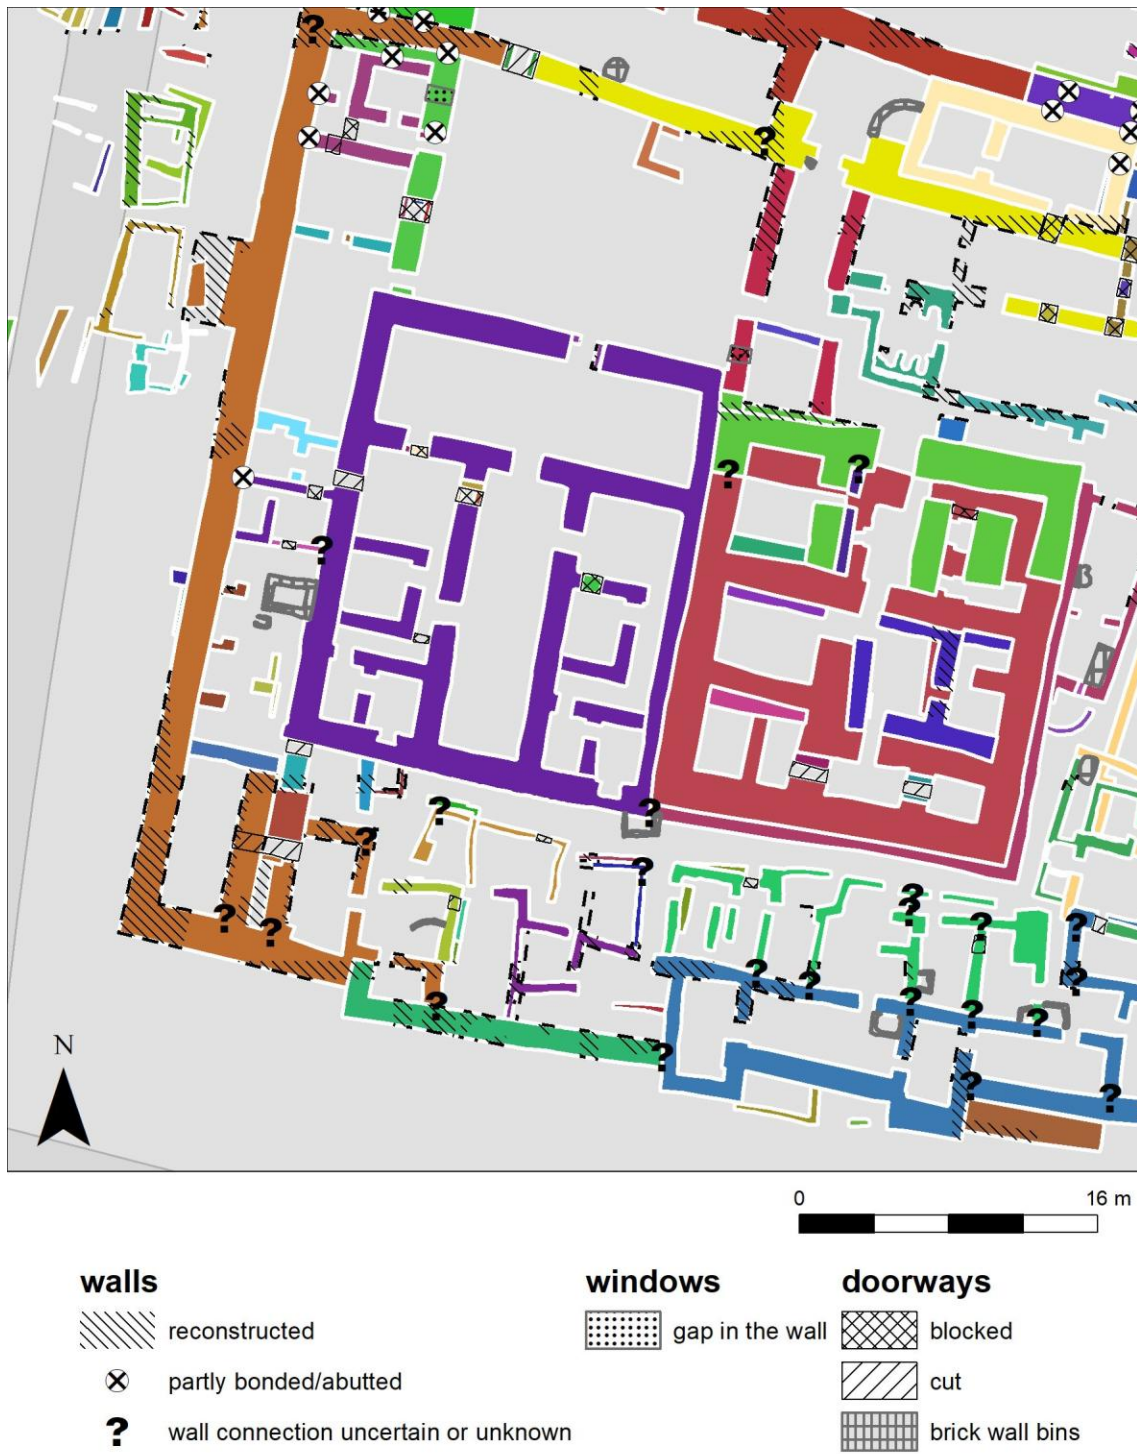
Figure 129. Construction units south-west.

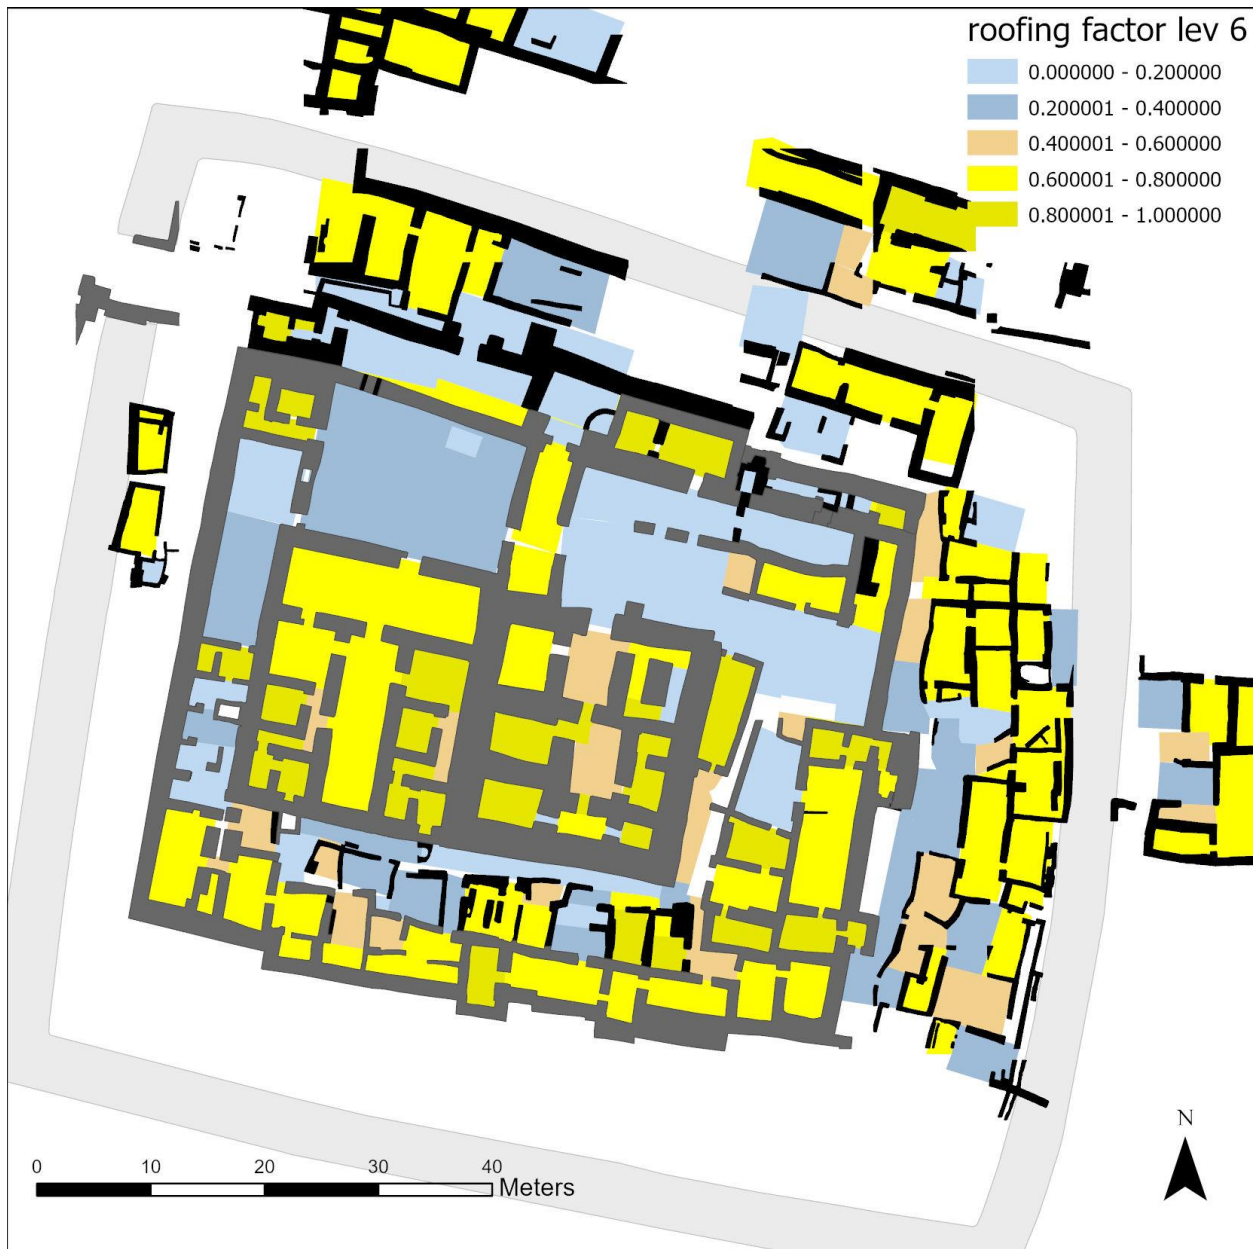
Figure 144. Roofing factor.

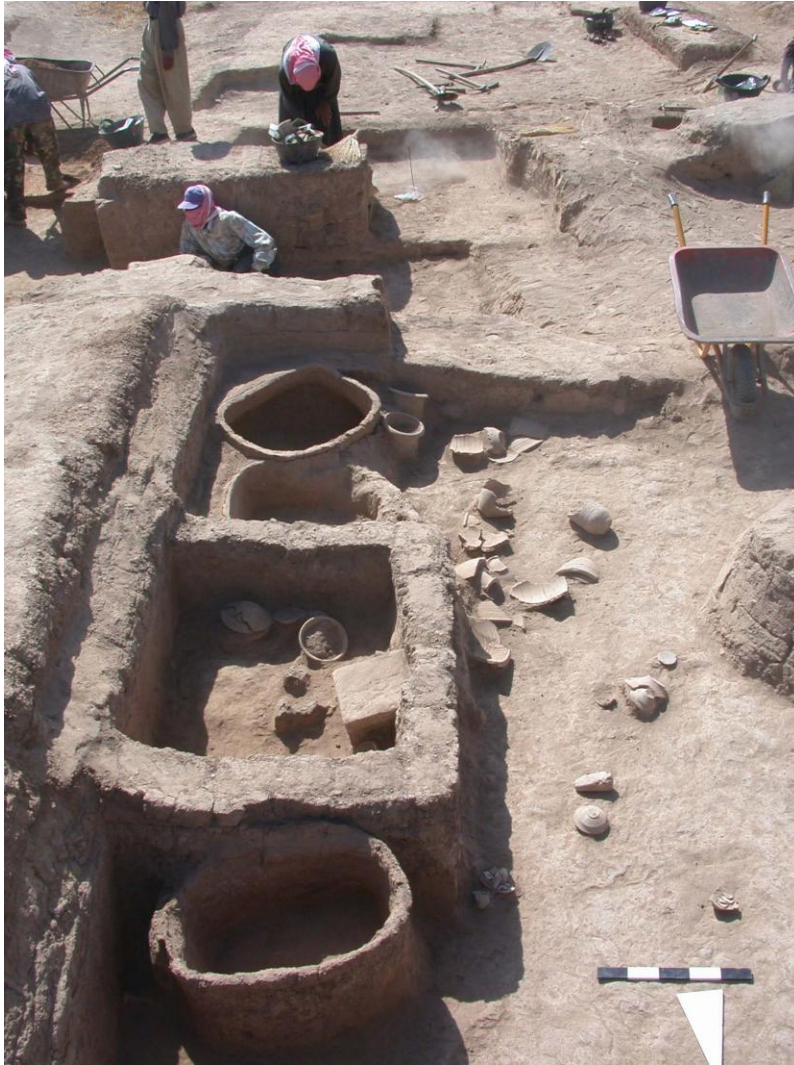
*Figure 179. A row of four bins at the large space behind the postern gate. The three smaller are hand modelled clay or loam structures. The large bin is made of mud brick. Note its similarity with the bins shown on figure 178 (photo by P. Akkermans).*
