Building Assyrian society: the case of the Tell Sabi Abyad Dunnu

Lanjouw, T.J.R.

VI. Architectural analysis

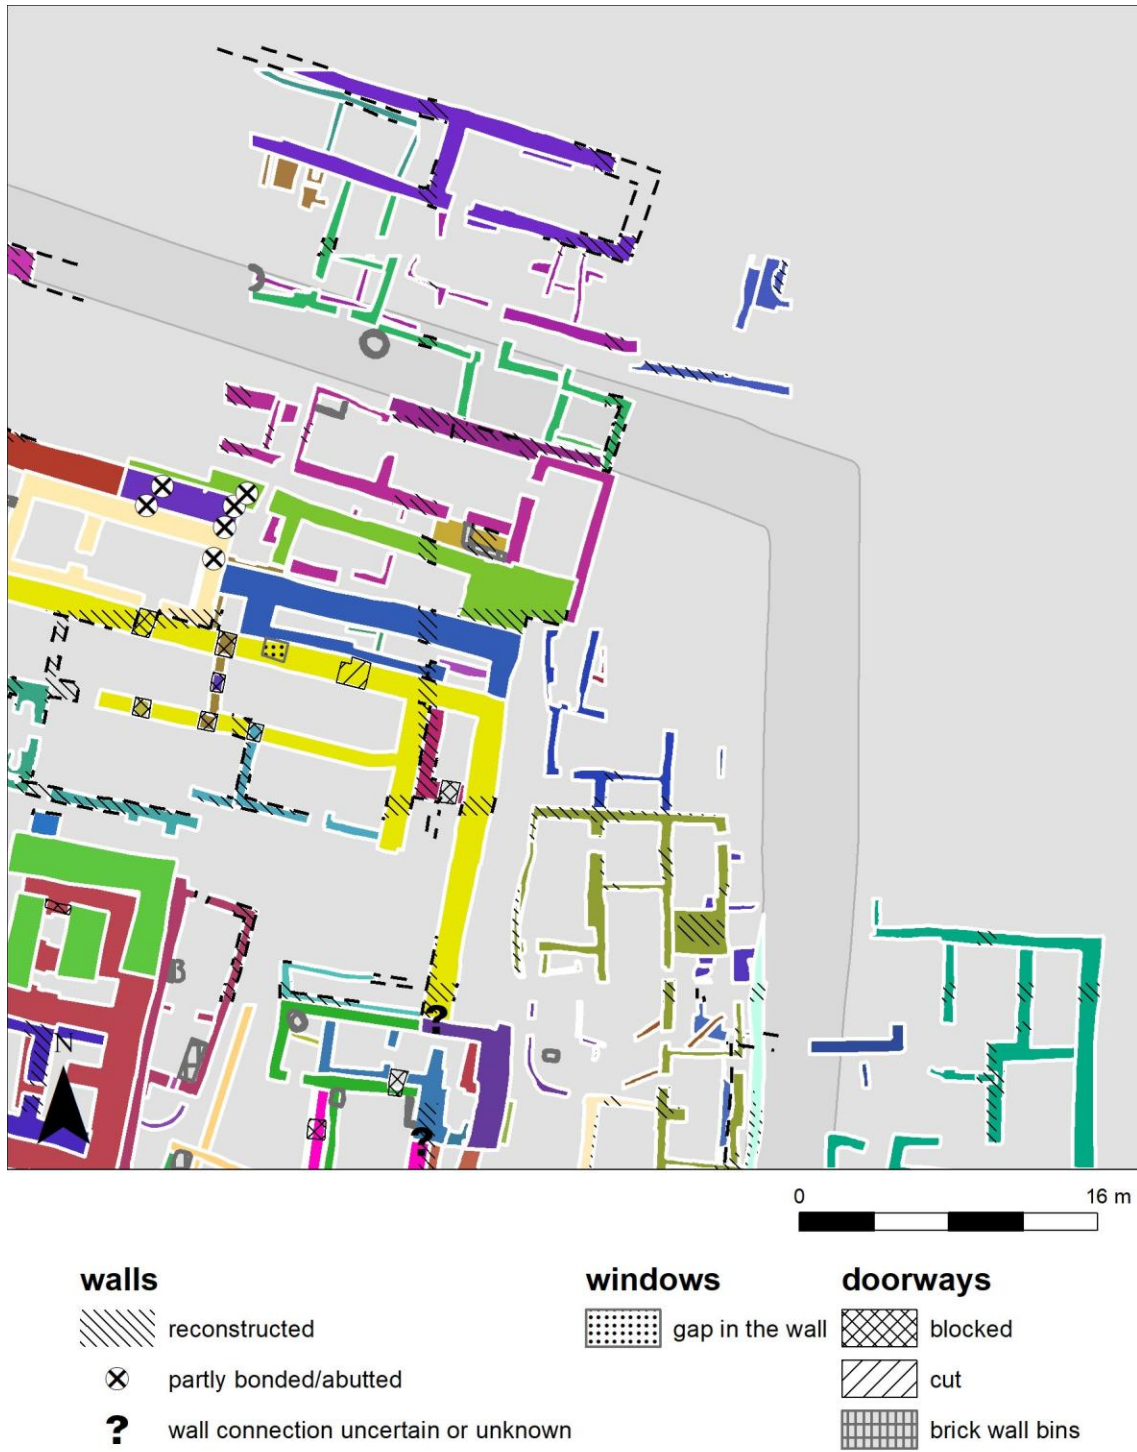
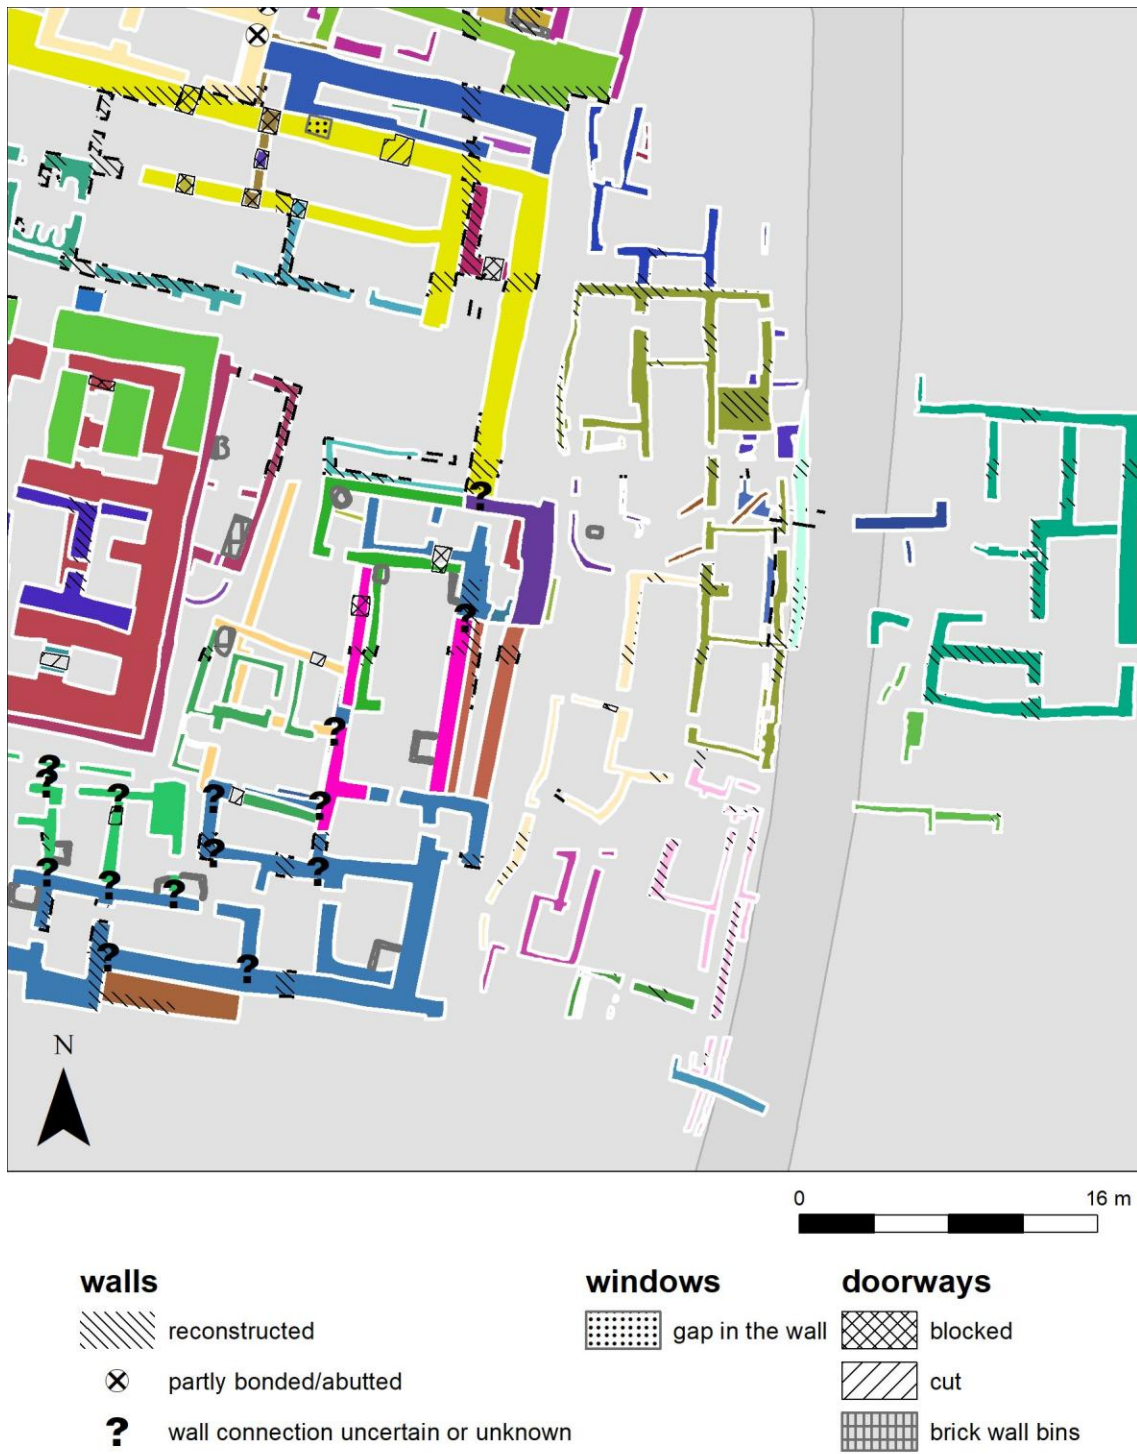
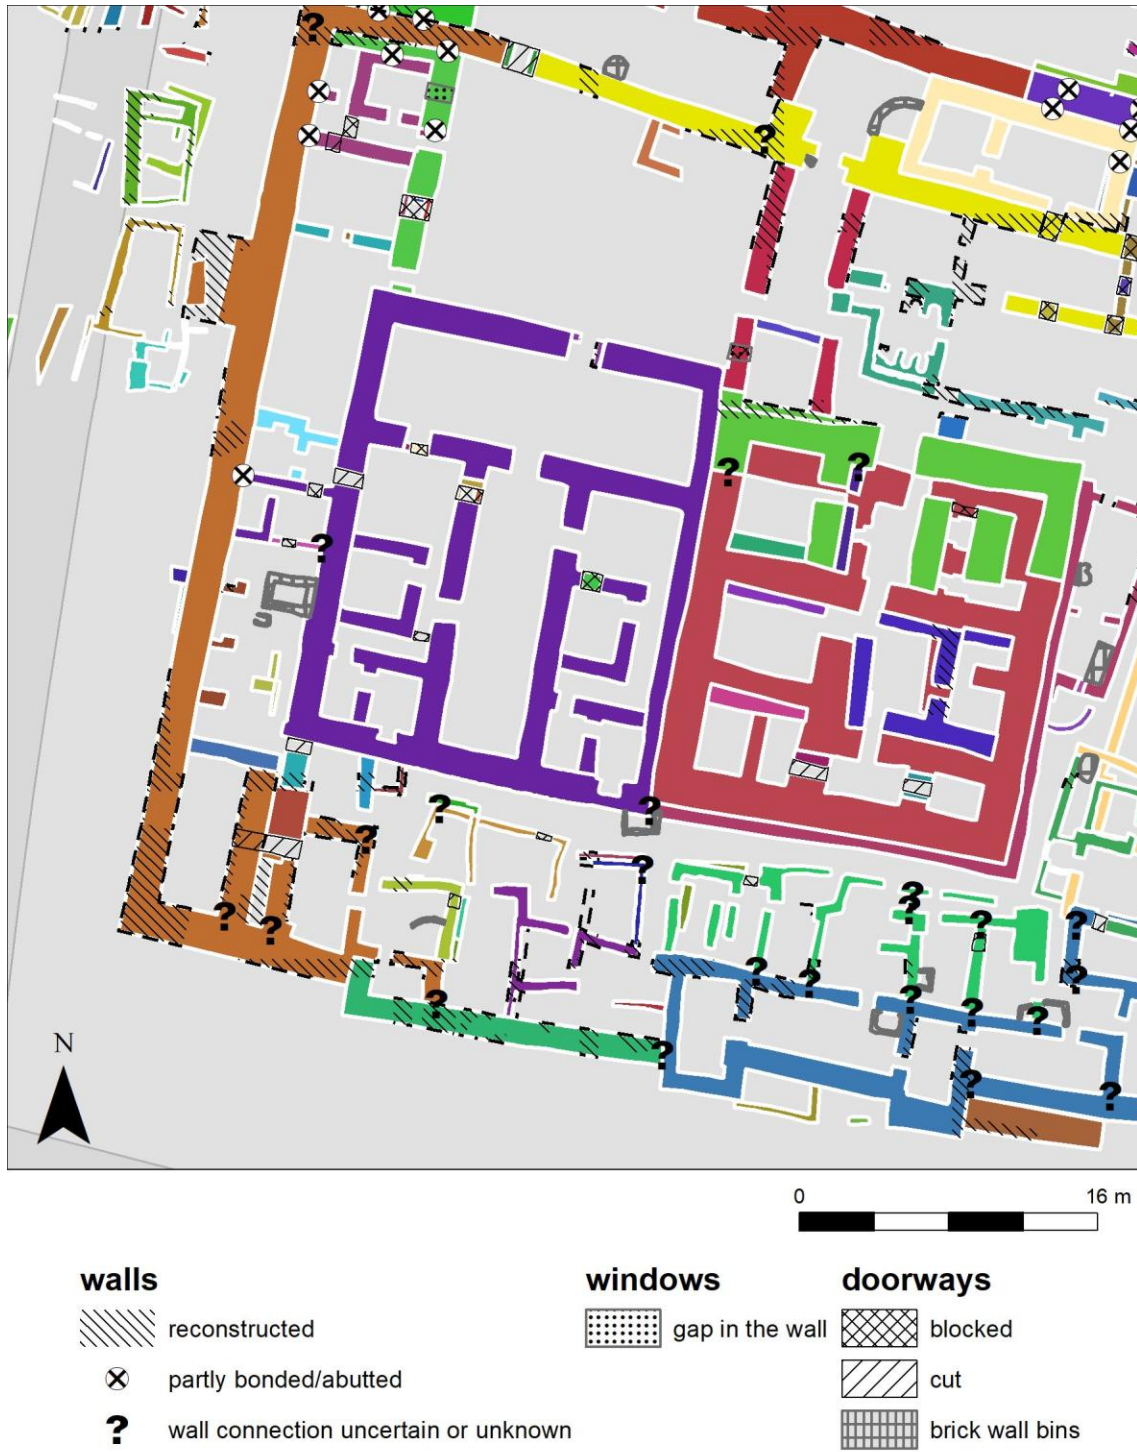
Figure 126. Construction units north-west.

Figure 127. Construction units north-east.

Figure 128. Construction units south-east.

Figure 129. Construction units south-west.

The fortification wall is not displayed as a single constructional unit, even though it would be logical if most of it was: an incomplete fortification would hardly be functional. The main reason that it is cut in several separate stretches, is that at some connecting points, the structural relation between the sections is very hard to establish. Either due to preservation issues, lacking detailed documentation, or apparent later modifications, the continuity of the constructional unit becomes hard to prove. For instance, halfway the eastern fortification wall, a tower-like projection is found, which appears to be stratigraphically later than the fortification wall itself, although the documentation on its stratigraphic relations is quite inconclusive. The possibility of such a later insert, in addition to other evidence for fortification modification in this area, creates large gap in the continuity of this structure. So, in this case it was chosen to split the north-eastern and south-eastern sections of fortification wall, although the contemporaneity of their original construction is still likely on logical architectural and defensive grounds.

The entire western section of fortification wall has also been assigned a separate constructional unit, but in this case, its apparent constructional separation could indeed be indicative of a later addition. The factors contributing to this notion are the orientation shift in the south and north, its heavier construction (4.5/5 bricks versus 3-3.5 elsewhere), its abutment to the southern fortification wall, and its placement on a different foundation layer than the southern fortification wall. This conclusion is however far from certain, as the interpretation of architectural contexts is inconclusive due to challenges presented by the archaeological record. In addition, its specific architectural features can also be explained otherwise: a difference in alignment may be the result of local topography, while the increased thickness may also indicate that on this side, the fortification wall was constructed higher than elsewhere. The latter would make sense in view of the fact that this would have been the side that visitors would see as they made their way across the fosse towards the main gate. In addition, the presence of the elite residence clearly marks this side of the *Dunnu* as the administrative and representative side. It may therefore be argued that this wall was constructed to impress, rather than explaining its unique features by being a later addition. Nonetheless, the latter may still also be the case. Hence, regardless the ambiguity of the reasoning and resulting conclusions, the wall has been assigned its own constructional unit.

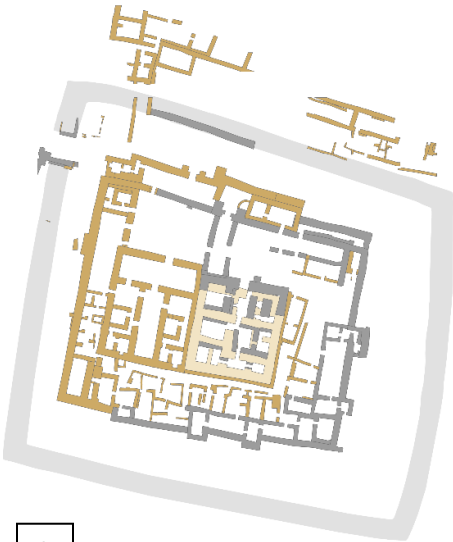
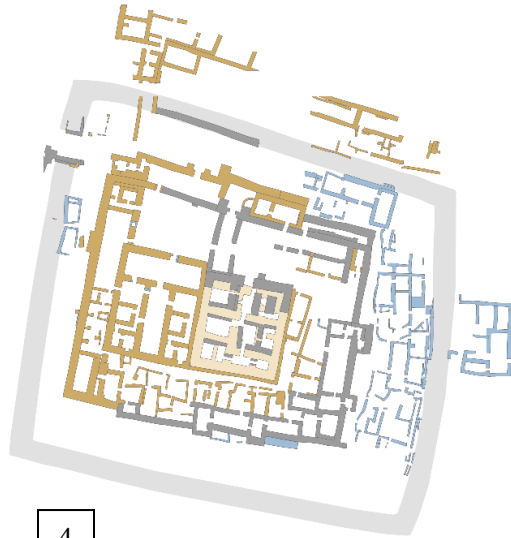
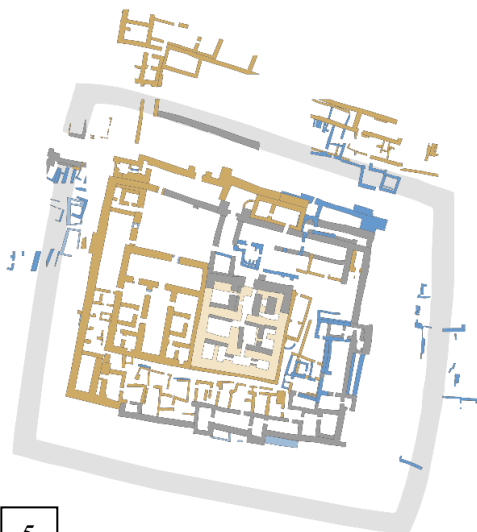
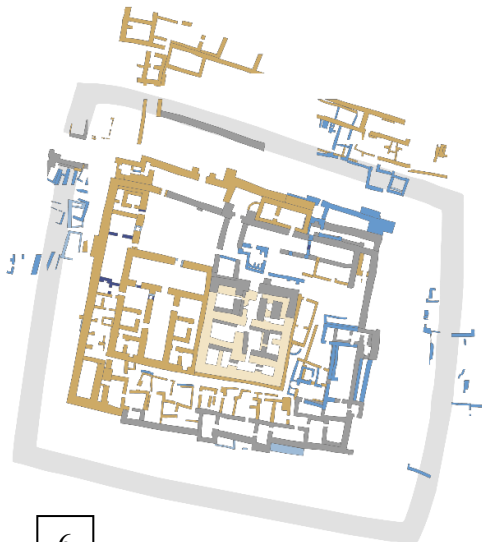
Figure 130 (previous page). Alternative site phasing. This is just one of various options possible.

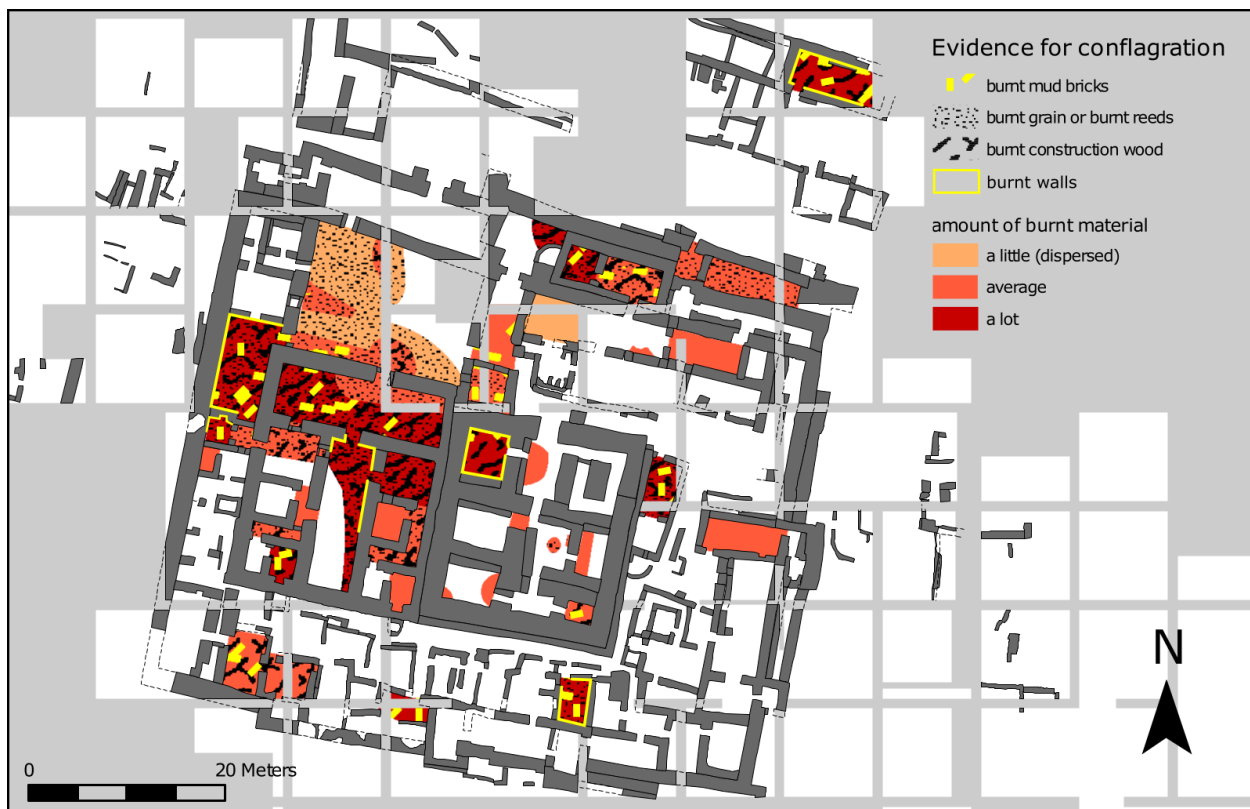
Figure 135. Recorded evidence for burning, burnt construction wood and reed impressions in the lower fill of level 5 spaces.

Direct material evidence for roofs may be in the form of burnt construction elements such as beams, reed cover or loam deck. As there was a fire that ended the *Dunnu*'s primary use phase, roof elements could potentially have been preserved. The distribution and nature of burnt deposits and features dating to this phase is displayed on Figure 135. Unfortunately, evidence for burning often includes just high concentrations of pieces of charcoal or grains, which is hard to link to roofs. Larger fragments that could potentially be identified as structural wood are rare, and never of a thickness that matches heavy beams. Nonetheless, as fuel for burning, the timber and reeds used in roof construction would have been the most readily available material (aside from remaining barley stocks, apparently). It is possible that remaining unburnt and partially burnt construction timber was later, taking the direct evidence away from our view. This scavenging activity, clearly evidenced by the post fire pillaging of materials in the large courtyard, would also have resulted in the presence of roof material in places that would not have been originally roofed, such as the large courtyard. As a result, with these caveats in mind, the map of Figure 135 can only be viewed as a very rough and incomplete indication of roofed area.

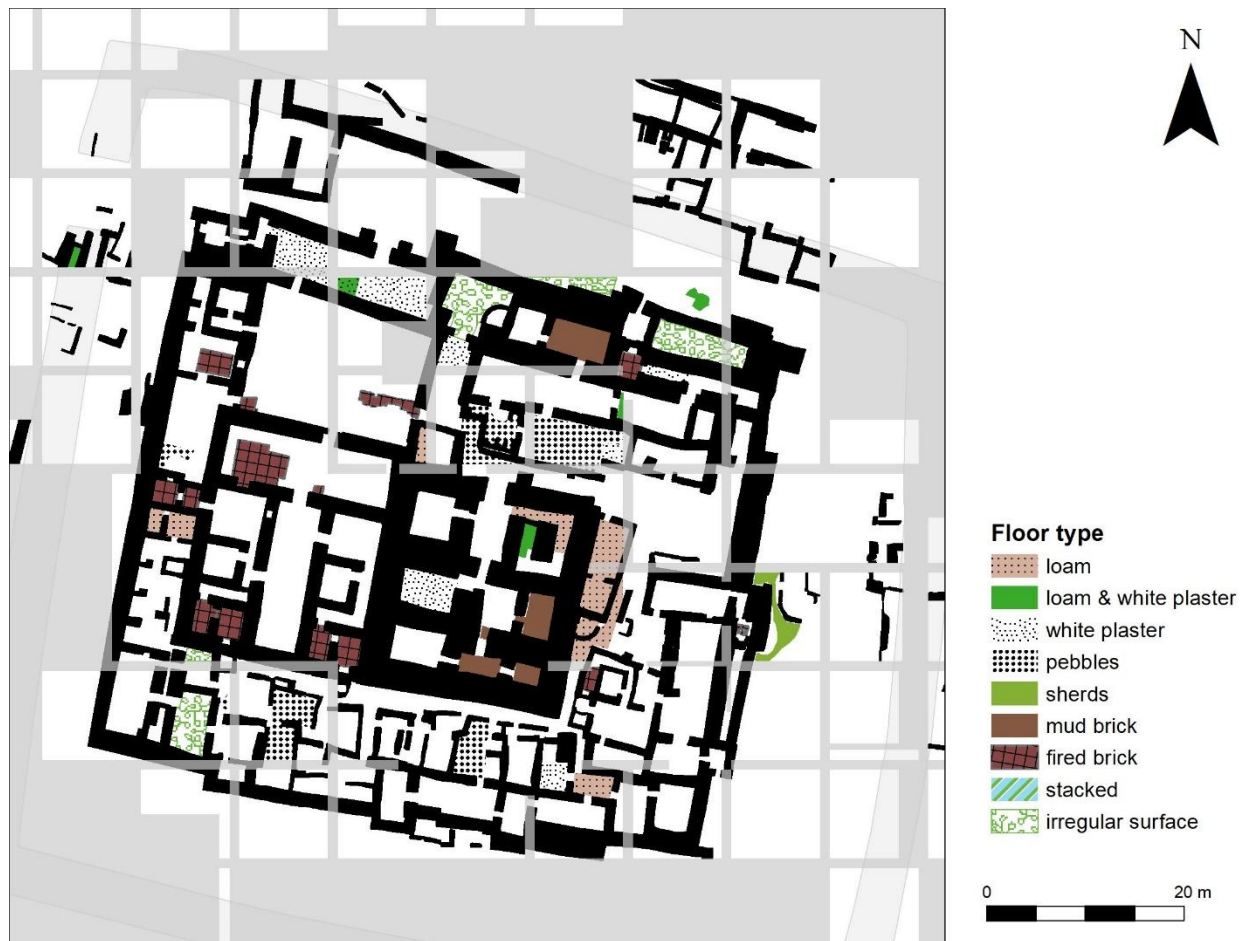
Figure 142. Recorded surface characteristics in the Dunnu.

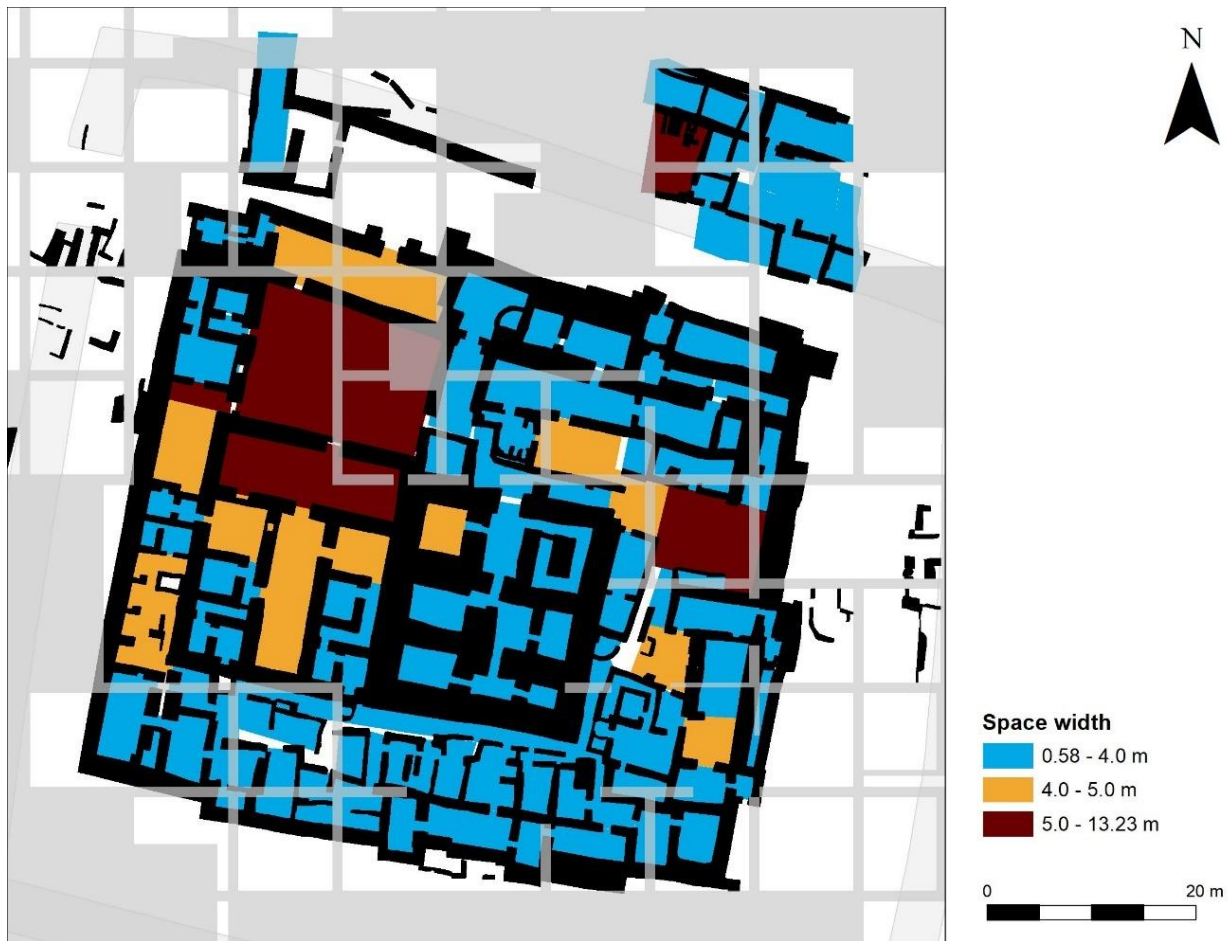
Figure 143. Width of spaces in the Dunnun.

Figure 143 below shows the width of each space in the *Dunnu*. This image reveals that most spaces could theoretically be roofed. Very few spaces exceed the 5-meter limit, confirming their status as ‘open areas’. Additionally, there are several spaces that fall in the 4-5 meters category. Those in the residence are interesting because on other grounds, these spaces are probably roofed. The large spans observed here, correspond to the high status that is assigned to this building. Some of the other spaces in this category are probably unroofed, while for others, this is less clear. The image also makes clear that many spaces that we would characterise as outside spaces, could theoretically have been roofed. We may consider for instance the possibility of partial roofing or creating passages across the narrow alley like spaces in the south and east. This would also allow us to take a very different perspective on accessibility and circulation within the *Dunnu*.

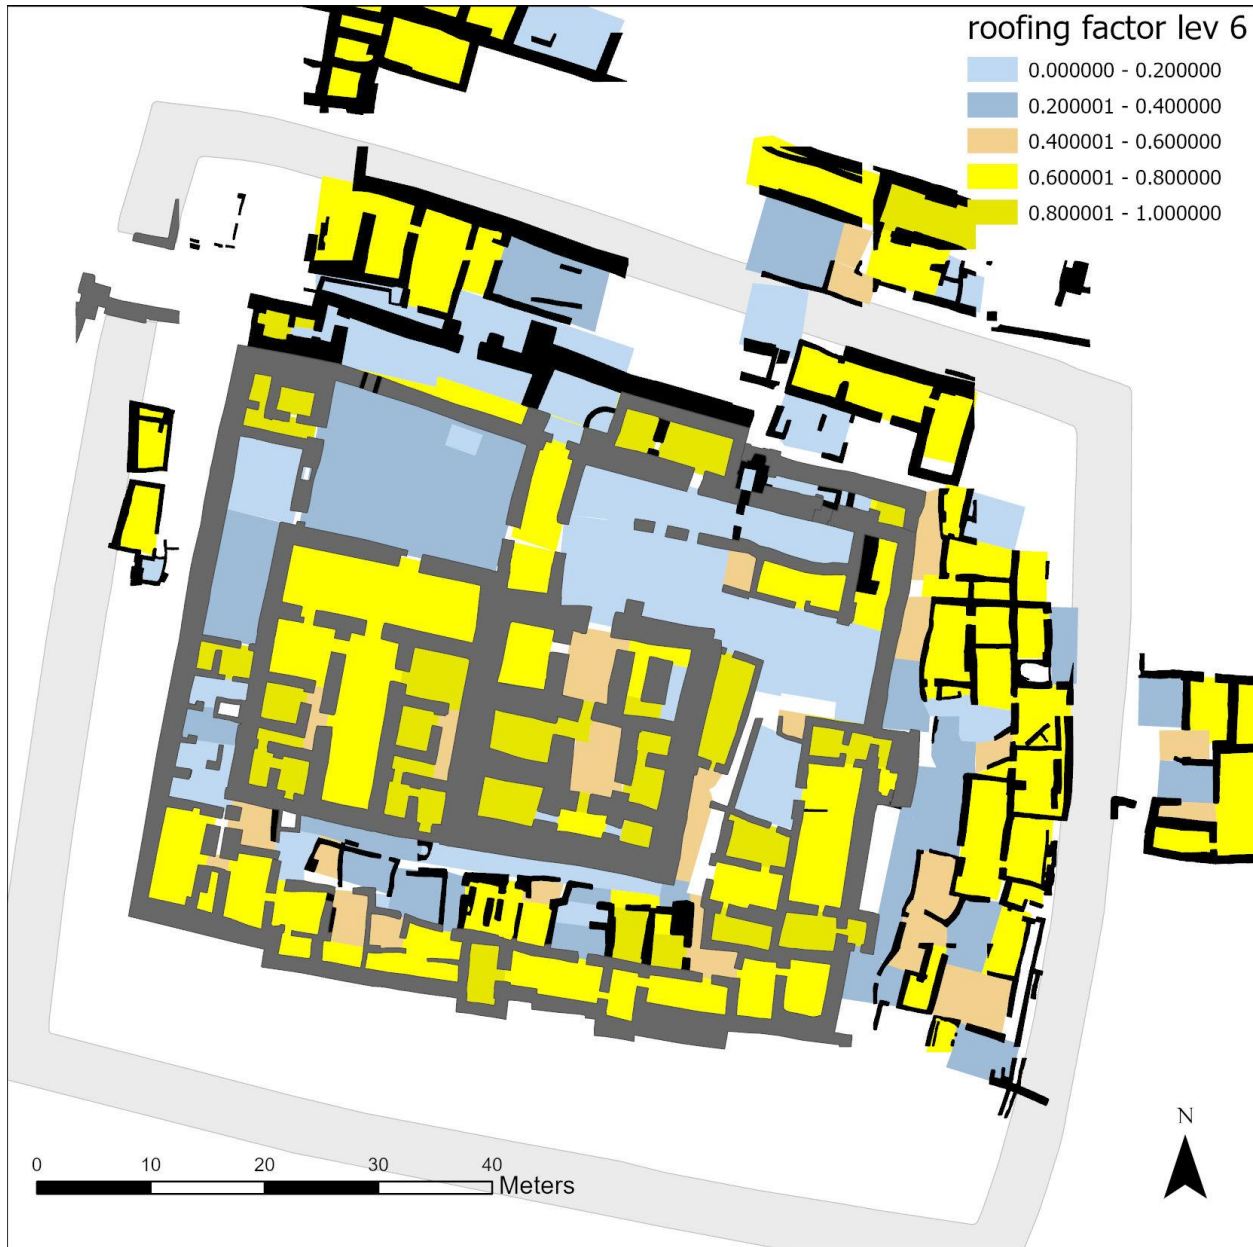
Figure 144. Roofing factor.

4. Walls on long sides: roof beams most likely placed across width of space. Requires two long opposing walls over entire length of space. 1 point for two opposing long walls. 0.5 point if one long wall is missing, but room is short enough to be roofed across its length ($< 4\text{m}$). 0 points if neither is the case.

5. Building plan shape: is it conceivable considering the form of the plan to roof the area? Very irregularly laid walls, or diverging walls cause a space to be of irregular width. These spaces are less likely to be covered with beams. Regular rectangular shape: 1 point. Diverging long walls: 0.5 point. Very irregular shape/inconsistent width.

6. Span: is it conceivable to roof the area without the use of additional support? Widths below 3.5 meters are considered roofable (1 point). Width between 3.5 and 4 meters are considered likely roofable (0.75 point). Widths between 4 and 5 are considered roofable if certain conditions are met (presence of very strong and thick timbers) (0.5 point). Over 5 meters: 0 points.

7. Character of floor: rough, irregular surfaces are more likely to be exterior spaces. Neatly laid loam or white-plastered floors are more likely found in interior spaces. Tile paved spaces (except bathrooms) on the other hand are, based on comparative evidence, more likely unroofed exterior spaces. -1 point for rough, irregular, or paved spaces.

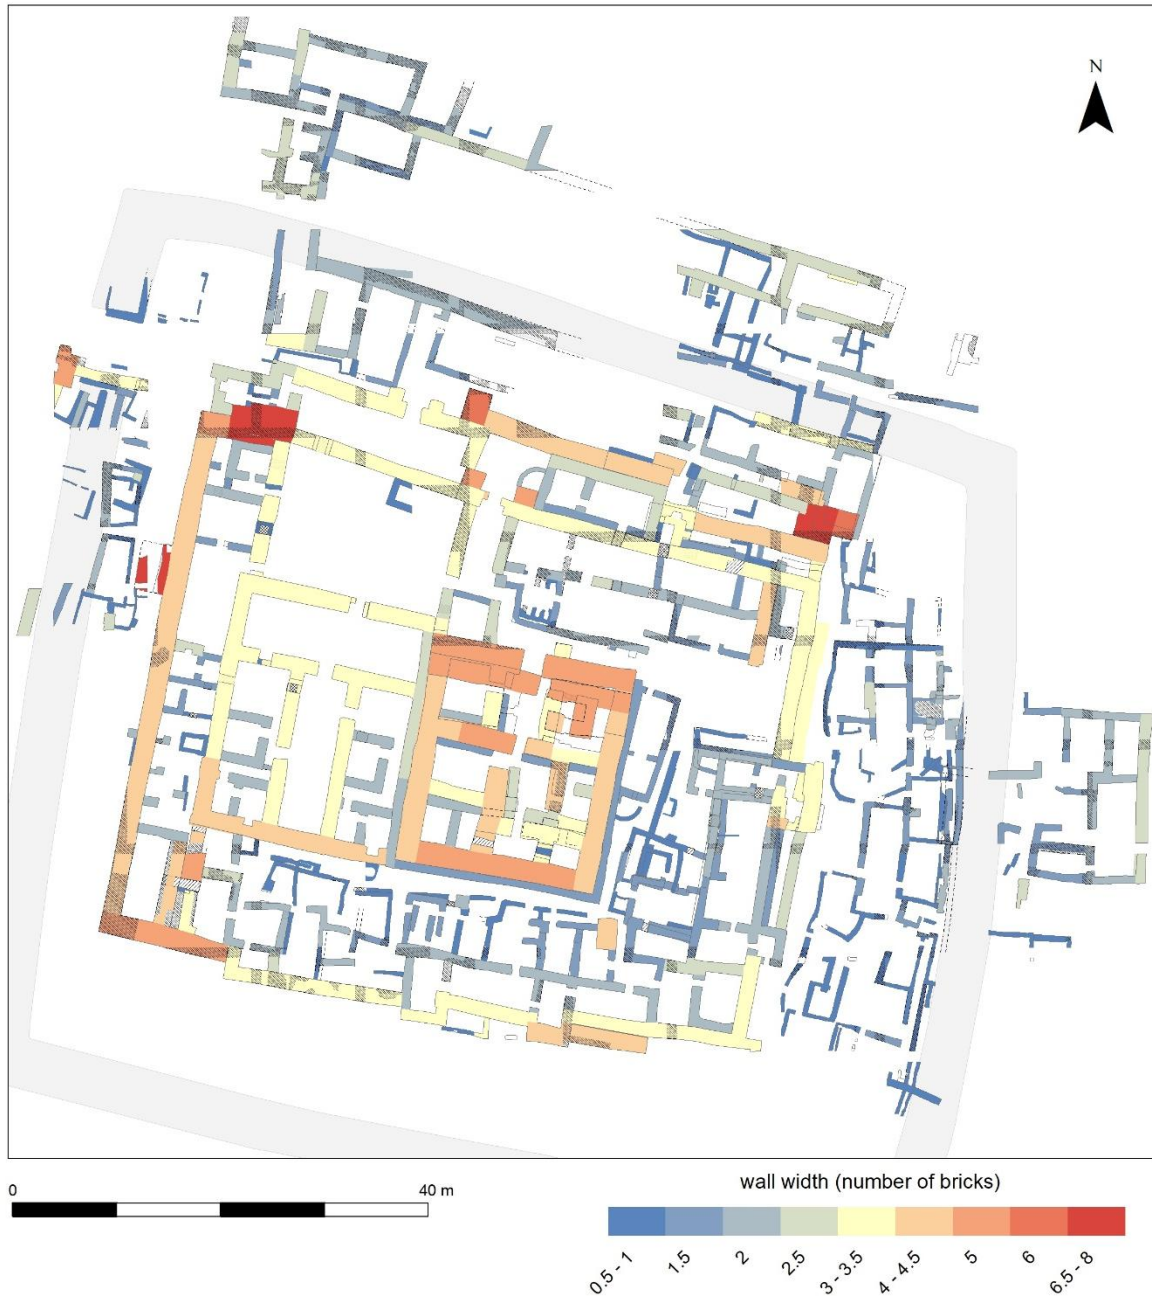
Figure 147. Widths of walls of the Dunnu.

Any of the walls found in the *Dunnu* could have been used for roofed architecture, as the minimum of 40 cm corresponds to known wall widths from traditional mud brick construction. Although in theory 40 cm mud brick walls take the load of a two-storey building, it is unlikely that they did, with the assumption that the conservative approach to construction seen in traditional village contexts is also applicable to the *Dunnu*. However, the archaeological and architectural evidence suggests that many of these single brick structures were probably open enclosures. The exceptions to this have been discussed in the section on wall construction in the *Dunnu* (V.3.7), and there are plausible structural explanations for them. As these are probably unique situations, we may propose that in general single brick walls in the *Dunnu* were used for open enclosures, or buildings with lighter roofs that were not meant for carrying live load (i.e. activity areas). In that case, 1.5 brick walls were the basis for most single storied architecture. Again, this is a conservative estimate, as this thickness (60 cm) could easily have supported two storeys. The architectural form, evidence for use and fill of these structures does indeed often suggest that a roof cover is likely.

If 1.5 bricks is the baseline for single storied buildings, any thicker walls potentially supported a multi storey structure, buildings with very high ceilings, or high enclosures. Two-brick walls are found used for several larger buildings, constructed against the interior of the fortification wall. These buildings seem to be part of the original design and planning of the fortifications. It is reasonable to assume, also in view of other archaeological evidence, that these buildings had at least two storeys. A smaller 2-brick-wall building found in the north-western corner of the *Dunnu* has various indications of being multi-storied is the structure. Here, the remains of a relatively low, vaulted ceiling on ground floor were found, which in itself

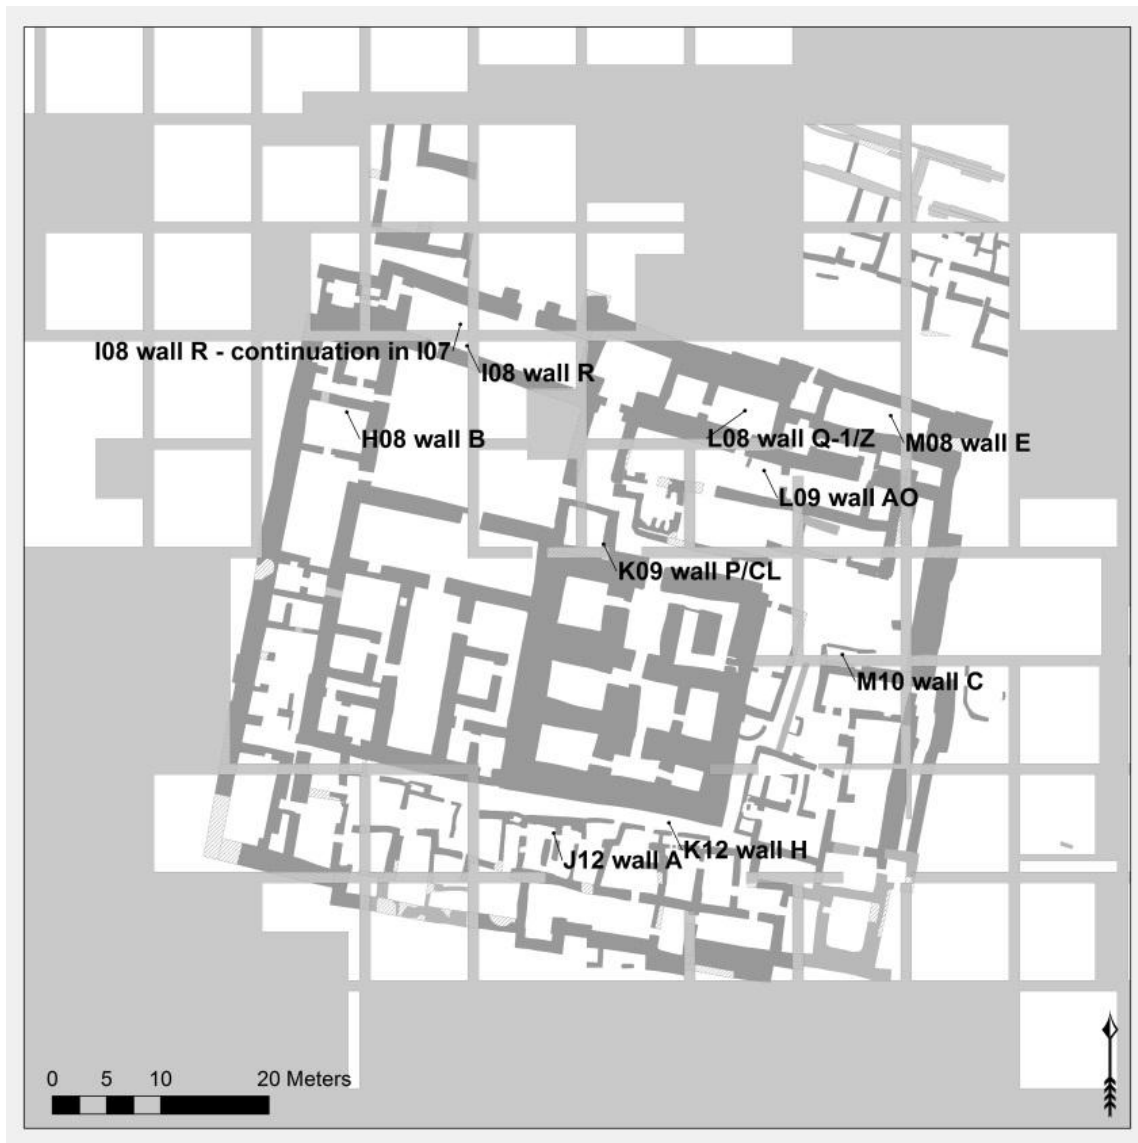
Figure 148. Locations of preserved large fragments of wall collapse.

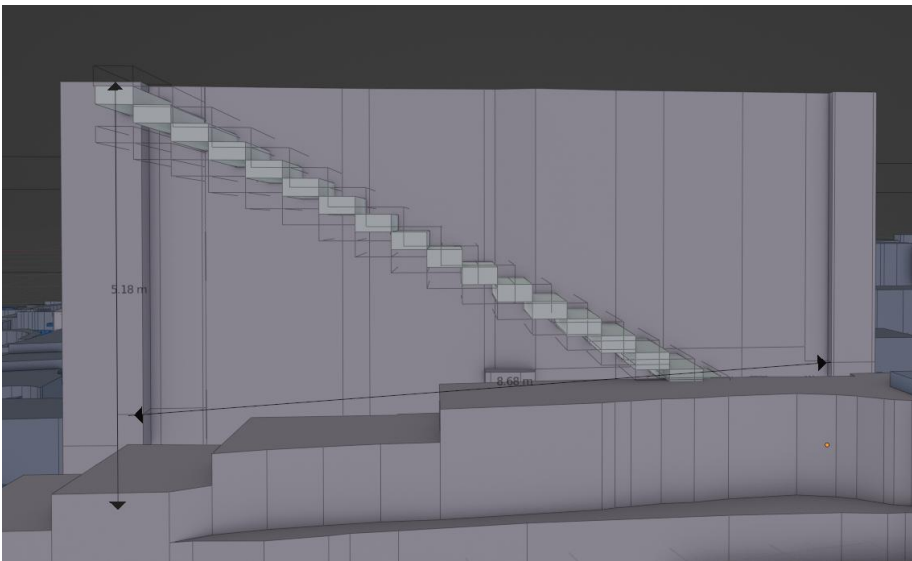
Figure 157. Visualisation of reconstruction range, using different riser and tread dimensions. The lower option has a reduced riser height (18 cm instead of 20 cm). The higher has both an increased riser height (22 cm) and tread length (42 cm).

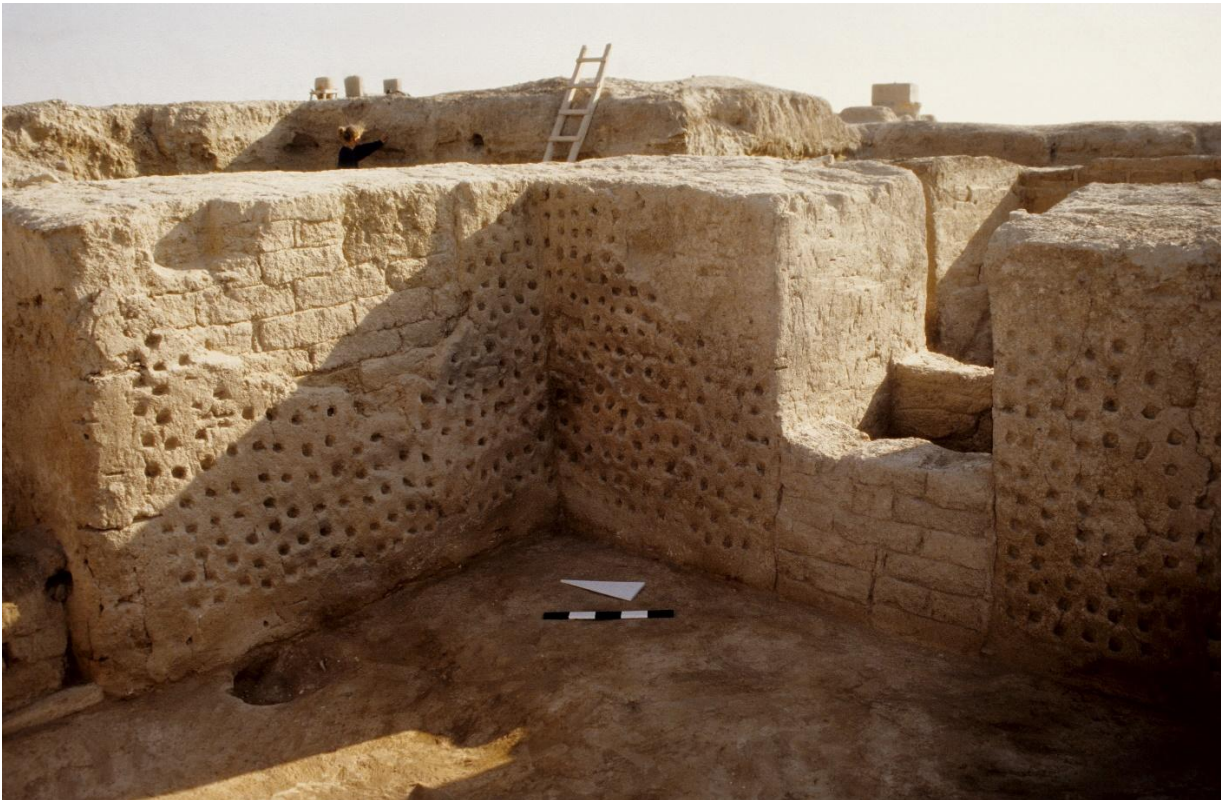
Figure 164. Windows or doorway blockings in residence room 2a (photo by Peter Akkermans).

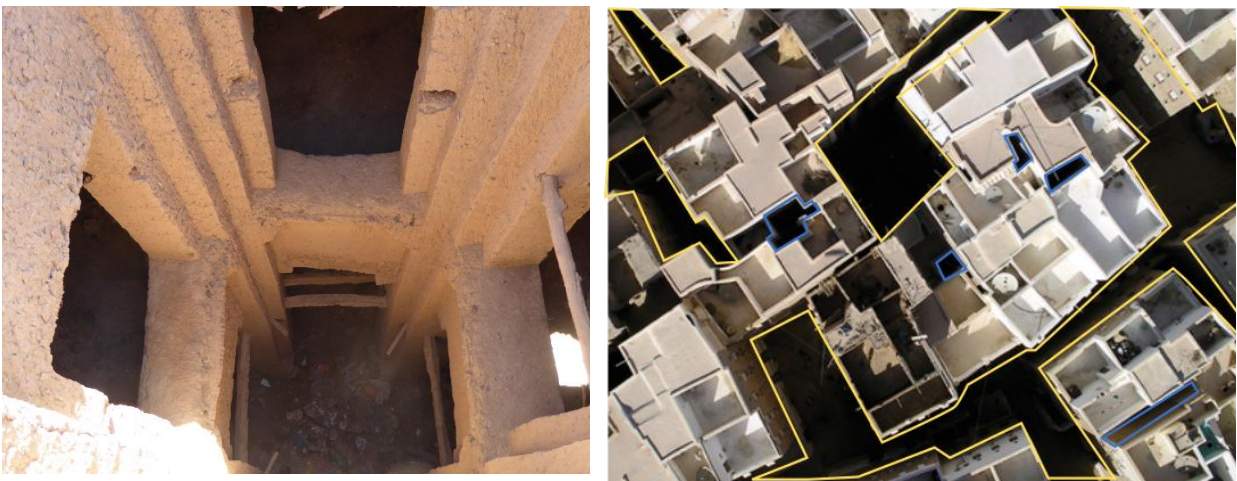
Figure 168. Air and light wells in recent architecture. Left: small central courtyard or light well in an abandoned town house, southeast Morocco (photo by author). Right: City of Shibam, Yemen. Lines indicate where light and air wells are placed. Yellow are public spaces (small squares, alleys), blue are internal light/air wells or small courtyards (photo: Shibam Urban Development project, <http://archnet.org/sites/5215>. Lines drawn by author).

A consideration of air and light has influenced the reconstruction of ancient palatial complexes, most explicitly so in the work of Margueron (1982, 1996, 1999a). From the study of these palaces, we may derive two main ways that access to light and air was guaranteed. The first is the use of light shafts or wells. These may take many different forms and sizes, from small shafts to entire light corridors and larger courtyards. A second strategy was probably used for spaces that are entirely enveloped by other roofed spaces. In such cases, varying the elevation of the roofs would create some space for clerestory windows at the top. Even before Margueron's formal formulation of this approach for reconstruction of these buildings, varying the heights of roofs was a common feature of architectural reconstructions of excavated palaces (figure 169)⁶¹. The elevated roof is a feature also frequently seen in reconstructions of archaeological building plans that have a tripartite main structure. In this building class, an elongated middle space is often bordered by groups of spaces on its long sides. To get additional light and air in this space, an elevated roof is often conjectured to be part of this architectural type (Figure 170).

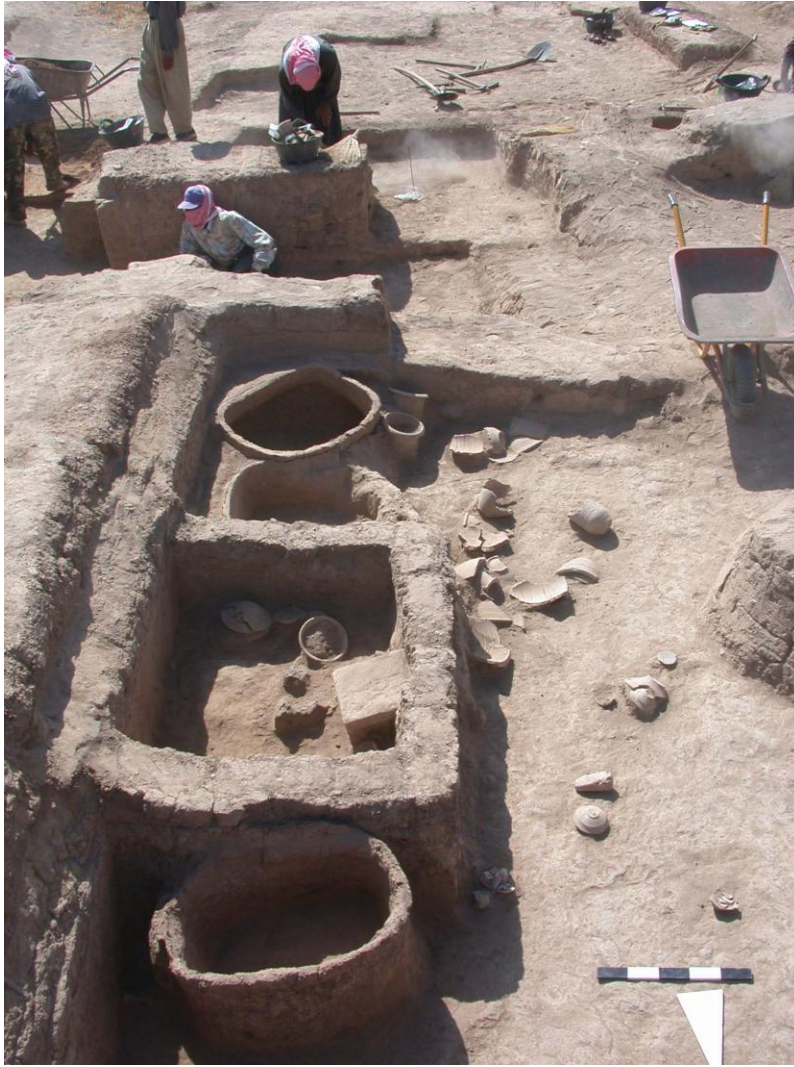
Figure 179. A row of four bins at the large space behind the postern gate. The three smaller are hand modelled clay or loam structures. The large bin is made of mud brick. Note its similarity with the bins shown on figure 178 (photo by P. Akkermans).

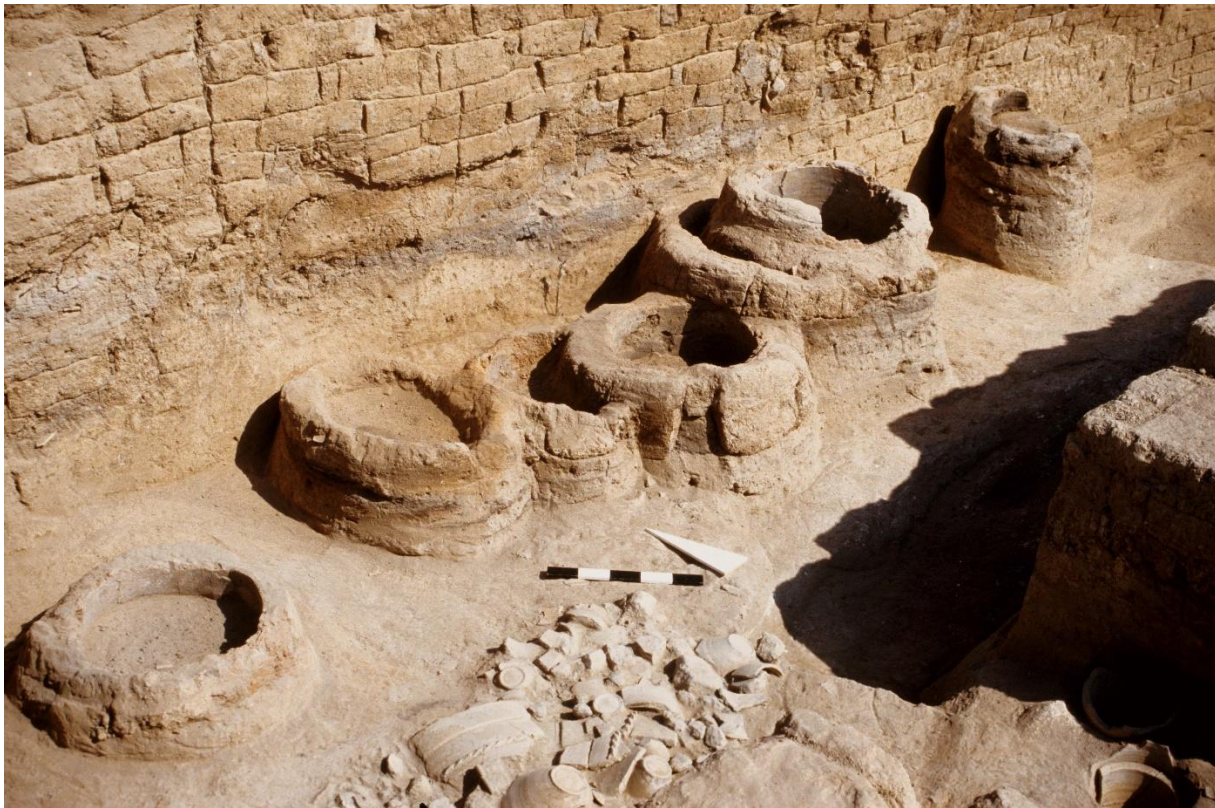
Figure 182. Tannurs located in the alley against the back wall of the tower. Very little room was left for people to maneuver (photo by P. Akkermans).

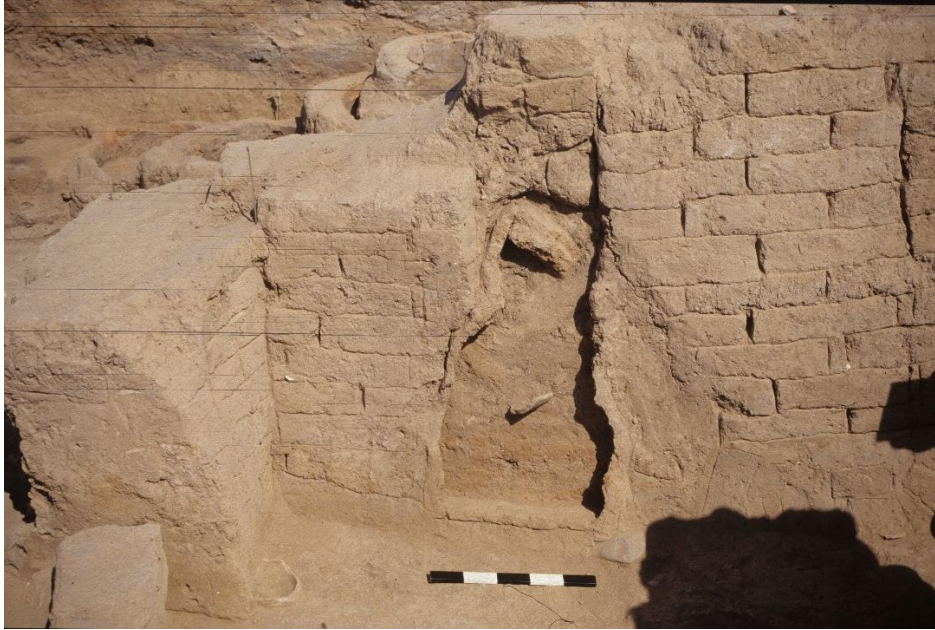
Figure 183. Oven integrated in the wall in space SW-6a (photo by P. Akkermans).

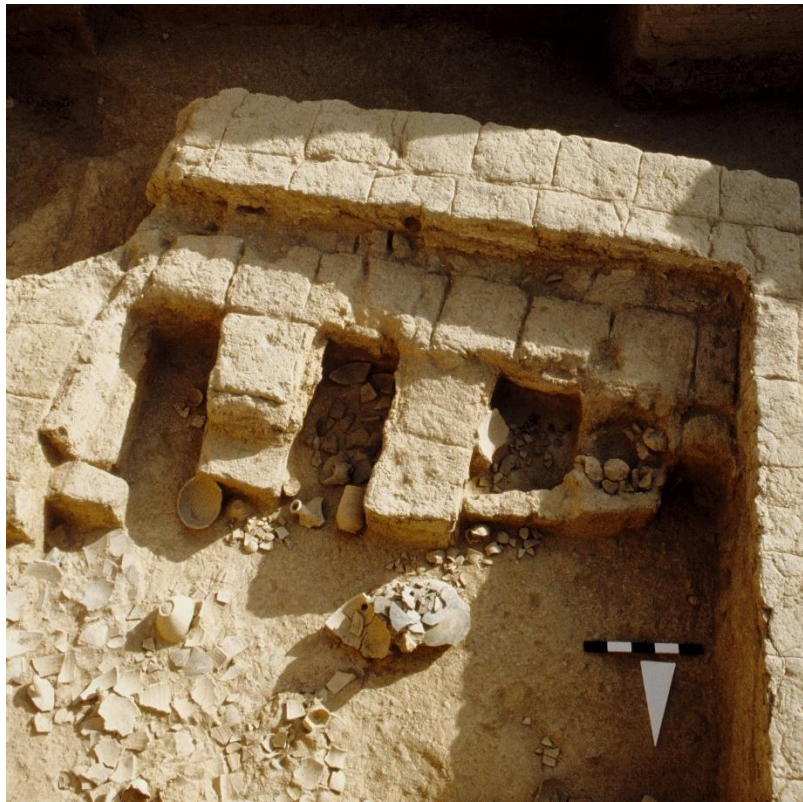
Figure 184. A row of three or four fireplaces integrated in the architecture in space NE-9c. These are simple stoves that could hold large pots above a fire. There is a cavity in the wall, plastered on the inside, which may be a kind of chimney, or simply point at an architectural modification (photo by P. Akkermans).

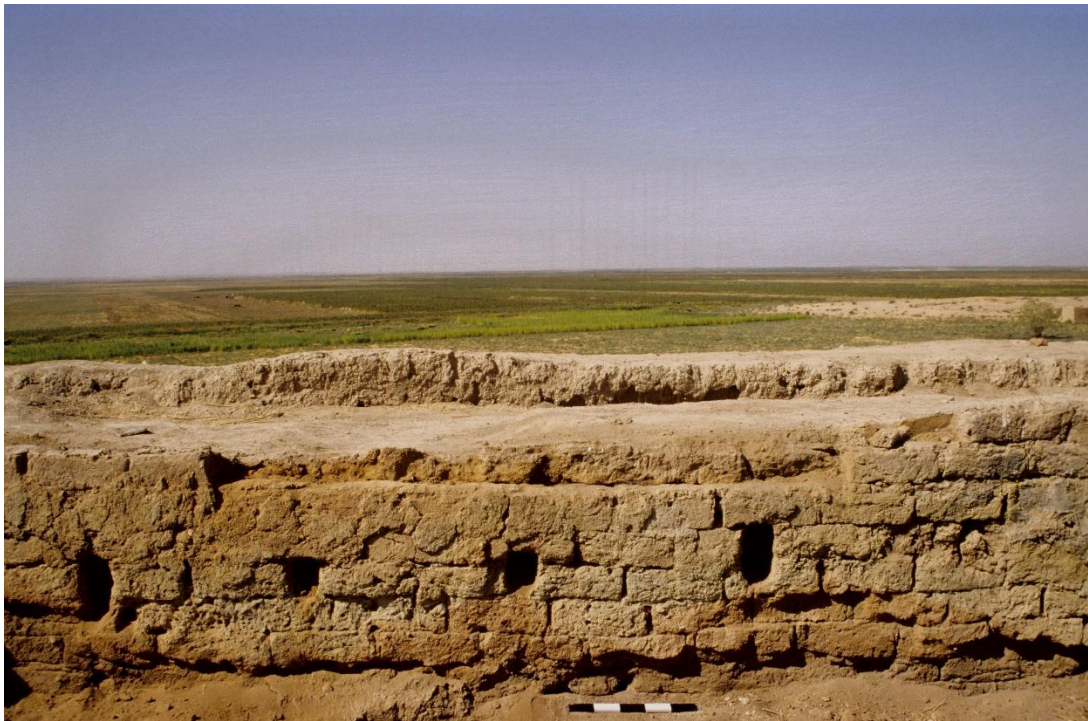
Figure 190. Holes on the interior face of the fortification wall in space NW1.
