Building Assyrian society: the case of the Tell Sabi Abyad Dunnu

Lanjouw, T.J.R.

VI. Architectural analysis

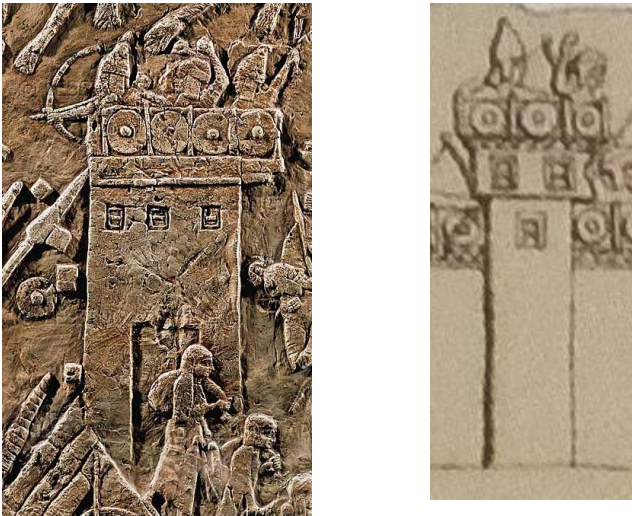
Figure 195. Left: a free standing tower on siege of Lachish with a platform. Note that the left side of the platform has already been destroyed by a siege machine. One of the shields and some bricks are shown falling. Right: one of the many towers in the city wall of Lachish.

For the shape of the superstructure, we have to refer to ancient depictions, or more preserved fortifications of more recent times. Although the depictions lack much detail, and may not even be accurate representations of reality, they do give a general idea of how complete fortifications looked. Most prominent

and useful are the bas-reliefs made to commemorate the conquests of the Neo-Assyrian kings (900-612 BCE). Although these are Iron Age in date, it is unlikely that fortification architecture had changed much since the Bronze Age, as siege technology had not seen significant changes from the Bronze to the Iron Age. On the Neo-Assyrian reliefs, we can see all the same tactics deployed – manual wall demolition, undermining, siege towers and battering rams – as were already listed for the Middle Bronze Age as essential elements. Also, most of the weapons carried by the offenders and defenders – the sling, the composite bow, the man-high curved defensive shield, smaller offensive shield, and spear and dagger – are essentially the same.⁷⁰ So there is some justification in using Neo-Assyrian representations of fortifications to develop an idea of Late Bronze Age fortifications. Moreover, depictions of Levantine and Syrian fortifications made in Egypt during the Late Bronze Age (Naumann, 1955, pp. 111–115), are in essence very similar to the Assyrian ones but for some minor details discussed below.

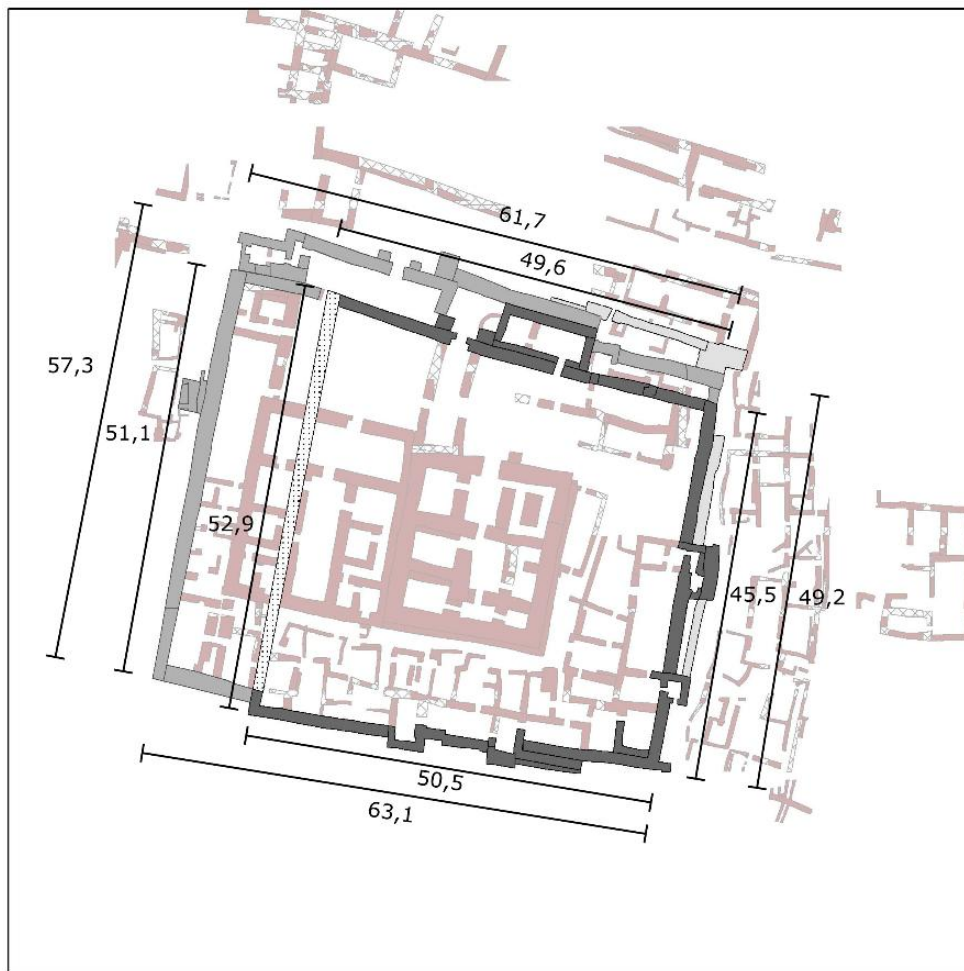
Figure 199. Dimensions of the fortifications, indicating a possibly smaller square, earlier phase.

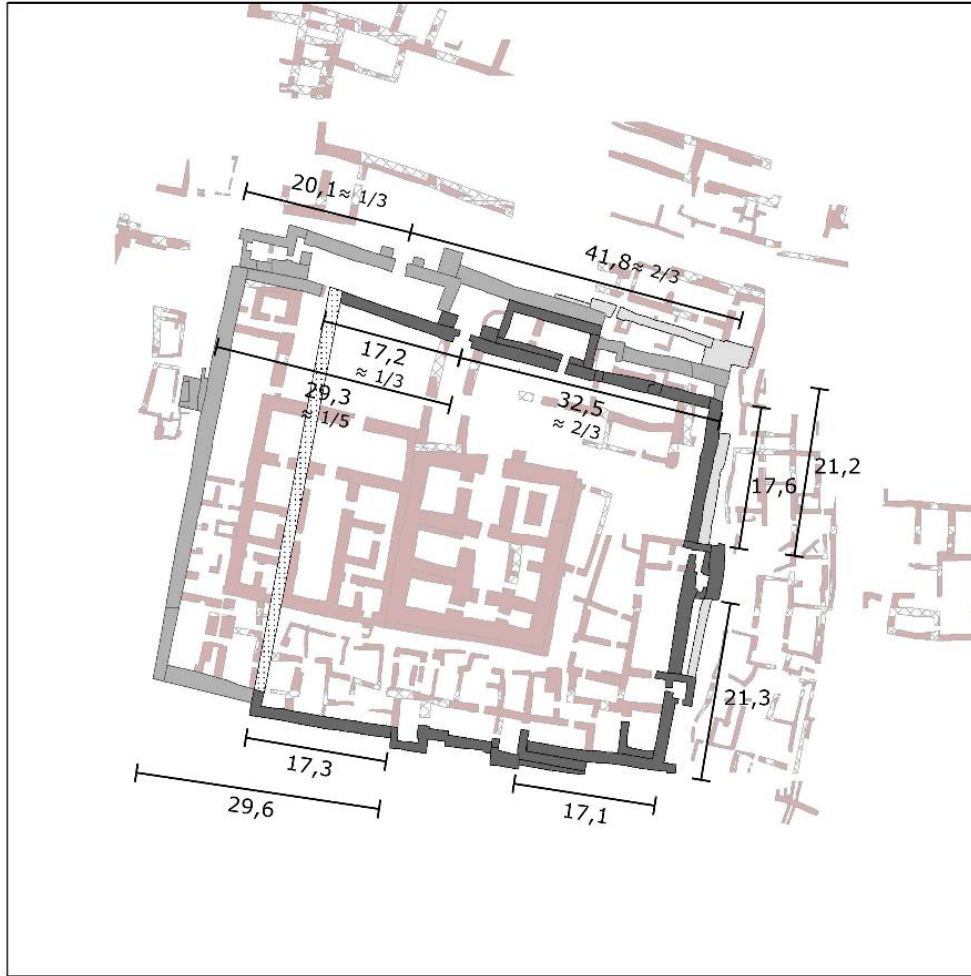
Figure 200. Dimensions of the fortification, indicating regularities with regards to placement of main gate (old and new) and other defensive features.

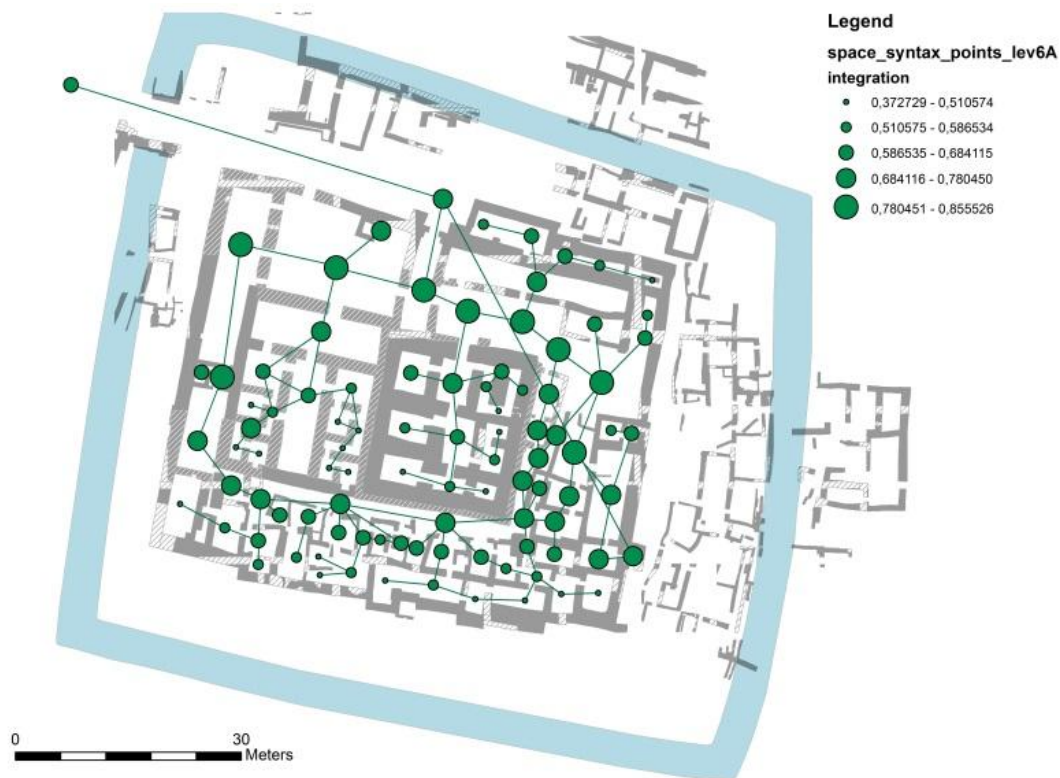
Figure 206. Integration, early phase Dunnu.

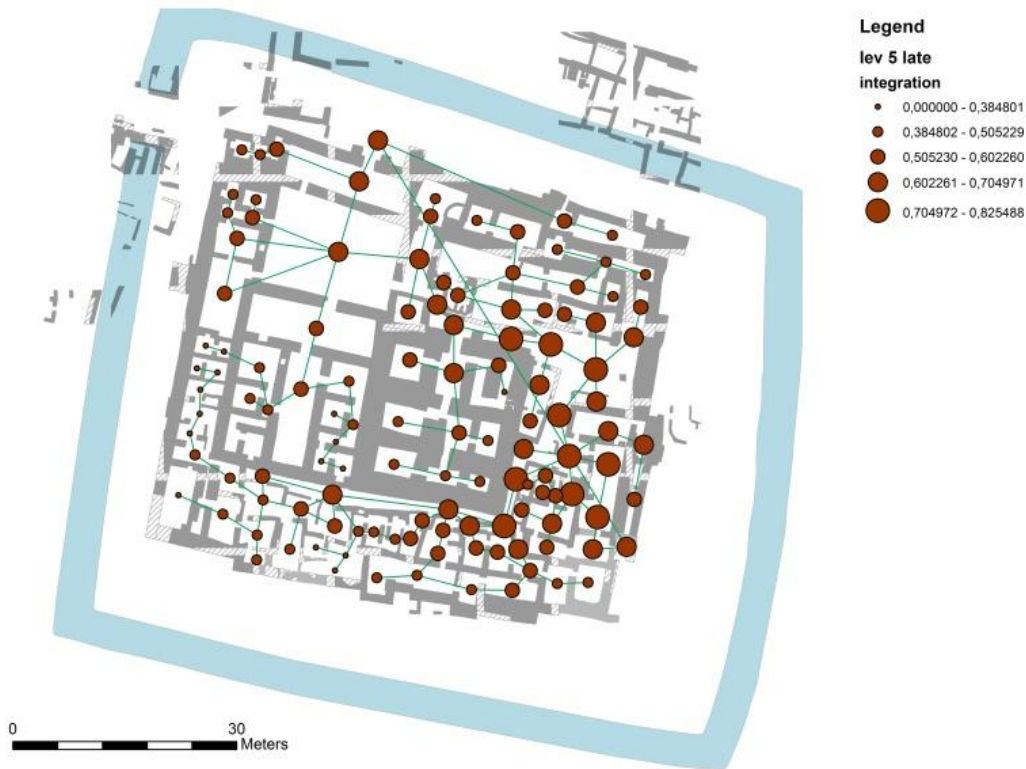
Figure 207. Integration, later phase Dunnu.

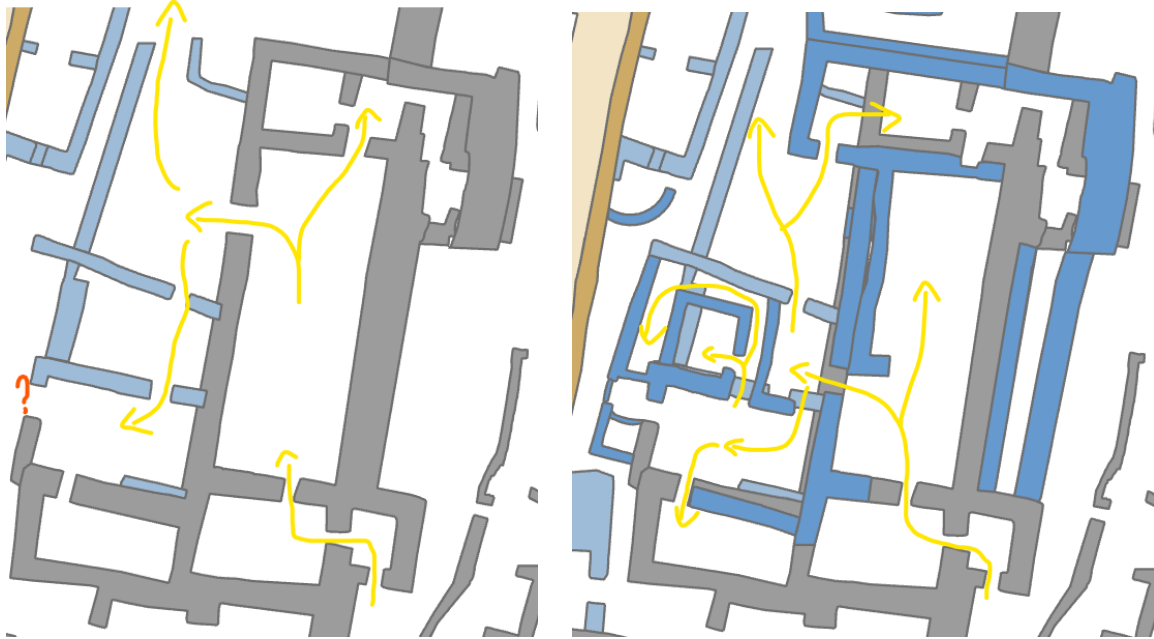
Figure 210. Modifications in south-eastern sector had significant effect on access configuration and distances.
