## Tailoring x-ray tomography techniques for cultural heritage research

Bossema, F.G.

## Integrating expert feedback in an explorative CT scanning workflow

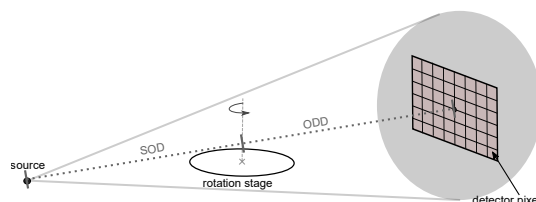
**Figure 2.1:** Schematic representation of a CT setup.

A CT setup consists of the following components: an X-ray source, a rotation stage and a detector. The diagram in figure 2.1 illustrates a point source that emits X-rays in a conical shape onto a flat panel detector. These X-rays travel through the object, which is mounted on the rotation stage. The absorption is material dependent [48, 50, 95]. The energy of the X-rays and the exposure time influence the quality of the data and determine the effective radiation dose the object receives. The potential effect of the radiation exposure depends on the settings of the scan and the characteristics of the object [17, 83].

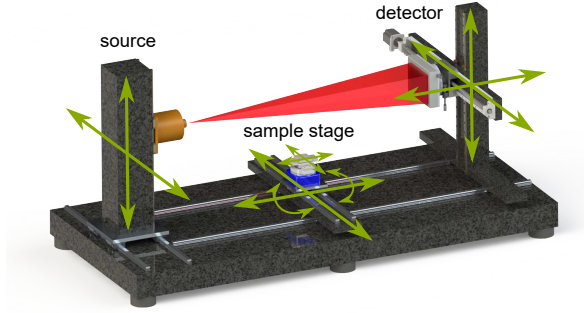
**Figure 2.2:** Schematic representation of the freedom of movement of components, indicated by arrows, in the FleX-ray laboratory CT setup. Image made after figure 2b in [53], with permission from the authors.

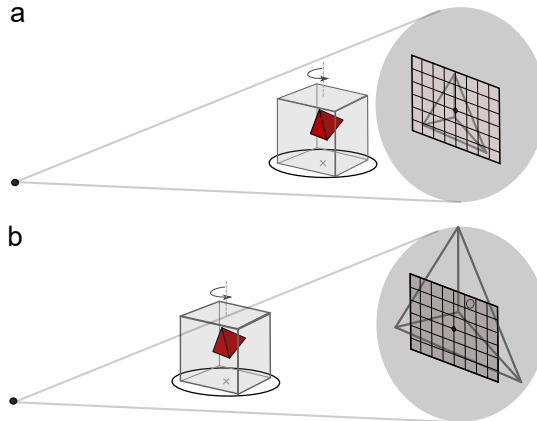
**Figure 2.3:** Schematic of the zooming in on an object in a CT setup. a) Imaging a pyramid in a box: at this magnification, the entire pyramid is visible on the detector. b) Zooming in to achieve higher resolution, by moving the rotation stage with the object closer to the source. More details can now be seen, such as the tiny void within the pyramid.

Zooming can be achieved by increasing the magnification of the object, for example by moving it closer to the source. This is shown in figure 2.3. In figure 2.4 an example of zooming is shown on a CT scan of a fragment of fabric [36], a mock object resembling a type of object we may encounter in cultural heritage studies.

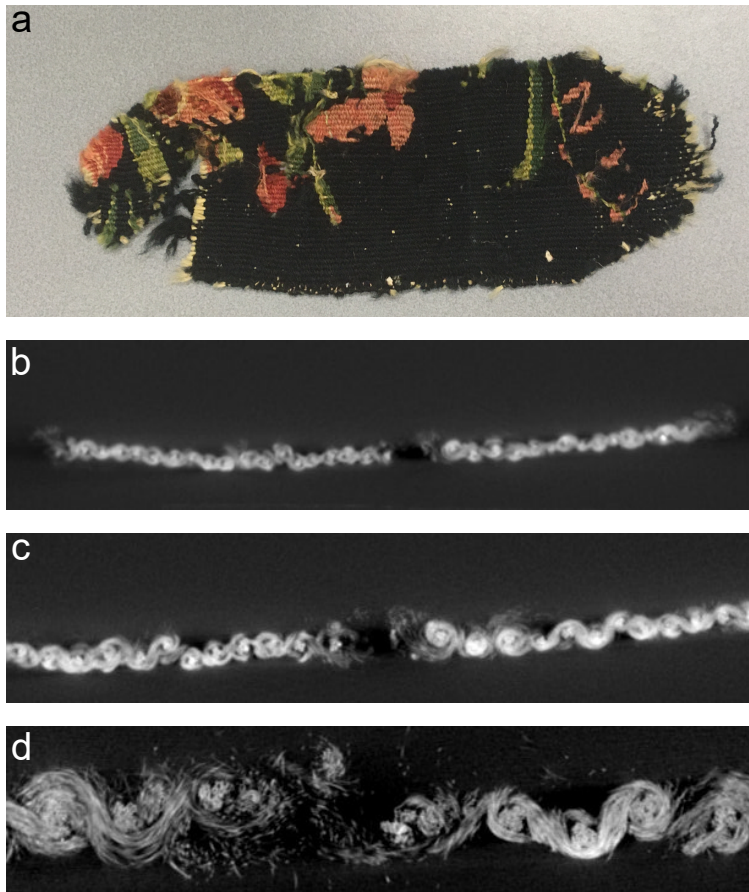
**Figure 2.4:** Example CT scans of a fragment of fabric to illustrate zooming. a) The piece of woven fabric that was scanned. b) Reconstruction slice from a low resolution CT scan (voxel size: 131 micron). The hole in the middle of the fabric can be perceived. c) Reconstruction slice from a higher resolution region of interest CT scan (voxel size: 82 micron). This higher resolution shows the knots in the weaving pattern of the fabric. d) Reconstruction slice from a high resolution region of interest CT scan (voxel size: 33 micron). At this resolution the individual yarns and, where the fabric is frayed, the individual threads that make up the yarn can be seen.

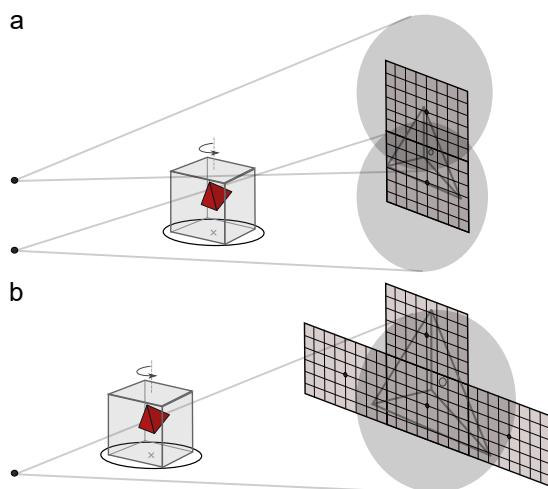
**Figure 2.5:** Schematic of how tiling is achieved in a CT setup. a) Vertical tiling: changing both source and detector positions between the CT scans. b) Tiling to capture the entire object at a higher magnification, example given here is performed by changing the detector position while keeping the source fixed.

Tiled scans can be performed by moving the source and detector around between CT scans, a full rotation of the object is recorded for each location. Examples of tiling modes are given in figure 2.5. In figure 2.6 we present an example of a vertically tiled CT scan [40, 41] of an oak sculpture of *Woman with lantern*, 35.8 cm high, c. 1500-1525 (Rijksmuseum, Amsterdam) [159]. It was scanned for the purpose of dating by tree ring measurement [63].

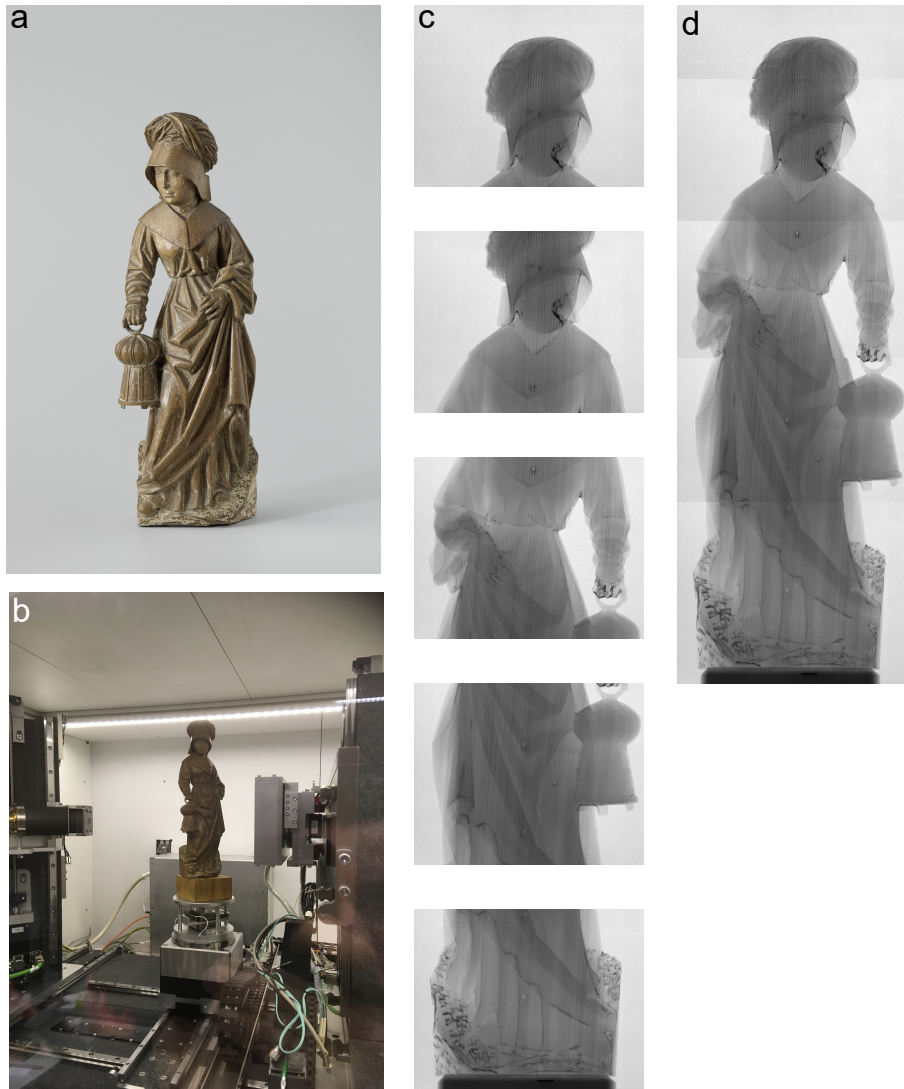
**Figure 2.6:** Example CT scan of a wooden sculpture to illustrate tiled scanning. a) *Woman with lantern* [159]. b) The sculpture mounted on the rotation stage in the FleX-ray scanner. c) Radiographs showing the five tiles needed to image the entire object. d) The radiographs in (c) combined to obtain a single radiograph of the entire sculpture.

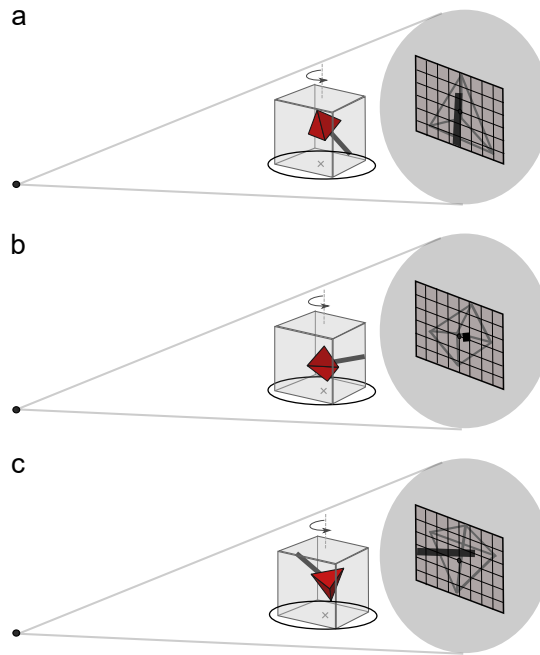
**Figure 2.7:** Schematic of changing object orientation in a CT setup. a) Here, the scanned object contains a metal stick. When rotated, the shape of the shadow on the detector remains approximately the same, forming a barrier over different parts of the object in the radiographs. b) Changing the orientation with respect to (a), with the metal stick now parallel to the rotation stage. The shadow of the stick ranges from only a dot to a horizontal bar (see (c)). The difference in shadowing during the scan will affect some parts of the object more than the others. c) The object in the same orientation as in (b), rotated by 90 degrees.

Object orientation can be adjusted either by manually changing the positioning of the object on the stage (possibly changing the mount of the object) or by adjusting the trajectory of the source and detector to achieve a similar change of viewpoint. In figure 2.7 the effect of object orientation on the radiograph of an object with a metal support is shown. As an example object, we CT scanned an ivory bead with a metal bar through the middle to show the effect of object orientation on the reconstructed image, shown in figure 2.8.

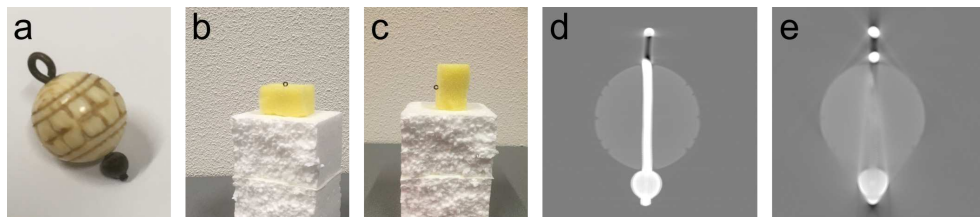
**Figure 2.8:** Example CT scans of an ivory bead on a metal bar to illustrate the use of object orientation to avoid shadowing by dense materials. a) Ivory bead on a metal bar. The bead is contained in a piece of sponge for scanning in two orientations: b) vertical (left) and c) horizontal (right). d) Slice of the 3D reconstruction of the bead with the bar vertical during CT scanning. e) Slice of the 3D reconstruction of the bead with the bar horizontal during CT scanning. The reconstructed volume was aligned with the volume in d) using manual landmark registration to show an equivalent slice through the object.

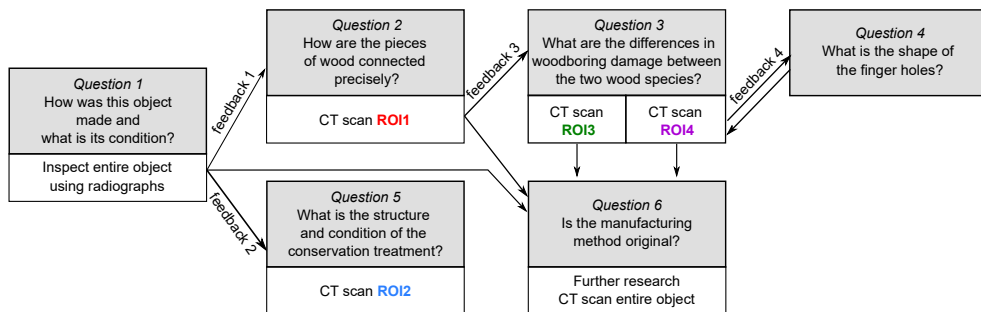
Figure 2.9: Schematic of the workflow employed during the investigation of the cornett.

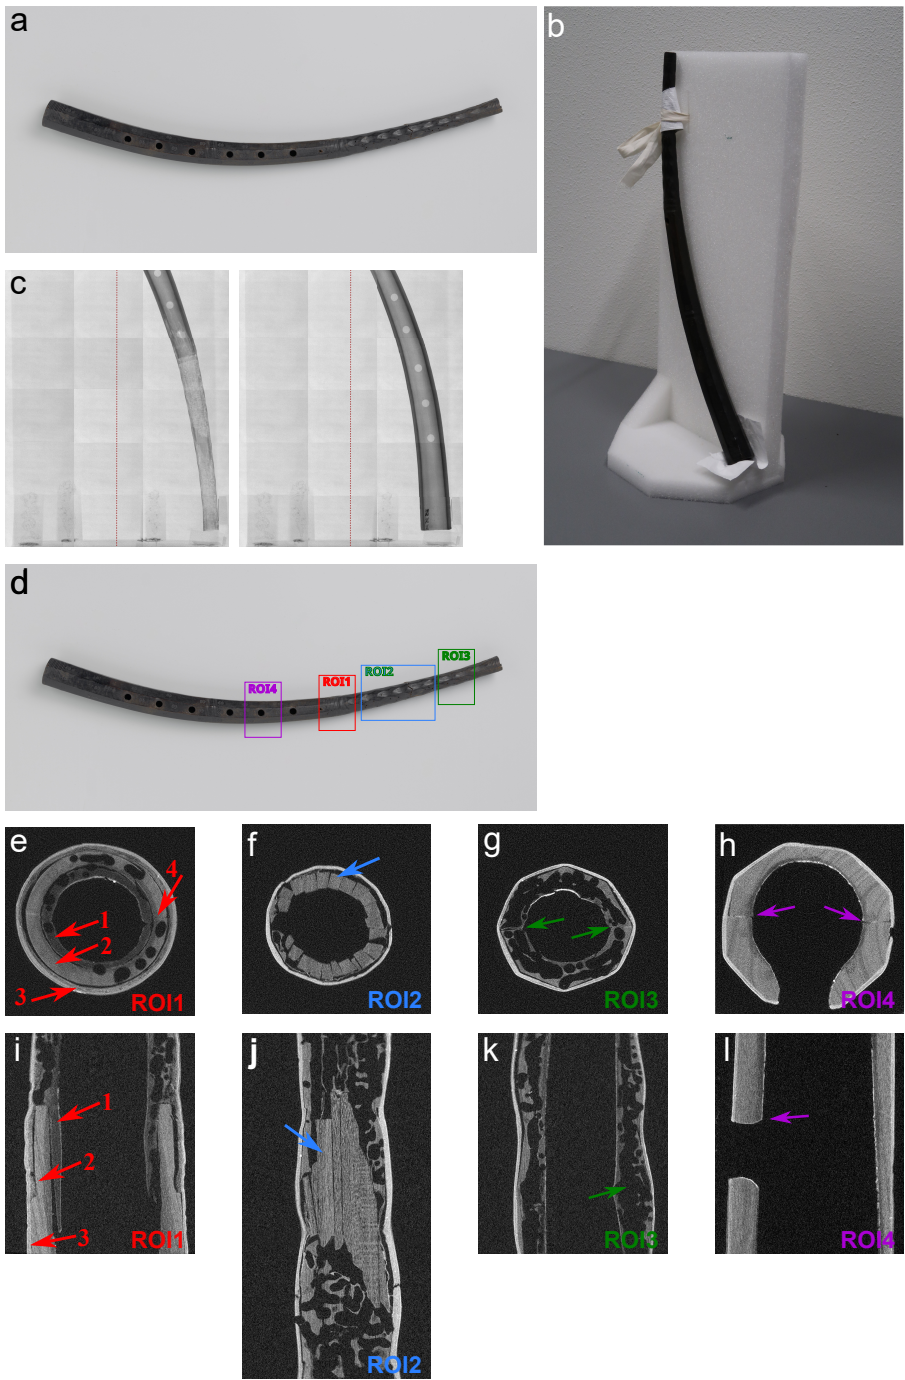
**Figure 2.10:** The case study concerning the CT scanning a 17th century cornett. a) Cornett. [157]. b) The cornett and its Ethafoam® mount. c) Left: 15 tiles to inspect the upper part of the cornett with radiographs. The 15 tiles show the necessary range of motion to rotate the object over 360° during inspection. Right: 15 tiles to inspect the lower part of the cornett with radiographs after rotating it vertically on the mount. The red dashed line indicates the centre of rotation mapped onto the merged radiographs. d) The cornett with the regions of interest (ROI) indicated in rectangles. e) Horizontal reconstruction slice of ROI1 (voxel size 25 micron), showing the wood of the upper part (1) and lower part (2) within each other, the leather lining (3) on the outside and the thin glue joint separating the two longitudinal wood pieces (4). f) Horizontal reconstruction slice of ROI2 (voxel size 25 micron), showing the wooden sticks inserted during the conservation treatment (marked by the arrow). g) Horizontal reconstruction slice of ROI3 (voxel size 25 micron), showing the damage by insect infestation in the upper section of the cornett and the joint (marked by the arrow). h) Horizontal reconstruction slice of ROI4 (voxel size 25 micron), showing the tree rings, joint (marked by the arrows) and a finger hole. i) Vertical reconstruction slice of ROI1, showing the lap-joint between the upper wood (1), and lower wood (2) and the leather lining (3). j) Vertical reconstruction slice of ROI2, showing the wooden sticks inserted during the conservation treatment (marked by the arrow). k) Vertical reconstruction slice of ROI3, showing the damage by insect infestation in the upper section of the cornett (marked by the arrow). l) Vertical reconstruction slice of ROI4, showing the shape of the finger hole (marked by the arrow).

The object under investigation is a cornett (see figure 2.10a), a curved woodwind musical instrument made in Italy between 1600-1650 (Rijksmuseum, Amsterdam) [157]. The cornett is made of wood, entirely lined with leather and is 56cm long. A recent study [93], performed during the conservation treatment on a fracture in the upper part of the cornett, has shown that it consists of different wood species: the upper section containing the mouthpiece, identified as cherry wood, being severely damaged by insect infestation, while the lower part containing the finger holes, probably made of boxwood, was left almost untouched. The initial question concerned the manufacturing method and conservation status of the cornett (*Question 1* in figure 2.9). As the leather lining does not allow a visual inspection of the wooden parts of the cornett, CT scanning was employed to visualise the interior.

To ensure that the object was securely mounted on the rotation stage, a mount was specifically designed for the cornett (see figure 2.10b). It was made from a rectangular piece of Ethafoam® [69], attached with polyethylene hotmelt adhesive within a groove in an octagonal foam base to create a vertical stand. One end of the object rested in a cut-out in the foam base, and the object was secured upright with a cotton tape through a hole in the vertical stand. This made it possible to safely modify the object position and to flip it vertically on the stand. Ethafoam® is often used for mounting as it is cheap and widely available, easy to mould into an appropriate shape, and lightly absorbs the travelling X-rays.

We zoomed in by moving the object closer to the source to focus on the region of interest with image resolution 25 micron (ROI 1, see figure 2.10e,i). Analysis of the reconstruction of this CT scan confirmed that the pieces of wood were connected with a lap-joint with different layers of material (leather and wood) clearly identified. It also became apparent that both the lower and upper sections consist of two longitudinal pieces of wood, as a thin glue joint was visible on the horizontal slices (figure 2.10e). The conservators then wanted to investigate the difference in woodboring damage between the two species (*Question 3*). Total time needed was 35 minutes (preparation: 5min, scan:15min, reconstruction: 10min, discussion: 5min).

The location for the ROI4 CT scan was chosen to include a finger hole, which could provide a possible insight into the manufacturing process: the shape of the finger and thumb holes (*Feedback 4*). Based on the analysis, the conservators identified the finger hole to be undercut to account for intonation corrections by the maker.

Following the inspection by radiographs of the full object, the conservators were also interested in the location where the cornett had been broken and later restored in 2018 [93]. In order to investigate and monitor the structure and long term effect of the restoration, ROI2 was scanned at 25 micron image resolution. According to the conservation report, small custom-shaped sticks were inserted to replace missing wood. The inserts were covered with Japanese paper and retouched so that the intervention is practically invisible from the outside. The region of interest was larger than the previous ones, meaning a 2-tile CT scan was necessary to capture the details at the same resolution. The reconstruction showed the conservation method clearly (Figures 2.10f,j), providing an excellent documentation for future reference and for the monitoring of long term effects. The total time needed for this investigation was 1 hour (preparation: 10min, scan: 30min, reconstruction: 10min, discussion: 10min).
